Failure evidences of reduced span bridges in case of extreme rainfalls The case of Livorno

Mario Lucio Puppio, Sara Novelli

ABSTRACT. The heavy rainfalls occurring in Italy in the last few years focused the attention on the vulnerability of the land and the related infrastructures. Critical situations involving losses of human life and deterioration or failure of relevant structures are frequent. These events were due to: (1) improper land-use; (2) aging of infrastructures, (3) insufficient maintenance and protection; (4) climate changes causing rainstorms similar to tropical events. The failure of small bridges in road networks plays a key role in this sense. The present paper aims to analyse the behaviour of small bridges during rainfalls or floods. In particular, the recent case of Livorno is analysed. The Italian territory has about 460.000 small bridges, mostly designed without the support of technical codes or a proper interaction between the hydraulic and structural aspects. A large part of them can be submerged by water flows during rainfalls and pushed by unexpected actions.

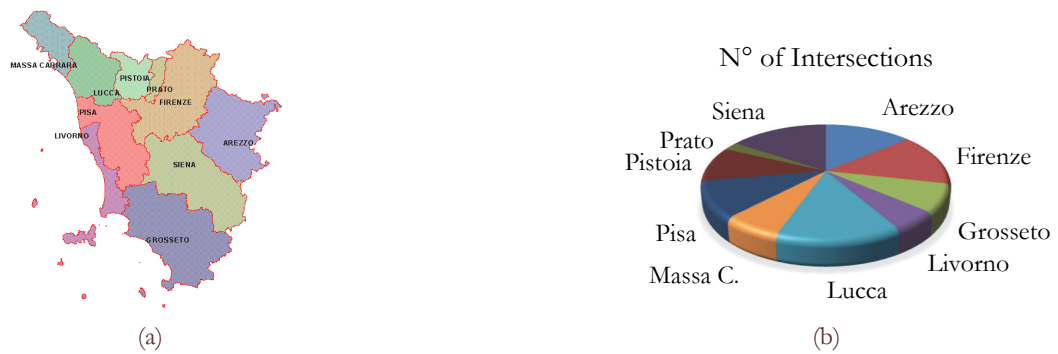
Figure 2: Distribution of small bridges in Tuscany. Extension of Tuscan provinces (a); Distribution of intersections per province (b).

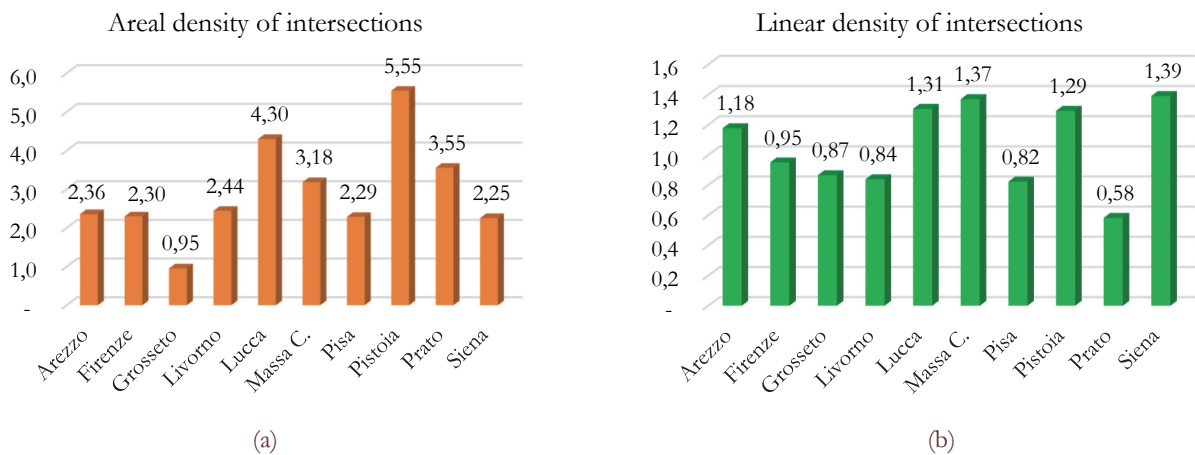
Figure 3: Areal density (a) and linear density (b) of reduced span bridges in Tuscany.

The survey of infrastructures in this area has been carried out through Gis software (Q-GIS rel. 2.18 Las Palmas) intersecting the road network with the hydrographical one [17-18]. This instrument allows a classification of bridges according to the importance of the networks generating the intersection. In Tuscany there are about 50.000 small bridges, whose classification in the Tuscan provinces is given in Fig. 2. An average density of 2.92 intersections per km² and a linear density of 1.06 intersections per km are recorded; the crossing density in the single provinces is given in Fig. 3.

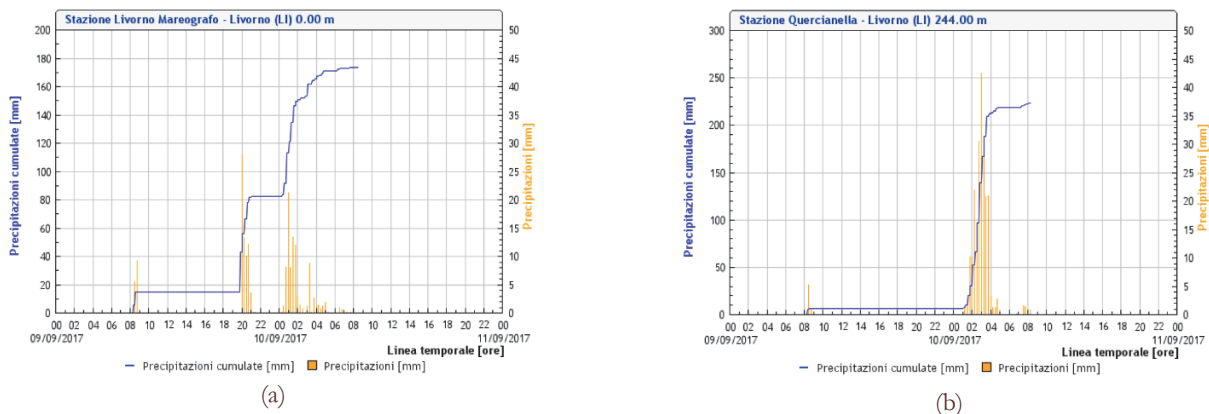
Figure 4: Rainfalls in Livorno between 09 and 10 September 2017. Station of Livorno - Mareograph, elevation 0.00m (a); Station of Quercianella, elevation 244.00m (b).

The event of Livorno in 2017 was characterised by several storm systems generated between the sea and the coast from 8 p.m. on Saturday 9 September and 6 a.m. on Sunday 10 September. The epicentre of low-pressure occurred in the area between Livorno and Pisa, with three intervals of a higher intensity (Fig. 4). During the first interval, lasting about 45 minutes, very high intensities of 24 mm were recorded as well as an amass of 65 mm. Later, in the early Sunday morning of 10 September, a new stormy impulse affected mostly the areas between the south of Livorno and Rosignano. During this interval there were 65 further mm falling on Livorno in about two hours. This was followed by another interval with a total height of rain of about 15 mm in a span of 5 hours. In the province of Livorno, near the thunder centre, maximum intensities of 42.5 mm were recorded in 15 minutes, with 235 mm in 3 hours (Pluviometer of Valle Benedetta). Comparing data shows that from 18.11.2017 to 18.12.2017 about 81 mm of accumulated rain fell on Livorno (in 30 days) with the maximum intensity of 32.1 mm a day. These data highlight the exceptional characteristics of the described meteorological event. Fig. 5 shows the map of accumulated rainfalls between 0.00 and 12 p.m. on 11.09.2017 (Fig. 5 - a) and accumulated rainfalls in the Station of Bocca d'Arno (Fig. 5 - b).

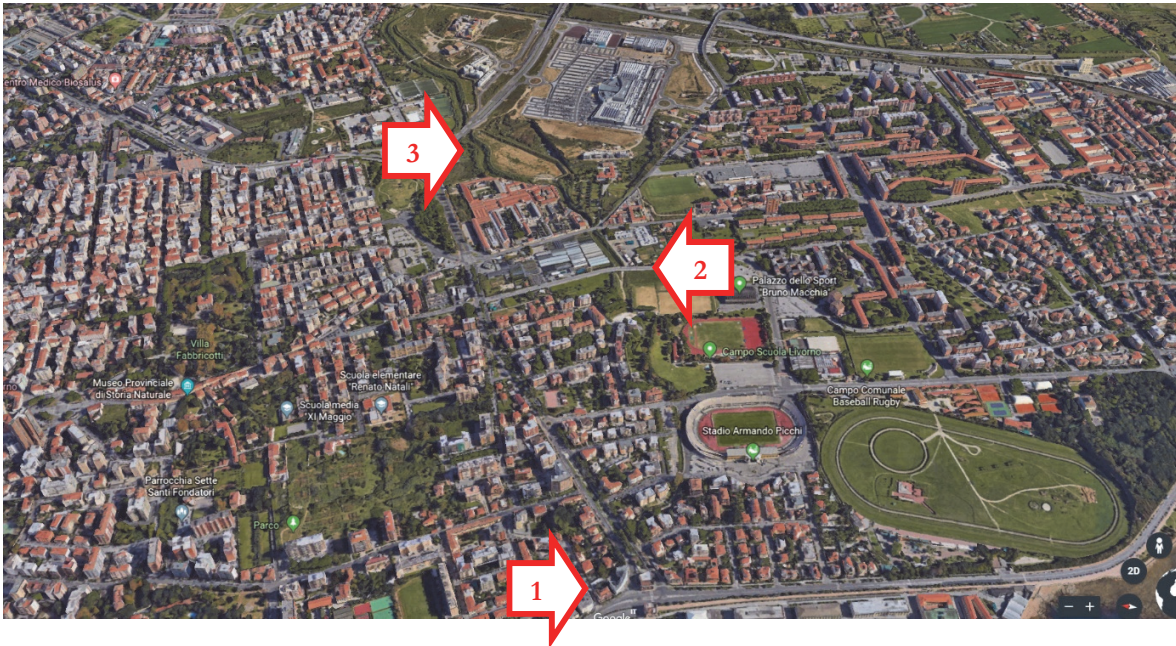
Figure 6: Top view of the area affected by the overflowing. (1) area of widest overflowing; (2) starting point where the Rio Maggiore is silted up; (3) one of the four detention basins.

The most remarkable event was the overflowing of Rio Maggiore. The filling of its final part took place in two stages and was concluded about 20 years ago. Upstream of the section where the Rio Maggiore is silted up there are four detention basins, recently created, mutually connected through a system of siphons (Fig. 6). The Rio Maggiore overflowing reached the first slab of some buildings, causing victims. According to surveys, the hydric height recorded in town equals about 50 cm in the filling mouth, up to a maximum of 4 m recorded in the lowest areas (Fig. 7).

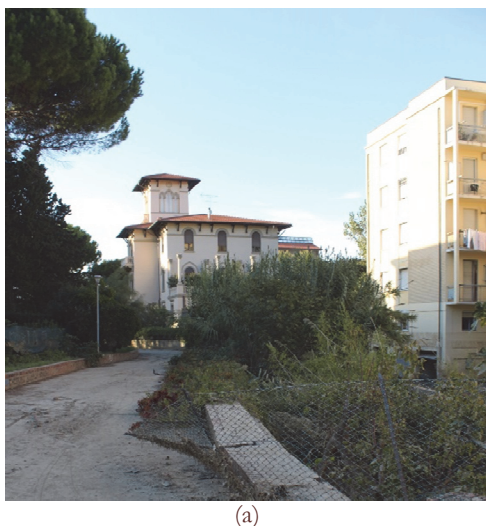
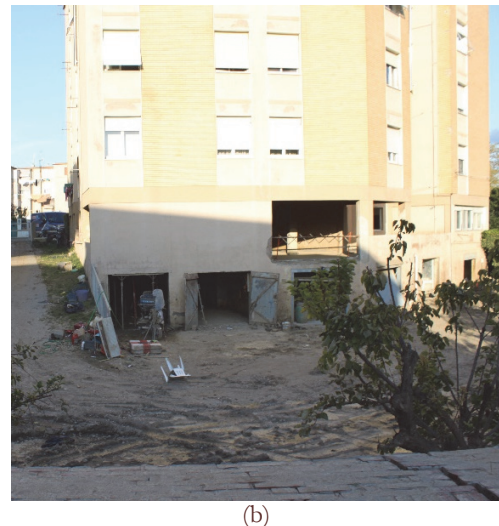
Figure 7: Buildings damaged by the flood, photo taken from an inner street near via Nazario Sauro. Building where the tragedy occurred, on the foreground a small wall overturned by the load of the flow; (a); other blocks of flats, the basement was totally flooded, the overflow reached the windows on the first ground (b).

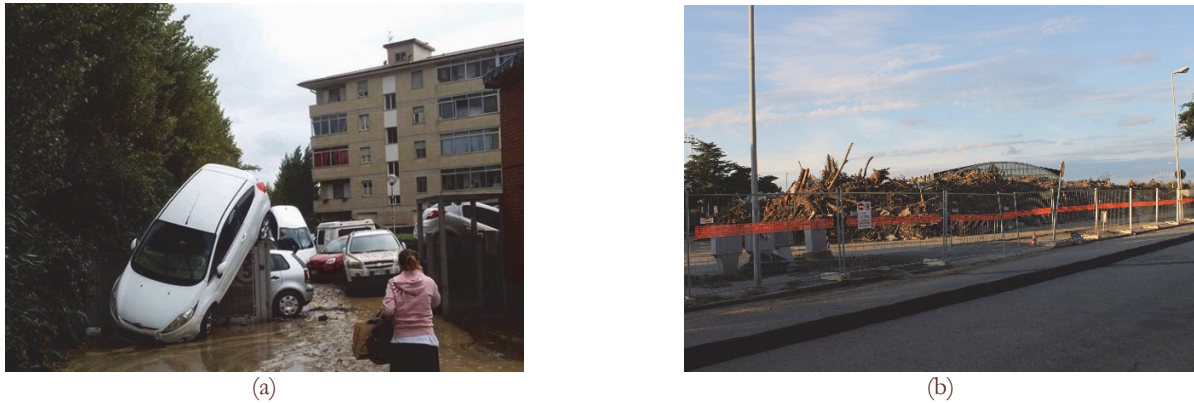
Figure 8: Cars damaged during the flood (a); waste carried by the flow, collected in a service area before being disposed (b).

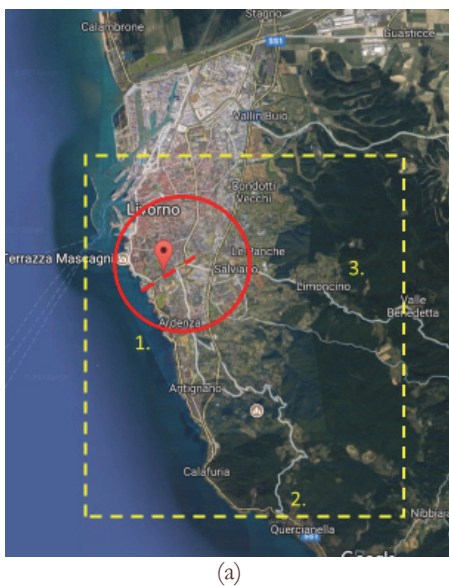
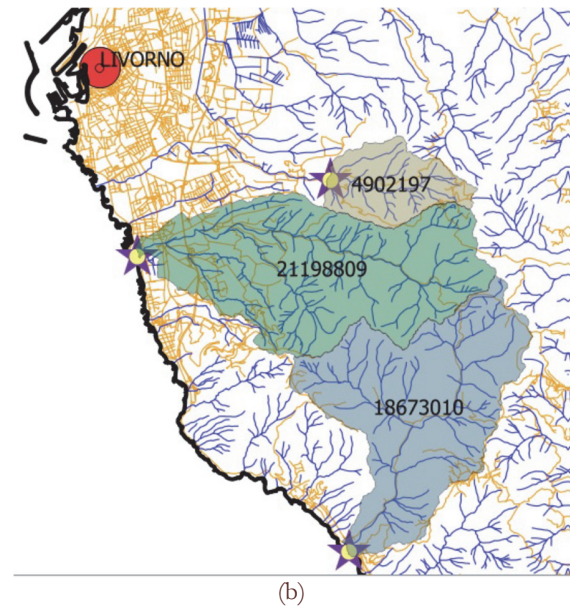
Figure 9: Identification of study cases. The bridge 1 is localized in the urban area while the bridges 2 and 3 in a suburban one. The circle highlights the flooded area where the Rio Maggiore overflowed (a). Catching basins related to sections 1, 2 and 3 (b).

These are: (1) the parapet collapse; (2) the dragging of decks; (3) the bridge abutments or the access ramps erosion. The hydraulic load on the deck in case of overflow can favour the latter. Surveys actually reported that the stream overflowed the three bridges. References to the three study cases are reported as follows. Their position is identified in Fig. 9.

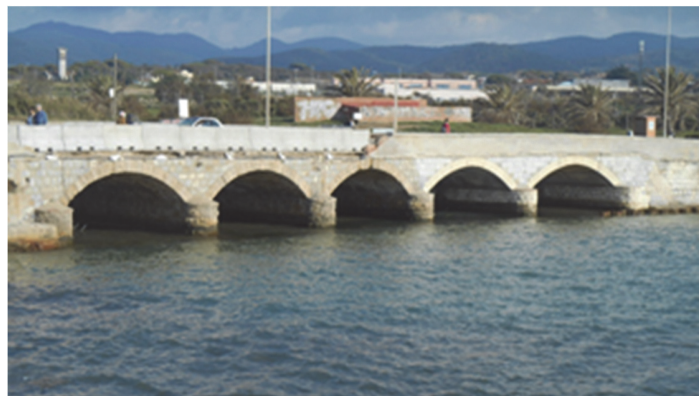
The first study case is a stonework bridge. It takes its name from the original structure including three arches, later widened to 5 as shown in Fig. 10. The bridge is on the mouth of the Ardenza River. It presents a slight upstream widening of the outflow section, in discrete maintenance conditions and characterised by low and grassy vegetation. The latter allows the stream slow down, thus protecting infrastructures in case of flood.

The bridge is made of big ashlars. Instead, the parapet was realised with a mix and vertical holed bricks. The use of cinder blocks is not infrequent in the realization of parapets. Arches present spans of 6 m (for a total outflow of about 30 m) and a rise of 3.5 m. The widest outflow section (when the infrastructure operates under pressure) corresponds to 63 m². A peak load equal to about 200 m³/s may be estimated as causing the collapse of a wide portion of the downstream parapet of the infrastructure.

Figure 10: Bridge on the Ardenza river, view from the sea side.

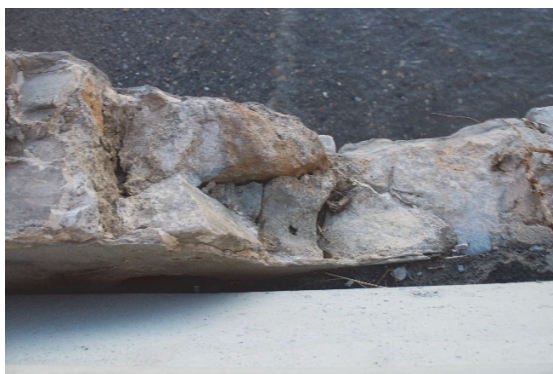
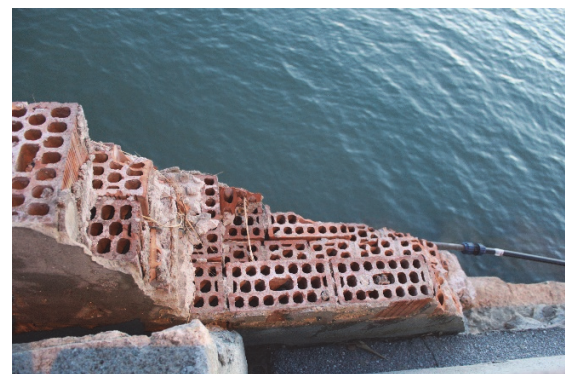
The study of further similar cases showed that in overlap conditions the downstream parapet is more affected, while the gradual load on the upstream one is partially balanced as the hydraulic level increases.

Figure 11: Residual portions of the parapet collapsed at "Tre Ponti".

The urgency provision for pedestrians' protection consisted in securing the site through concrete "new jersey" barriers (Fig. 11).

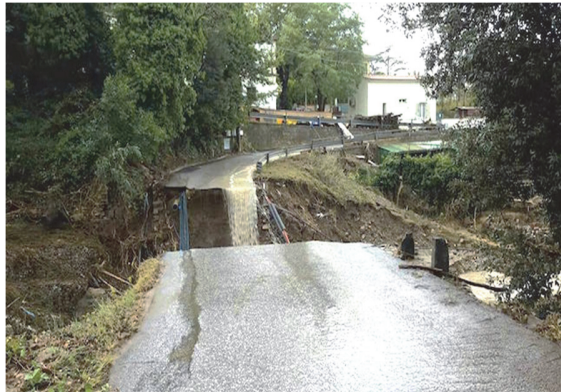
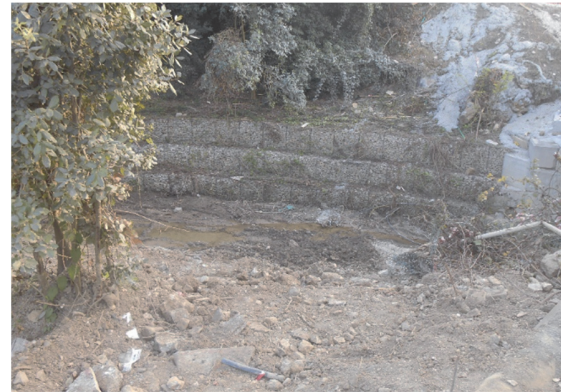
The flood wave dug out the downstream abutment causing either the collapse or the cutting of the plants spread along the road network (Fig. 12 - a). The gabions protecting the banks in the upstream section were not affected (Fig. 12 - b), and this also due to a wider upstream section of outflow. The bridge was promptly reconstructed with steel bars and a reinforced

Figure 12: The collapsed bridge on the Limoncino (a). Section of the upstream riverbed protected by gabions (b).

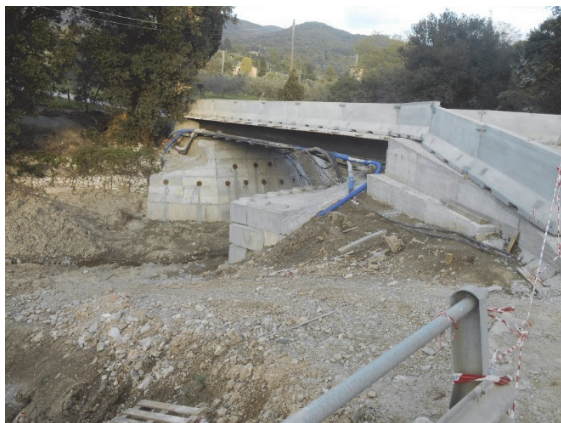
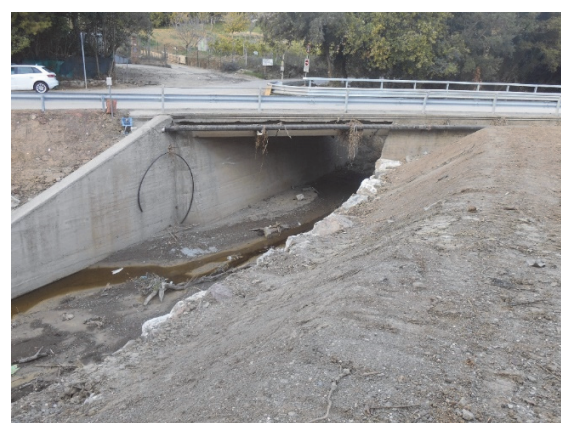
concrete deck (Fig. 13 - a). The benefits of coating abutments with reinforced concrete walls were experimented in a section geometrically similar to the collapsed one, further downstream along the same watercourse. The section on the bridge, though insufficient to allow the free outflow of the stream, resisted to the flood thanks to concrete wing walls. (Fig. 13 - b).

Figure 13: Reconstruction of the Limoncino bridge through steel beams and reinforced concrete abutments (a); further bridge on the Rio Maggiore showing overlap signs (b).

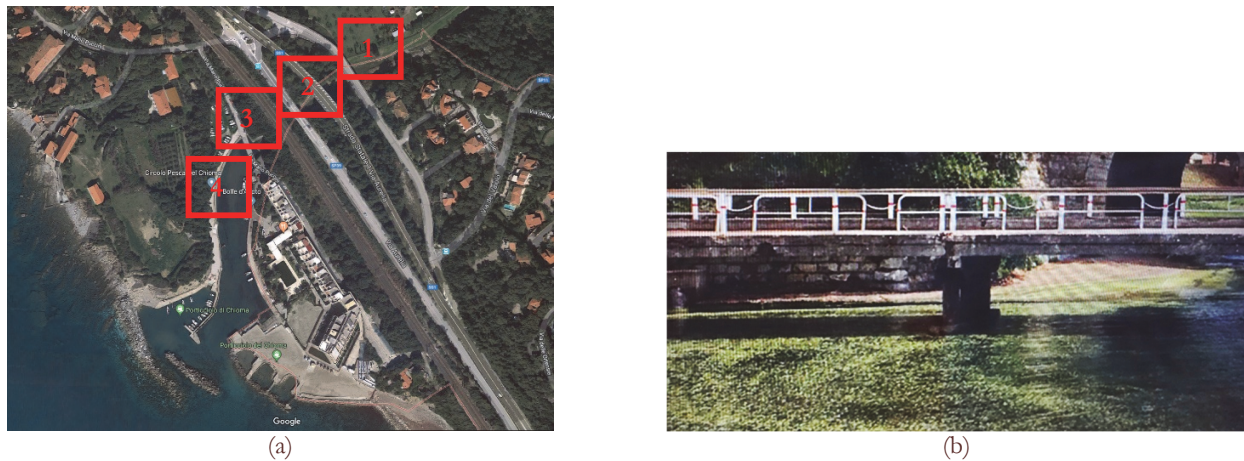
This bridge stands on the river Chioma, near its outlet, inside a small touristic harbour. It is a bridge for vehicles, of the beam type, with an intermediate pier centrally positioned inside the riverbed. Parapets were realised with steel tubular profiles.

In this area four bridges stand very close to each other, of different types and building periods as represented in Fig. 14 (a). The outflow sections of these bridges arranged in a series are higher than the ones of the failed bridge.

The structure of the small harbour, with an outflow section widely extended to the sea and a good protection from the waves, allows favourable outflow conditions at the bridge (number 4 in Fig. 14 (a)). At 03:40 of 10 September 2017 (as proved by online videos) a free surface outflow was recorded at the level of the bridge intrados. An hour later the hydric level had reached the bridge extrados, making the infrastructure operate under pressure. At about 05.00 in the morning, after 30 minutes of this operating pressure, through the strongest hydraulic load, the infrastructure was crushed by the flow. The collapse occurred under a very strong hydraulic load, probably because the abutment on the right bank had been undermined, leading to the consequent collapse of the central pier.

Figure 14: Top view of the Chioma small harbour (a) View of the small bridge with the intermediate pier (b).

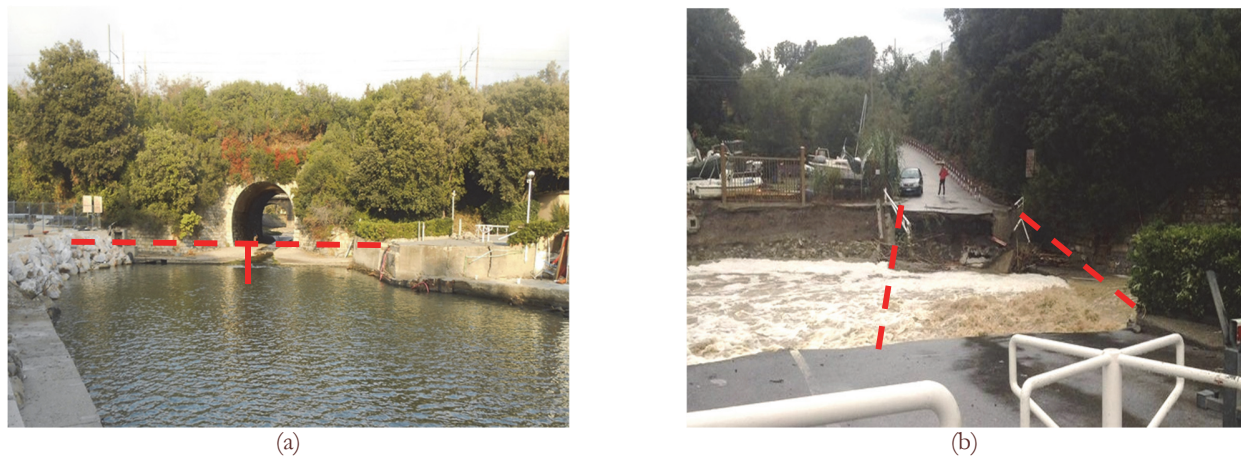
Figure 15: View from the Chioma small harbour (a) Bottom view of the harbour (b).

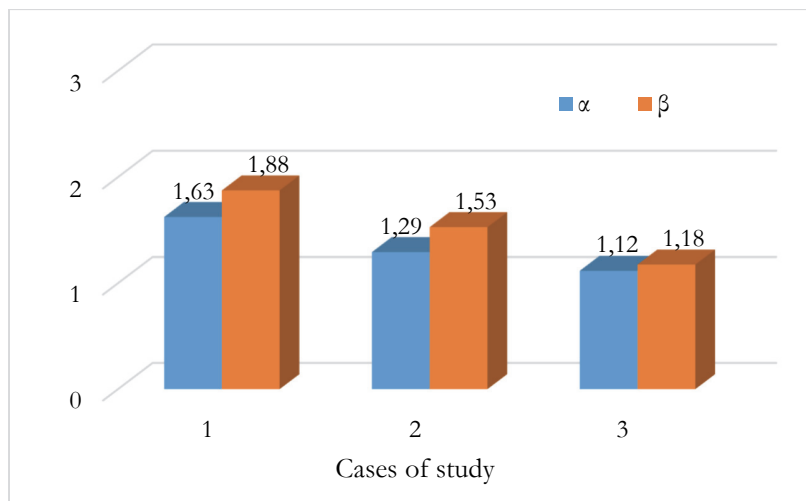
Figure 17: Coefficients α and β for the three study case examined.

Normalizing the flow rates Q_B and Q_C according to the flow rate Q_A , the following coefficients are calculated. These are higher than the unit, being Q_B and Q_C always higher than Q_A and represent the further outflow capacities that the bridge can have in unusual conditions. These are represented in the histogram of Fig. 17 for the three study cases examined. As it can be seen, the bridge 1 (Tab. 7) shows higher outflow capacity than the study cases 2 and 3. This does not prove the safety of the bridge, since in case of overlap the resistance to unusual and erosive actions has always to be considered [9].
