# FRACTURE OF CONCRETE CYLINDERS SUBJECTED TO TORSION

G. Lilliu and J.G.M. van Mier

Microlab, Faculty of Civil Engineering and Geosciences,  
Delft University of Technology  
P.O. Box 5048, 2600 GA Delft, The Netherlands

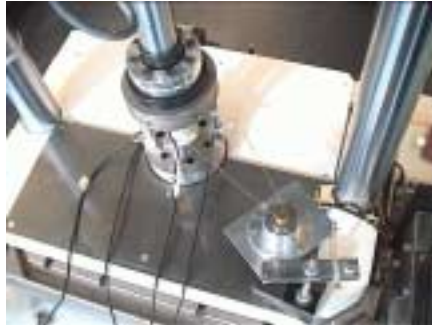
**Figure 1:** Set-up for measurements of the rotational angle

The tests were conducted with a servo-hydraulic INSTRON 8874. This machine has rotational and vertical loading axes, which can be coupled or de-coupled. The maximum loads which can be reached are 100 Nm and 10 kN, respectively. The feed-back signal during the tests is the rotation, measured with a rotational potentiometer connected to a wire attached to the upper loading platen, as shown in Figure 1.

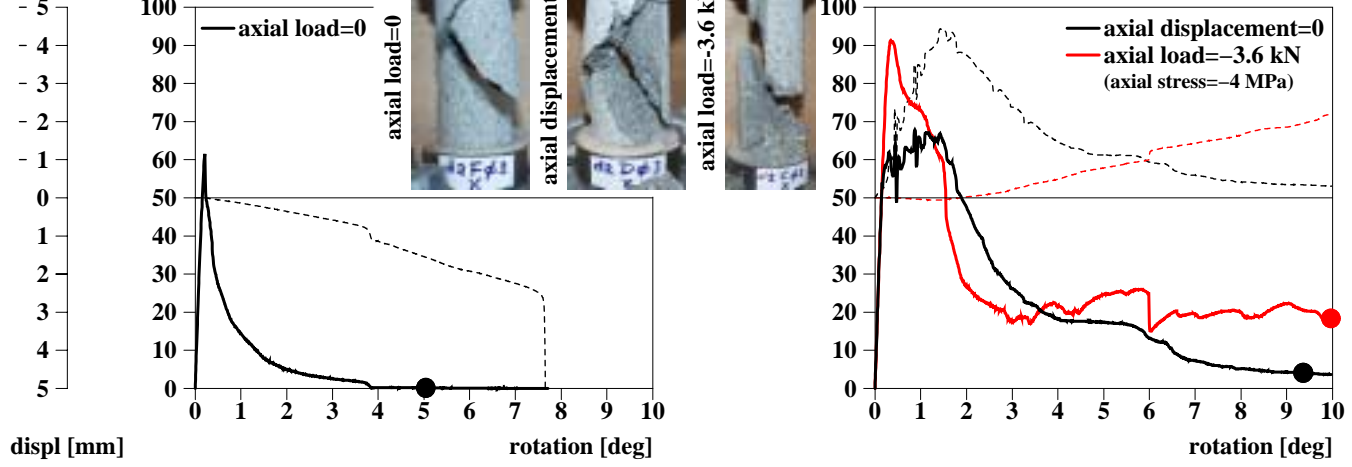
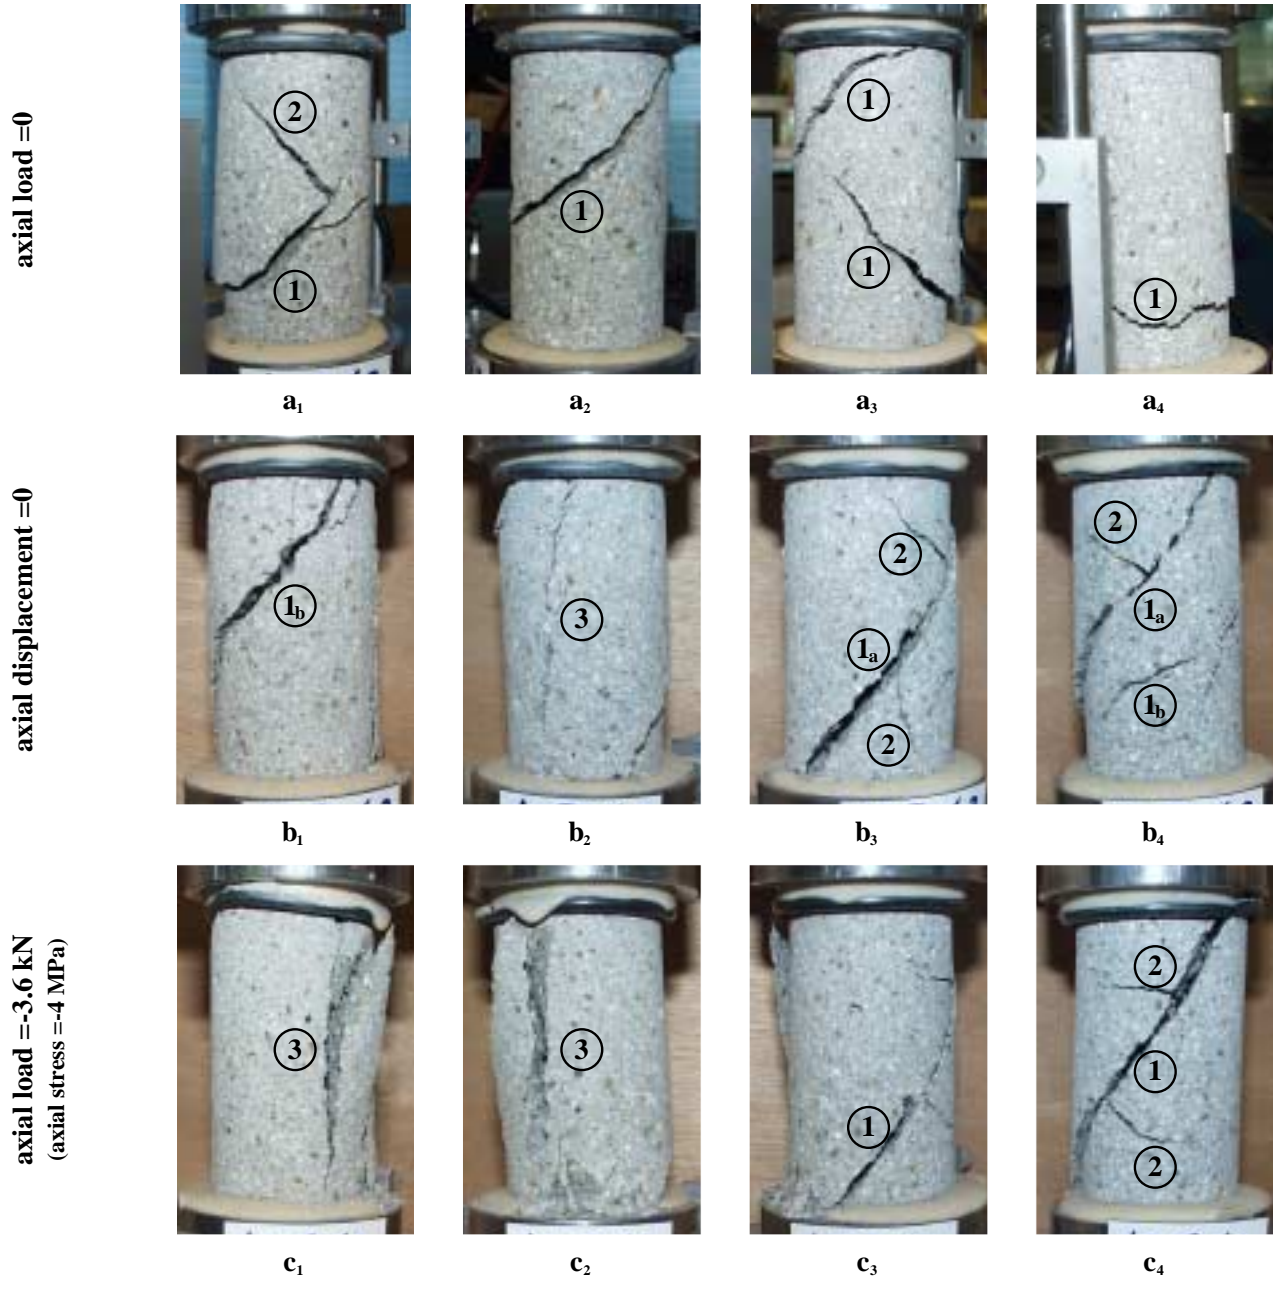
**Figure 2:** Experimental results obtained with un-notched specimens under zero axial force (a), zero axial displacement (b) and constant compressive load (c)

Independently from the axial restraint, the crack which can be detected as first with the naked eye is that with label 1 in the subfigures of Figure 2. This crack spirals around the specimen. It is not clear if it starts along the body of the specimen or at one of the ends, since it could be detected only after it covered the whole length of the cylinder. According to the solution of the linear elastic problem, the twisting moment is constant and the crack initiation should be just a consequence of stress concentrations due to the internal structure of the material. However, the specimen is clamped to the loading platens and cannot contract freely. As a consequence, a biaxial tensile stress state might arise at the ends of the specimen causing crack initiation. Other cracks, indicated with the label 2, depart from the spiralling crack as "wings". The spiralling crack can be either continuous or consists of more overlapping branches, like shown in Figure 2-a<sub>1</sub>. In other cases, more than one of such cracks can be detected (see Figure 2-b<sub>1</sub>, b<sub>3</sub> and b<sub>4</sub>).

When no axial load is applied, the spiralling crack travels towards the end of the specimen (Figure 2-a<sub>1</sub>) and turns, forming a loop (Figure 2-a<sub>3</sub>). In case of axial restraint, vertical cracks develop, producing spalling of concrete, as shown in Figure 2-c<sub>1</sub>. The cases of zero axial displacement (Figure 2, right top diagram) and constant axial compressive load are similar. In fact, when the specimen cannot elongate freely, a compressive force arises. Thus, the vertical cracks seem a consequence of the axial compressive stresses, although these are of very limited magnitude (4 MPa).

The torque-rotation diagrams have a peak and a softening branch. The tests stop when the external rotation has reached the maximum value, namely 10 deg. When there is no axial load the softening branch is extremely smooth and presents a long tail. The shape of the diagrams is somehow more complex when there is an axial restraint. In case of zero axial displacement, the torque-rotation diagram starts to descend gradually when the compressive force has reached the maximum value. Then, it shows changes of curvature, with corresponding changes of slope in the load-rotation curve. In case of compressive load, as in case of zero axial load, the diagram drops after the peak and the post-peak region is characterized by several changes of curvature, corresponding to a small elongation of the specimen. Afterwards, the cylinder begins to contract and the torque increases with the rotation. The presence of a constant compressive load seems to be a very effective confinement and, thus, strengthens the material. In fact, the peak torque is much higher than in the case of zero axial displacement, where the compression varies during the test.

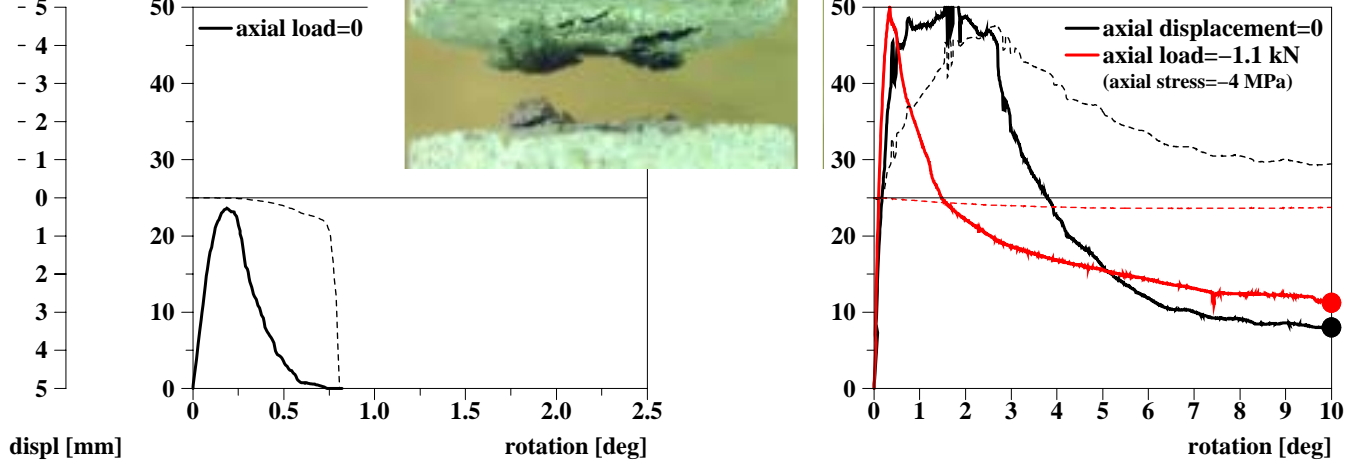
**Figure 3:** Experimental results obtained with notched specimens under zero axial displacement (a,c) and constant compressive load (b,d)

If no axial restraint is applied, the notch causes the localization of the fracture within its height. During the test, it was possible to observe inclined, parallel cracks on the surface of the cylinder's core. Coalescence of such cracks produced the final failure, as shown in the inset of the torque-rotation diagram (Figure 3).

When an axial restraint is applied cracking also starts at the notch. However, cracks are not localized within the height of the notch, but develop along half or even the complete specimen length. These cracks are similar to the spiralling cracks observed in the un-notched cylinders and seem to start right at the notch, where they show a wider opening. In the tests conducted under constant axial load only one half of the cylinder, namely the top half, was cracked (see Figure 3-b<sub>1</sub>, b<sub>2</sub>, b<sub>3</sub> and b<sub>4</sub>). Two of the tests conducted under zero axial displacement

Figure 3-a<sub>1</sub>, a<sub>2</sub>, a<sub>3</sub> and a<sub>4</sub>). In all the cases considered, a final conical failure surface as reported earlier by Bažant et al. [5] was observed. The cone appeared flatter in the tests conducted under constant compressive force (see Figure 3-d) than in tests under zero axial displacement (see Figure 3-c).

Similar to the tests on un-notched cylinders, in the notched cylinder tests under zero axial displacement a compressive axial force developed. The ascending and descending branch in the load-rotation diagram correspond to an extended zone of nonlinearity and to the softening branch, respectively, in the torque-rotation diagram. The diagrams do not present any change in curvature in the softening branch, as it was observed in the tests on un-notched cylinders. The same happens when the tests are conducted applying a constant compressive force: the torque after the peak decreases gradually without showing changes in curvature. In contrast to the un-notched cylinders, the peak load does not increase when the compressive force is constant during the complete test.
