Damage Quantification of Concrete Surface Layers by Semi-Variogram Analysis

Tetsuya Suzuki¹, Masao Aoki¹, Masayasu Ohtsu²

¹*Nihon University, Kanagawa, Japan;* ²*Kumamoto University, Kumamoto, Japan*

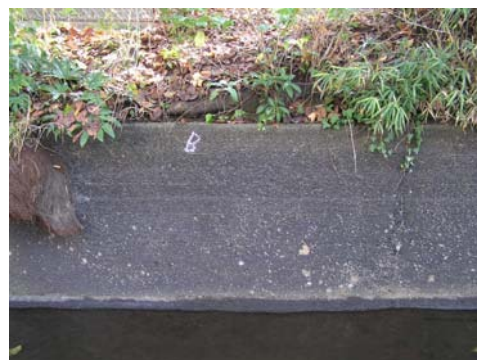
Photo 2 Overview of non-damaged concrete water channel wall in normal section.

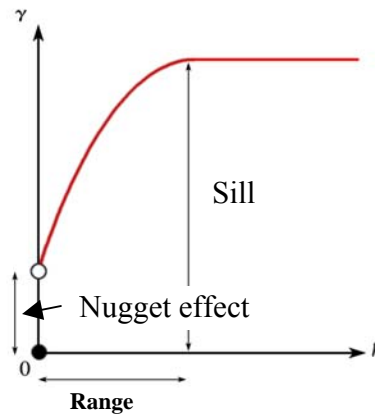
Fig.1 Semi-variogram model.

In geo-statistics, semi-variogram model is generally used to analyze spatial dependence of physical properties. Semi-variogram is a graph with lag h , sampling interval on the X axis and semi-variance $\gamma(h)$ on the Y, and used for evaluating the relationship between lag h and semi-variance $\gamma(h)$ (**Fig. 1**). The semi-variance $\gamma(h)$ expresses the degree of variation in evaluated values for $N(h)$, all the combinations of two measuring points with a distance of h .

In this study, the physical properties are considered to be spatially continuous unless concrete walls have local damages. Therefore, concrete walls without local damages, continuous semi-variogram is obtained, as shown in **Fig. 1**. The semi-variance increases with increasing lag and in most cases reaches the maximum at a certain distance. This maximum value is called “sill”, expressing the internal variation in data, and the lag at the time of the sill is called “range”. A range shows a boundary of spatial dependency. In other words, a range is an extent where data can be interpolated.

Semi-variance at lag 0 is called “nugget effect”, showing random variations such as experimental errors. Each parameter can be obtained based on the relationship between lag and semi-variance by regression analysis using least squares method. Spherical or exponential models are generally used [6]. In this paragraph, the spherical model used in this study is shown.

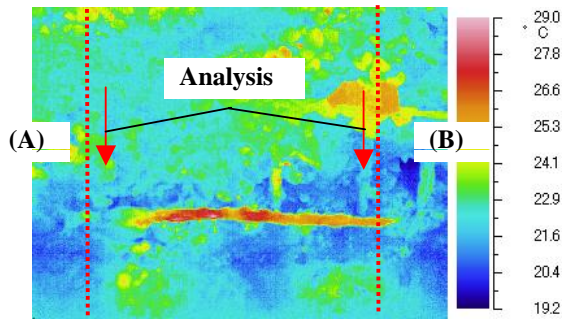
Fig.3 Result of thermal image before heating in damaged section.

Fig. 3 (visible image: **Photo 1**) and **Fig. 4** (visible image: **Photo 2**) show thermal images before heating. It is clearly shown that a damaged section, such as steel being exposed and defect concrete, was heated to a higher temperature. In normal sections, the upper part of the concrete walls marked higher temperature, compared to the lower part of the walls. The surface temperature distribution is shown in **Figs. 5** and **6**. The surface temperature was 21 to 23 degrees C in normal sections, while in damaged sections it was 20 to 30 degrees C, showing a

with steel being exposed (in **Fig. 3**) in the same manner as in **Fig. 10**. **Fig. 3** shows that semi-variances $\gamma(h)$ varied between 0.38 and 1.56 in Section (A) (**Fig. 3(A)**), showing no clear range, while in Section (B) (**Fig. 3(B)**) $\gamma(h)$ reached between 4.24 and 4.70 at $h=5$ to 10cm. This is because spatial dependence of thermal image data decreased due to the effect of local concentration of high-temperature sections, such as corroded reinforcing bars. In **Fig. 10**, normal sections showed the similar tendency to wear sections (B). At $h=5$ to 45 cm, $\gamma(h)$ was 0.01 to 0.04 below the waterline and 0.001 to 0.01 above the waterline where water flow did not affect. From these considerations, it is confirmed by thermal characteristic analysis of concrete walls that intact concrete walls (walls after repair) showed a clear range in semi-variograms. The comparison of local damage sections with normal sections suggests that small lag h could cause $\gamma(h)$ to increase. As a result of the examination, the method suggested in this study, where intact sections and local damaged sections of concrete are compared using semi-variogram, is confirmed to be effective.

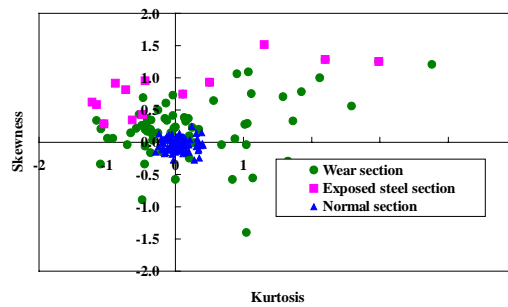
Fig.7 Relation between skewness and kurtosis in damaged portion.

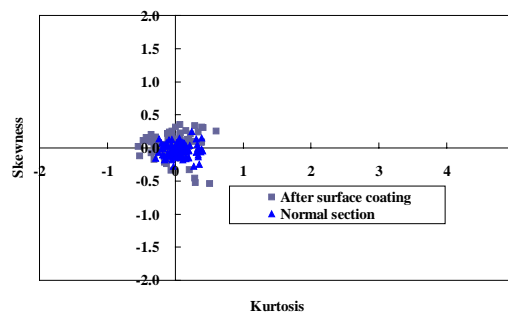
Fig.8 Relation between skewness and kurtosis (After surface coating).

wide variation. It is found that in concrete where damages progress, the surface temperature ranged widely and the microscopic thermal distribution were affected by damage. In order to evaluate local thermal distribution, thermal images were divided into 80 sections and the relationship between skewness and kurtosis was obtained based on statistics values for each section. In the normal sections, the distribution of skewness and kurtosis was centered around 0.0 (Fig. 7). In the wear sections, skewness was -0.5 to 1.0 and the kurtosis was -1 to 4. In the sections where steel was exposed, the degree of distortion was confirmed to be higher than in the wear sections. When damaged sections were repaired with surface coating, the distribution of skewness and kurtosis was centered around 0.0 with a slightly larger variation than that for the normal sections. The relationship between skewness and kurtosis revealed that when concrete walls were exposed to water flow, the distribution of the surface temperature ranged wider due to local damages (Figs. 5 and 6), which caused the data distribution patterns to change (Fig. 7). The sections with surface coating treatment and the normal sections showed the similar distribution, suggesting that the effectiveness of surface coating treatment could be verified by examining the distribution of the surface temperature (Fig. 8). It is also

From these monitored results, it is confirmed that spatial dependence of thermal characteristics of damaged concrete walls treated with surface coating can be evaluated using semi-variogram. The examination of effectiveness of concrete repair work using thermal images revealed that in sections with progressed damage, surface temperature widely distributed and the distribution of skewness and kurtosis expanded from 0.0 in a positive direction. Especially in sections with corroded reinforcing bars, the degree of distortion was confirmed to be higher, compared with wear sections (**Fig. 7**). After surface coating treatment, the distribution of skewness and kurtosis was centered around 0.0 (**Fig. 8**). Therefore, appropriately treated damaged concrete showed a narrow thermal characteristic

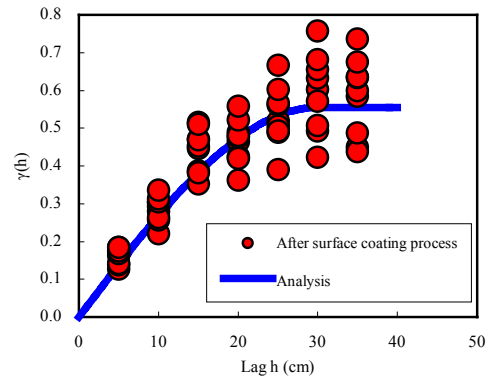
Fig.9 Results of semi-variogram analysis in damaged section treated after surface coating.

The primary characteristic of semi-variogram is that it can evaluate spatial dependence of measured data. In Section 5.3, after evaluating characteristics of semi-variogram of damaged sections treated with surface coating, cross-sections of normal sections and damaged sections with treatment are compared. **Fig. 9** shows the semi-variogram of damaged concrete after surface coating treatment. The target area of 40 cm by 50 cm was divided laterally into 10 sections with a pitch of 5 cm, and lag h was set at 5 cm from the top end toward the base for each section. Then, semi-variance $\gamma(h)$ was calculated using Equation (2). The analytic values were evaluated using a spherical model. The nugget effect was assumed to be 0.0. The distribution of the semi-variances $\gamma(h)$ calculated from the measured values expanded as lag h increased. The semi-variance is an indicator, which shows the degree of variation in evaluated values at a certain distance. A large semi-variance means a large variation in measured values. The analytical result using a spherical model suggested that until lag h was about 25 cm, the physical properties of the damage section treated with surface coating should be spatially dependent. The semi-variogram of the damaged concrete before surface coating is shown in **Fig. 10**. Semi-variance $\gamma(h)$ was calculated for Section (A) with only wear and Section (B)

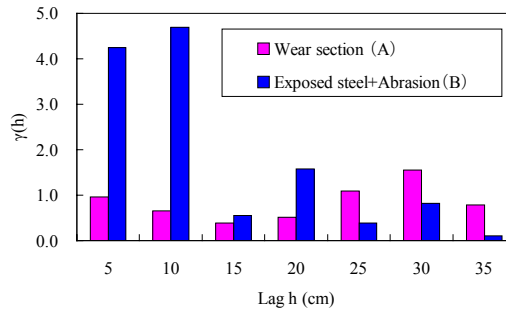
Fig.10 Results of Semi-variogram analysis in damaged section.

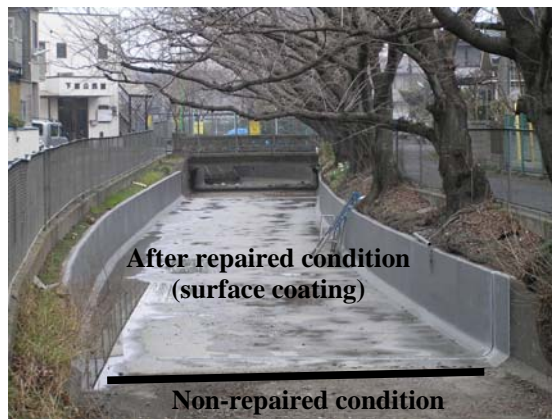
Photo 3 Comparison between surface coating and non-repaired conditions in monitoring water channel.
