# Structural Disintegration of Al 2024 Rolled Plates in a Marine Environment: Effect of Morphological Parameters of the Microstructure

J. Stolarz, G. Blanc

*Ecole Nationale Supérieure des Mines, CNRS UMR 5146, Saint-Etienne, France*

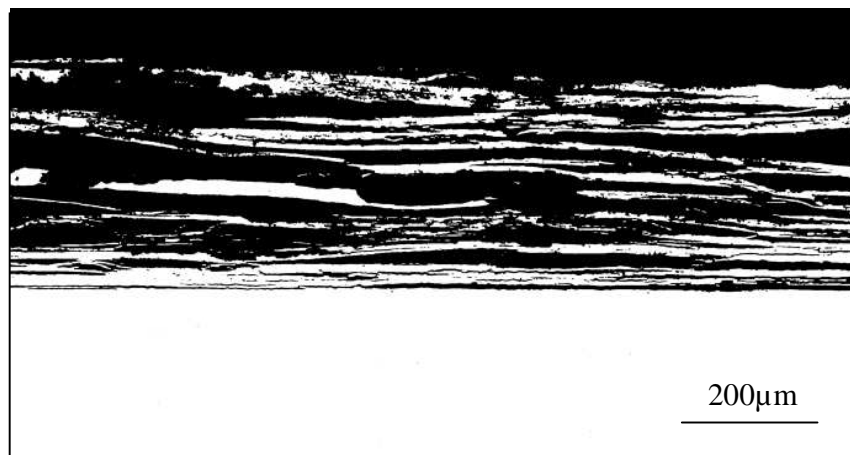
Fig. 1. Exfoliation corrosion as visible on a section of an Al 2024 T351 rolled plate after the immersion test according to ASTM G34.

The exfoliation corrosion (EC) is a well known degradation mode of several aluminum alloys, strongly dependent on aging conditions and on morphological parameters of the microstructure. It occurs exclusively in microstructures composed of plate-like or fibrous grains, typical for rolled plates and sheets. It consists in an intense corrosion (inter- or transgranular) with propagation paths parallel to the rolling surface, followed by the material disintegration through 'exfoliation' (Fig. 1).

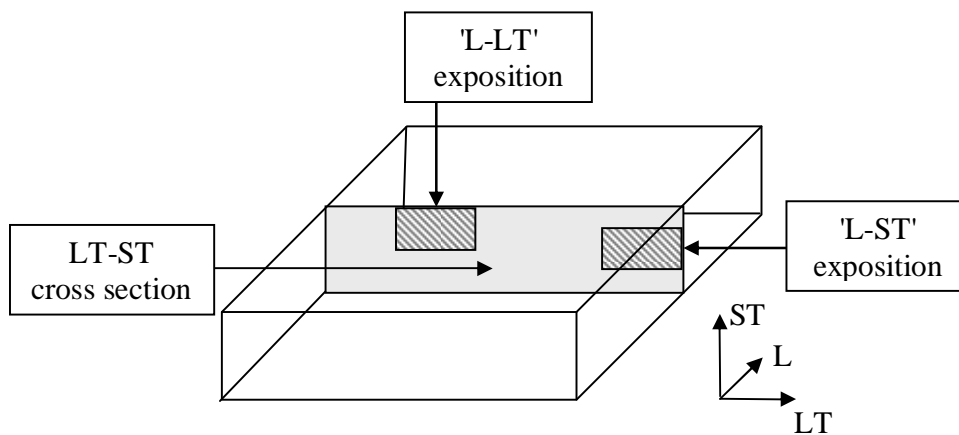
Fig. 2. Orientation of samples for corrosion examination.

The study has been carried out on samples issued from a rolled plate, 35mm thick, of a commercial Al 2024 T351 alloy. The microstructure is composed of plate shaped grains, oriented parallel with respect to the L-LT plane (Fig. 2). The linear grain dimensions are approximately 300 $\mu\text{m}$ , 100 $\mu\text{m}$  and 20 $\mu\text{m}$ , respectively for L, LT and ST directions. Samples have been exposed in a marine environment during 1 to 12 months at the French Corrosion Institute in Brest. After visual surface examination, observations on a LT-ST cross section, according to Fig. 2, have been carried out by optical microscopy.

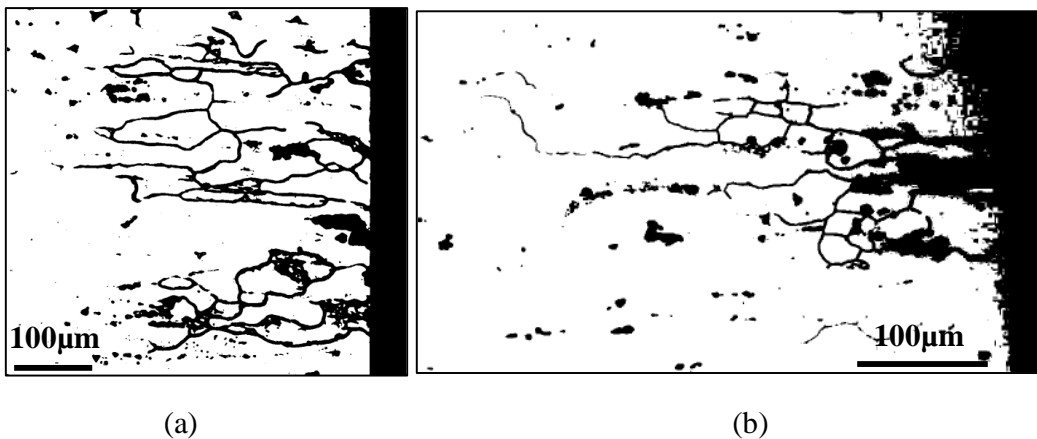
Fig. 3. Intergranular corrosion on the LT-ST cross section (L-ST plane exposed) after (a) 1 month and (b) 6 months exposition.

Fig. 3 shows the aspect of the LT-ST cross section after exposition of the L-ST surface (Fig. 2) during one and six months. In both cases, intergranular corrosion, starting from few intersections of grain boundaries with the L-ST surface, can be observed. After one month, the maximal penetration depth reaches roughly  $300\mu\text{m}$  and no measurable evolution takes place when the exposition continues until the total duration of six months.

Observations carried out on the same cross section after six (Fig. 5a) and twelve (Fig. 5b) months confirm the decisive role of the initial grain displacement with respect to the corrosion kinetics. The width of the corroded layer reaches  $1.5\text{mm}$  after six months and nearly  $3\text{mm}$  after one year. Therefore the progression is nearly linear versus time which contrasts with the observations reported in Fig. 3

for which the 'ordinary' intergranular corrosion reached its maximal penetration after only one month and did not progress during further exposition.

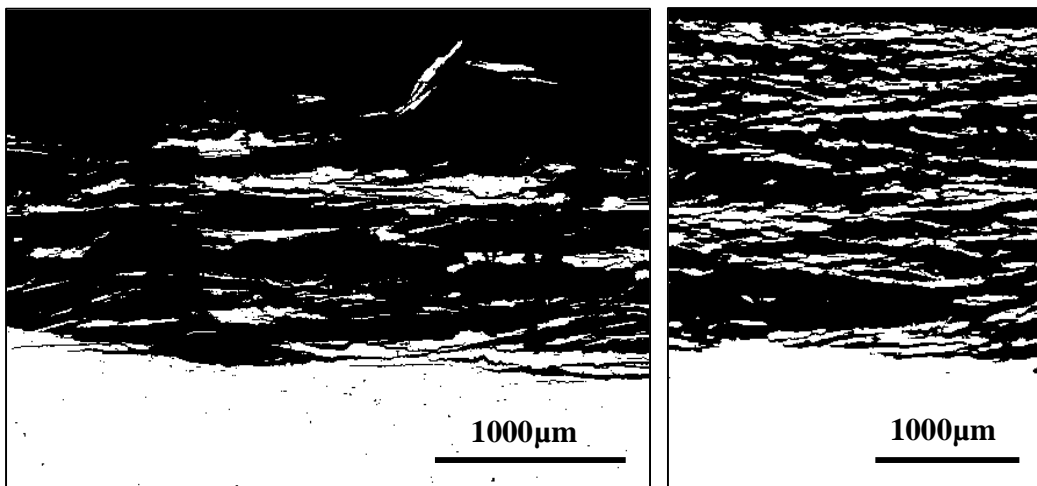
Fig. 5. Effect of exfoliation corrosion on the microstructure integrity as observed on the LT-ST cross section after expositions from the L-LT plane during six (a) and twelve (b) months.

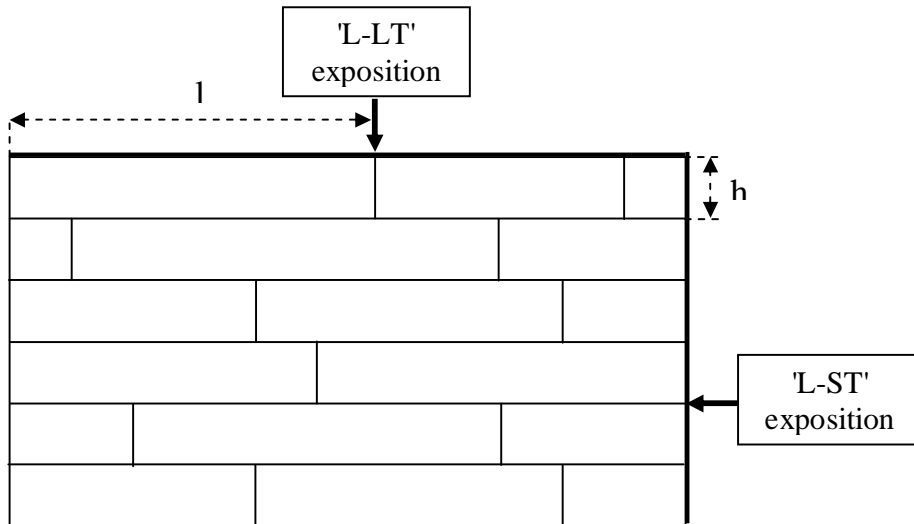
Fig. 6. Two dimensional model microstructure with the average shape factor ' $l/h$ ' equal to five. Arrows indicate grain boundaries along which corrosion initiates.

Observations reported above give precious information about the mechanisms of the exfoliation corrosion and about some kinetic aspects of damage. Firstly, intergranular corrosion is undoubtedly the basic damage mechanism. Secondly, the penetration of the 'pure' intergranular corrosion, i.e. non followed by exfoliation, stops at depths close to 300µm and it does not affect the microstructure integrity when the exposition is continued. The intergranular corrosion evolution can be easily represented with the help of a simple 2D geometrical model of the microstructure (Fig. 6).

In Fig. 6, a 2D microstructure composed of grains with the average shape factor ' $l/h$ ' equal to five is represented. Intergranular corrosion is supposed to initiate from two emerging boundaries, one parallel to the long axis of grains ('L-ST' exposition) and one parallel to the short one ('L-LT' exposition), simulating the real situations observed on the LT-ST cross section (Fig. 2).

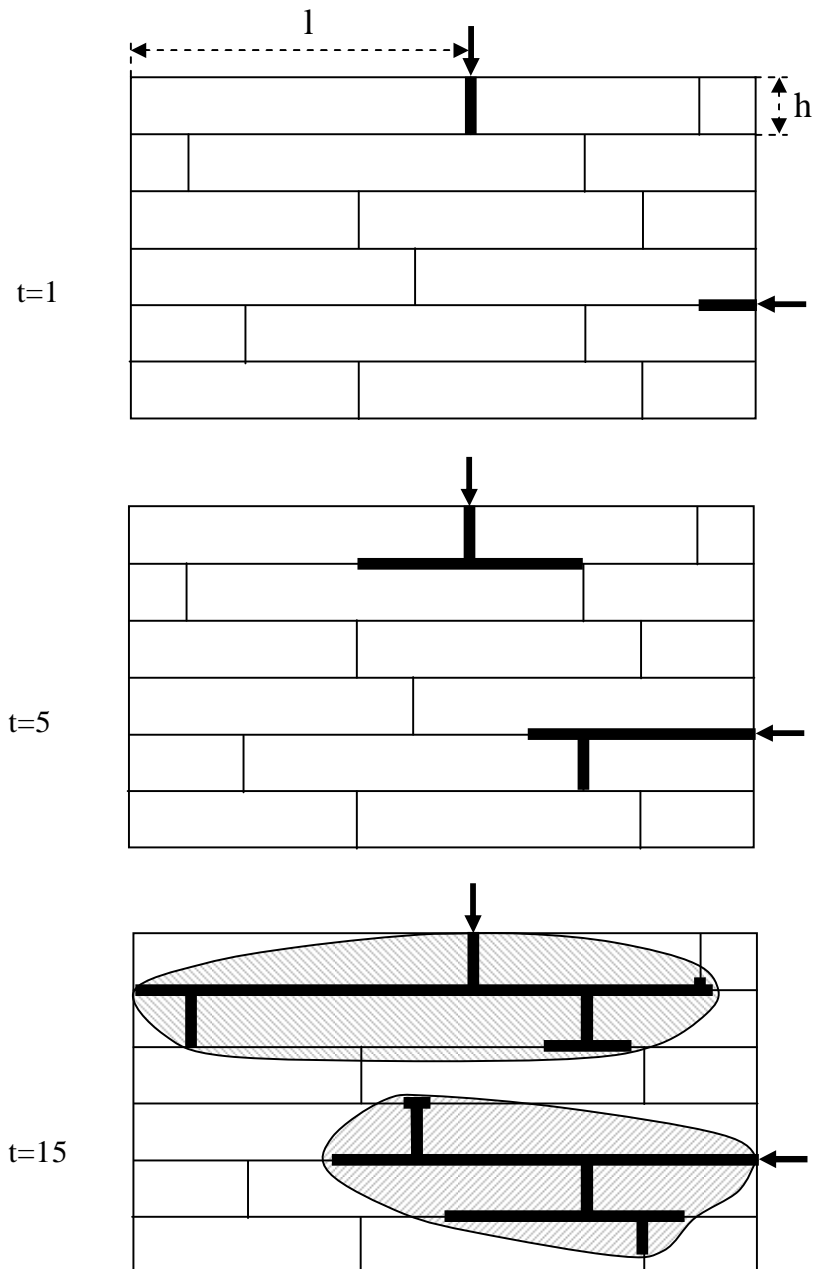
Fig. 7. Simulated evolution of intergranular corrosion on the simulated LT-ST cross section (arbitrary time units).

In Fig. 7, the theoretical evolution of intergranular corrosion on the LT-ST cross section according to Fig. 2 has been represented for exposition times of 1, 5 and 15 (arbitrary units). The shapes of the affected zones are indicated. They correspond qualitatively to those observed experimentally (Fig. 3,4).

According to Fig. 7, grain exfoliation is only likely to occur when corrosion is initiated from the sample surface parallel to the long axis of grains. Segments of the intergranular corrosion path between consecutive triple points are a linear function of the shape factor of grains. Consequently, long segments of corroded grain boundaries are filled with corrosion products whose expansion can help to remove surface grains from their initial position and enable the penetration of the corrosive environment into the free space created (cf. Fig. 4). The process can thus be periodically reactivated which explains a nearly linear evolution of the exfoliation corrosion versus time (Fig. 5) while the intragranular corrosion rate rapidly drops to zero, when no exfoliation is possible (Fig. 3).

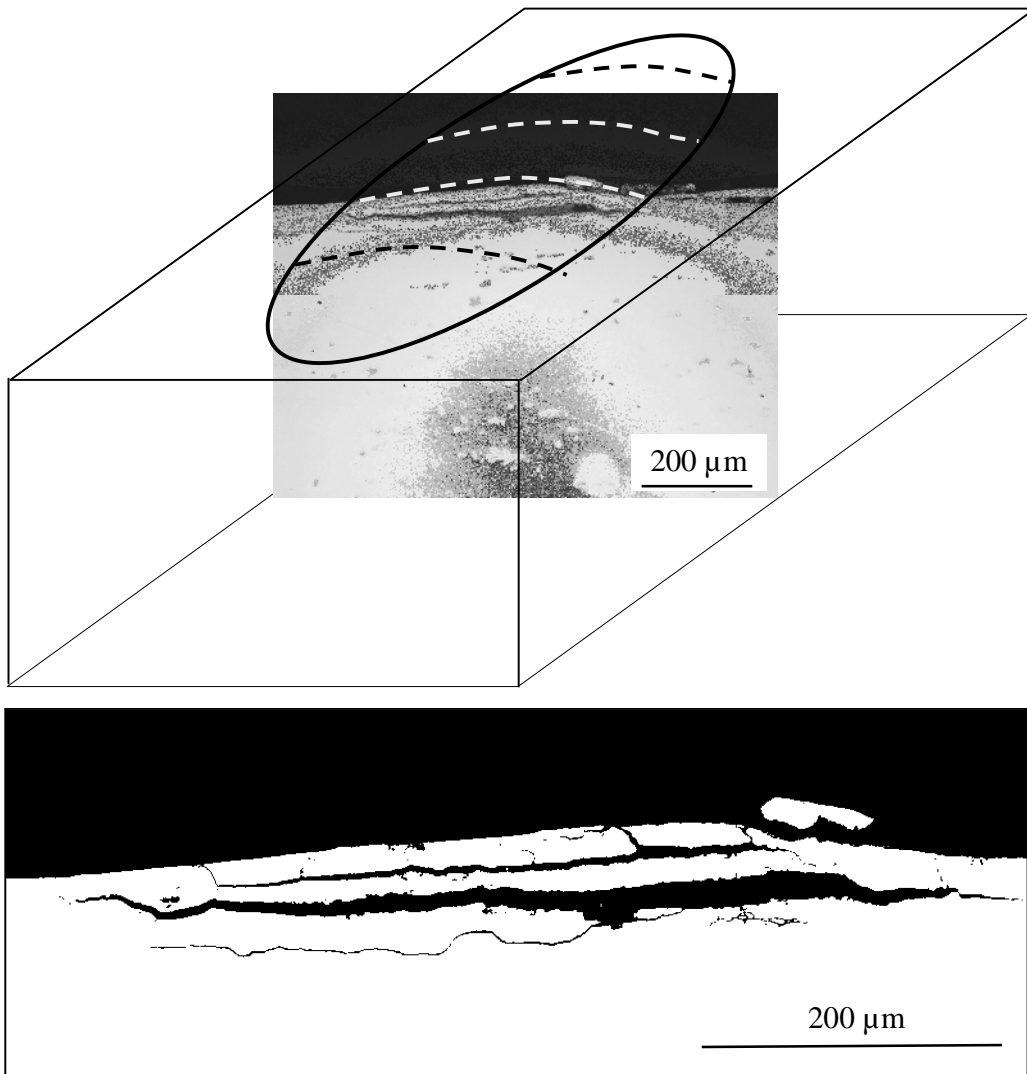
Fig. 8. Initial stage of exfoliation in a 2024T351 alloy exposed during 1 month in a marine environment.

According to the schematic representation presented in the previous section, intergranular corrosion will degenerate towards exfoliation if grains from the surface layer are deformed or displaced enabling the corrosive environment to penetrate along previous boundaries and reactivating locally the initial corrosion rate. This elementary event is illustrated in Fig. 8. A section parallel to the short axis of an elliptic blister shows two grains with the shape factor of roughly 10, deformed through the internal pressure of corrosion products along dissolved grain boundaries. The vertical grain displacement 'f' as seen in Fig. 8 can result both from a local force P applied at their extremities and from a uniform stress q/b acting on the grain surface, 'b' being the grain dimension along the direction parallel to the long axis of the blister (Fig. 8):

Consequently, for given morphological parameters of the microstructure (l, b, h), it is possible to calculate the intergranular stress 'q' required to induce the grain flexion 'f' (Fig. 9). For the configuration presented in Fig. 8, this intergranular stress is close to 0.5 MPa which is roughly 10 times lower from the Robinson's estimation [5]. This result is not really surprising if one takes into account that the mechanism proposed in the present approach does not involve mechanical failure but only a deformation of grains previously separated from the bulk through intergranular corrosion.

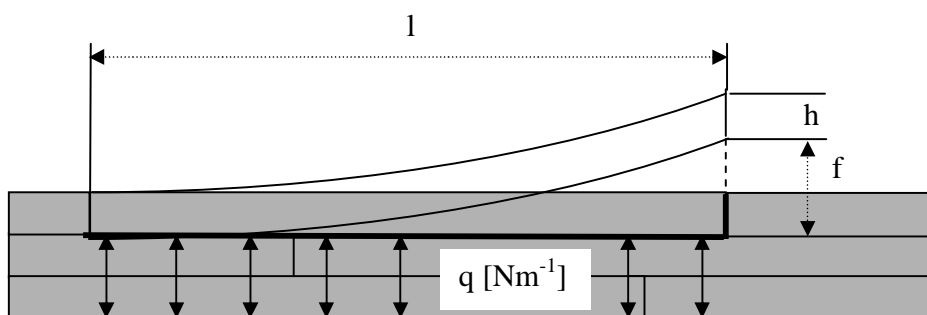
Fig. 9. Grain flexion induced by the pressure of corrosion products along a dissolved grain boundary.
