A fractographic study of the stress corrosion cracking of titanium and its alloys

D. T. POWELL and J. C. SCULLY,
University of Leeds, England.

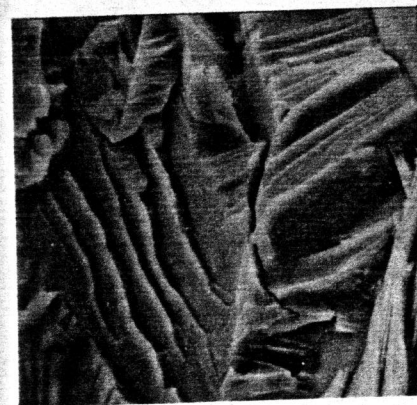
Fig. 4. Scanning electron micrograph of the fracture surface of a specimen of Ti-5Al-2.5Sn alloy pulled in air after immersion in MeOH/HCl. (Magnification 2250 x.)

This type of intergranular failure was also observed in unstressed specimens that were exposed over long periods of time and then broken in air. In the alloy, small areas of cleavage were occasionally observed in these fracture surfaces, as shown in Fig. 4, and in one specimen exposed for 35 days very severe embrittlement has occurred resulting in the unusual intergranular appearance shown in Fig. 5. Anodic polarisation at low current densities accelerated grain boundary attack and resulted in the selective removal of grains.

The slow loss of strength experienced by both materials in methanolic environments in the absence of stress is the result of preferential dissolution. Under open circuit conditions, hydrogen evolution will also occur. Certainly the cleavage regions seen in such fractures (Fig. 4) and the excessively embrittled fracture surface seen in Fig. 5 are probably the result of hydrogen adsorption, possibly also accompanied by dissolution.

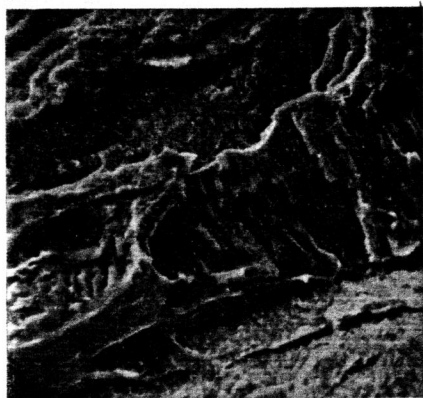
Fig. 6. Scanning electron micrograph of the fracture surface of a specimen of Ti-5Al-2.5Sn alloy cracked by charging in a solution of 0.03N H_2SO_4 at 50 mA/cm² for 14 days. (Magnification 710 \times .)

Cathodic polarization of stressed specimens of the alloy in 0.03N H₂SO₄, a solution employed by Tomashov [8], caused cracking after a period of 14 days at a current density of 50 mA/cm², using platinum anodes. The fracture surface produced was transgranular, showing poorly-defined cleavage, which may have been caused by hydride precipitation (Fig. 6). There was also evidence of etching and intergranular attack. Cracking did not occur in the metal under these conditions, but both materials exhibited extensive hydride precipitation when examined optically.
