## The stress corrosion cracking of a non-age-hardenable aluminium alloy

R. G. WEBER\* and A. J. McEVILY, Jr.†

### Summary

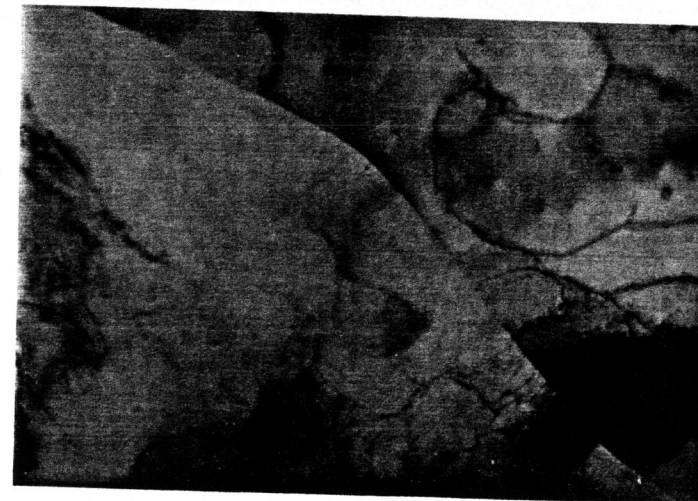
Fig. 1. Grain boundary region of 5052-H34. (60,000 ×)

The aluminium alloy used was commercial 5052-H34 sheet, 0.020 in thick. The designation H34 indicates that the alloy was cold rolled 40% and stabilized at 150°C for 4 hours. A few check tests were also made with 0.050 in sheet. The alloying addition is nominally 2.5 w/o Mg and 0.25 w/o Cr. According to Beck and Sperry [2], up to 2 w/o Mg is soluble in aluminium, but precipitation is not appreciable until the magnesium content exceeds 3.5 w/o. Electron microscopy showed the grain boundaries of the alloy to be free of precipitation, Fig. 1. The grain size is about 50 microns, but boundaries are difficult to observe by light microscopy because of prior cold work.

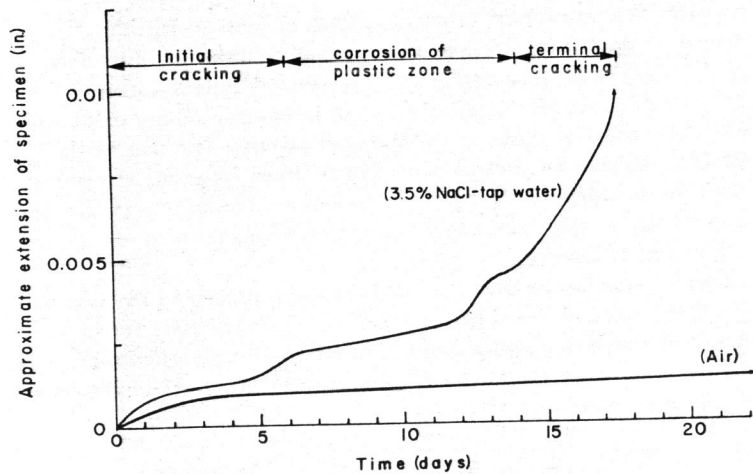
Fig. 3. Approximate specimen extension as a function of time.

A plot of specimen elongation as a function of time for a constant load test in 3½% NaCl-tap water and in air is shown in Fig. 3.
