## Critical mechanisms in the development of fatigue cracks in 2024-T4 aluminum

J. C. GROSSKREUTZ and G. G. SHAW

Center for Applied Research on Materials, Midwest Research Institute,  
Kansas City, Missouri, U.S.A.

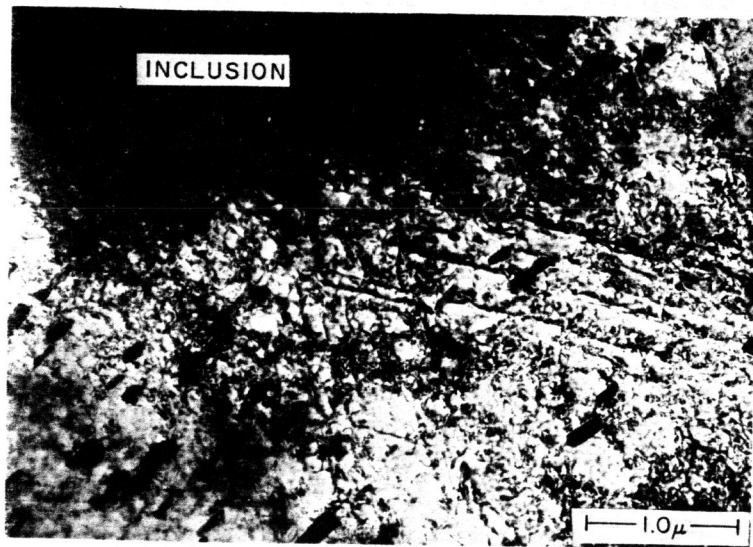
Fig. 4. Transmission electron micrograph of surface area around an inclusion. Concentrated slip traces are visible as well as many small dislocation loops.  $3 \times 10^5$  cycles at  $\pm 9,200$  psi. (Dimpled specimen.)

Transmission electron microscopy of the deformed area around an inclusion has been accomplished; results are shown in Fig. 4. The dislocation density is much higher in this area than it was in Fig. 2. Moreover, a heavier concentration of dislocations is seen to be trapped at the oxide-surface interface along traces of the primary glide planes. Traces of a secondary slip system can also be observed in faint contrast in Fig. 4.

Although no other high quality electron replicas of a crack nucleation site were obtained, the general results of the investigation showed no correlation between crack nucleation and concentrated slip lines at inclusions. Careful examination of Figs. 2 and 4 and many more micrographs of similar nature has failed to reveal zones of precipitate reversion or overaging which might give rise to regions susceptible to crack nucleation. In addition, attempts to find cracked inclusions, in both uncycled and fatigued specimens were unsuccessful.

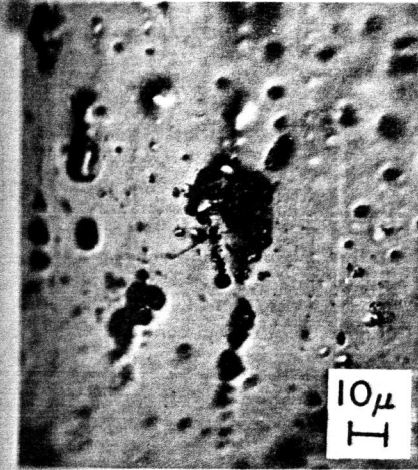
Fig. 5. Optical micrograph of early crack nucleating at inclusion.  $4 \times 10^5$  cycles at  $\pm 13,600$  psi.

Optical examination of the fax-film replicas showed that all primary failure cracks (and indeed all secondary cracks) nucleated at surface impurity inclusions. At optical magnifications, no concentrated slip could be seen in association with these early cracks. Fig. 5 illustrates an early crack, only 10  $\mu$  long, for which extensive electron replicas were obtained as the crack developed. It should be noted that this crack has nucleated at an inclusion cluster. These clusters are a rather common site for crack nucleation. All of the observations reported here were made on samples which were electropolished prior to cycling. To test whether preferential chemical attack at the inclusions was a factor in crack initiation, identical observations were performed on mechanically polished samples. Cracks were observed to nucleate at inclusions in the same manner and after equivalent numbers of cycles. An electron surface replica taken at a somewhat later stage in the development of this crack is shown in Fig. 6; the inset shows the optical photograph at this later stage of development. Careful examination of the replica does not disclose any concentrated slip in association with the failure crack origin.

Finally, longitudinal sections were made through the nucleating inclusion shown in Figs. 5 and 6 to see whether near-surface defects were contributing to the nucleation of the crack. Fig. 7 is an optical micrograph of a section taken within  $\pm 1 \mu$  of the point indicated by the arrow in Fig. 6. This photograph shows clearly the multiplicity of inclusions which make up the cluster responsible for crack nucleation. Although polishing marks obscure the exact point of origin of the crack in this photograph, subsequent etching (which destroyed much of the inclusion detail) showed the crack to originate at the interface between the matrix and a surface inclusion (arrow, Fig. 7).
