Microstructural aspects of the fatigue behavior of rapid heat treated steel

Prof. T. KUNIO*, Assist. Prof M. SHIMIZU† and K. YAMADA*

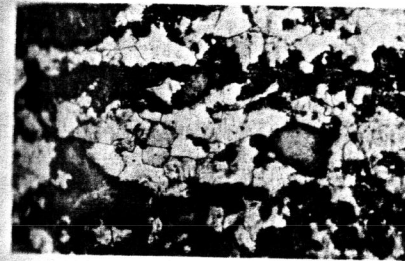
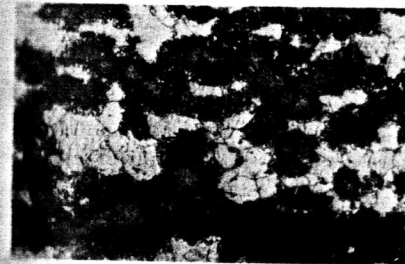
(a) 1000°C, 5 sec.

(b) 1000°C, 12 sec.

(c) 1000°C, 20 sec.

Fig. 1. Rapid heat treated microstructure (x 100)

Some typical examples of the features of the microstructure of a rapidly heat-treated low carbon steel are shown in Fig. 1; the composition of the steel is shown in Table 1. The time required for specimens to reach 1000 °C varied between 3 and 25 sec., and in every condition, retained ferrite was observed in the microstructures. The domain of retained ferrite in the microstructures became narrower as the heating duration was lengthened. Hardness measurements, taken at random locations on the specimens are shown in Fig. 2. Rotating bending and reversed torsion fatigue tests were made on thin-walled specimens (Fig. 3). Thin walled specimens were used to avoid the generation of residual stresses by the rapid heating and cooling of the specimen, and to eliminate the effect of stress gradient. Residual stresses were measured by Sachs method, typical results are shown in Fig. 4. Their magnitude was considered sufficiently small to conclude that the fatigue behavior of the specimens would not be affected by their presence. The results of the fatigue tests are given in Figs. 5 and 6. They show that the fatigue limit of the specimens is independent of the heating duration, i.e., $\sigma_{w0} = 30 \text{ kg/mm}^2$ (rotating fatigue limit) and $\tau_{w0} = 18 \text{ kg/mm}^2$ (reversed torsion fatigue limit). The fatigue limits of annealed specimens are $\sigma_{w0} = 19 \text{ kg/mm}^2$ and $\tau_{w0} = 12 \text{ kg/mm}^2$, respectively.

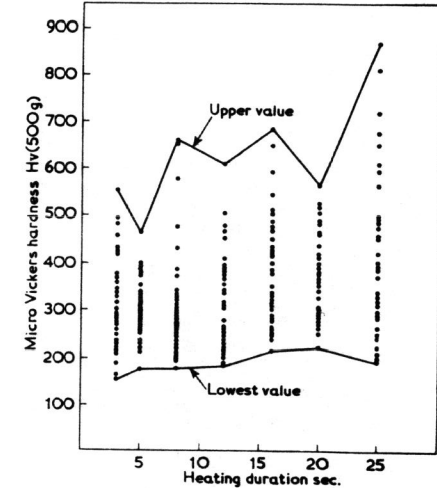
Fig. 2. Relations between the heating duration and distribution of hardness.

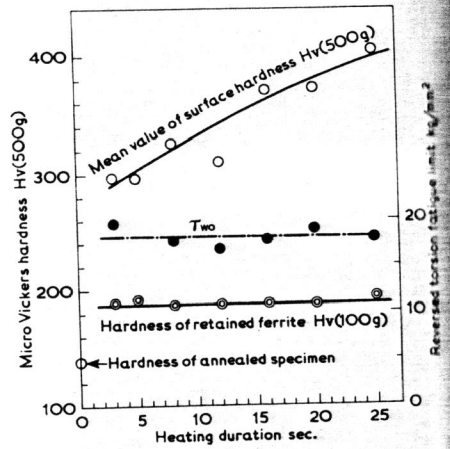
Fig. 5. Relations between the mean value of surface hardness, retained ferrite and reversed torsion fatigue limit.

specimen. The test results shown in Figs. 5 and 6 seem to confirm that it is. However, to investigate this point further the microstructural changes below the fatigue limit, in the retained ferrite domains were observed. The results of this investigation revealed that the microstructural changes observed below the fatigue limit in the retained ferrite were identical to those observed above the fatigue limit. Similar fractures occurred in the local domains of retained ferrite, but fracture of the bulk specimen did not occur (Fig. 9). Thus the suggestion that the fatigue limit of a specimen is the minimum stress required to fracture the retained ferrite is invalidated. To understand the significance of the fatigue limit of mixed microstructures, attention was focused on the microstructural changes which occur near the fatigue limit. It was observed that many microcracks were present in the retained ferrite at stresses from well below the fatigue limit up to the fatigue limit, and that all of the cracks were contained within the domain of retained ferrite, their propagation beyond these being impeded by surrounding microstructures. Consequently, the fatigue limit of mixed microstructures, containing retained ferrite, is the minimum stress required to propagate the fatigue cracks in the retained ferrite through the surrounding microstructures. Cracks in the retained ferrite could be regarded as 'stage I cracks', as proposed by Forsyth [11]; the cracks propagating into the surrounding microstructures could be regarded as 'stage II cracks', thus, the fatigue limit could be described as the critical stress required to cause a stage I crack in the retained ferrite to extend across the surrounding microstructures into a stage II crack.

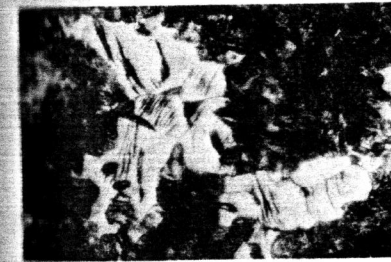
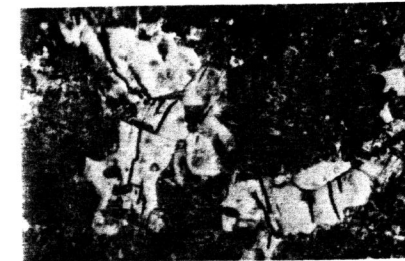
(a) $N = 0$, before fatigue stressing

(b) $N = 2 \times 10^3$ slip marking first appeared (indicated by arrows)

(c) $N = 2 \times 10^4$

Fig. 7. Microstructural changes in the retained ferrite due to fatigue stressing on the 1000°C, 8 sec. specimen at the stress level of $\sigma = 36 \text{ kg/mm}^2$ (120% of the fatigue limit) $\times 540$.

(d) $N = 10^5$ intensified slip bands

(e) $N = 10^5$ after light electropolishing

(f) $N = 10^5$ Micro fatigue cracks in the retained ferrite were revealed by the application of $\sigma = 100 \text{ kg/mm}^2$ of tensile stress after electropolishing.

Microstructural changes due to fatigue stressing, are shown in Fig. 7. A stress level of $\sigma = 36 \text{ kg/mm}^2$, which was 120% of the fatigue limit was applied. A fine slip marking first appeared within the domain of retained ferrite after about 1% of the fatigue life. This slip band gradually increased its width and depth with further fatigue stressing and progressively developed into a more intensified slip band [9] spanning the entire domain of retained ferrite (Fig. 7 (c), Fig. 7 (d)). After approximately 50% of the fatigue life, the slip bands had increased their width and depth to the stage where they could not be eliminated by light electropolishing [10] (Fig. 7 (e)). At this stage it was considered that they had already become micro fatigue cracks, and this was verified by applying the $\sigma = 100 \text{ kg/mm}^2$ tensile stress (Fig. 7 (f)). Accordingly, it is evident that fatigue fracture commences in the retained ferrite of the mixed microstructures (Fig. 8), as appreciable changes were only observed in the domains of retained ferrite. With further fatigue stressing, the fatigue cracks in the retained ferrite propagated across the surrounding microstructures to final fracture.

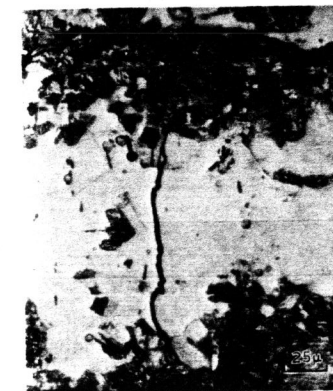
Fig. 9. $\sigma = 28 \text{ kg/mm}^2$, $N = 10^7$ the crack, impeded its propagation by surrounding microstructures (non-propagating crack) after light electro-

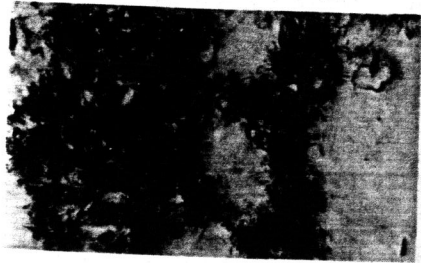
Fig. 12. Micrograph of 15 IH specimen ($\times 270$). White domain, the center and right, is the martensite which is difficult to etch by dilute nitric acid solution.

Details of the specimen used in this experiment are shown in Fig. 10, and Table 2. The maximum temperature of the rapid heat treatment specimens was controlled at 1100 °C and the times required for the temperature to reach 1000 °C were selected as 10 and 15 sec. The 10 sec specimens (denoted by 10, IH) contained small quantities of retained ferrite, while the 15 sec specimen (denoted by 15 III) contained no retained ferrite, (Figs. 11 & 12). The results of rotating bending fatigue tests on these specimens are shown in Figs. 13 and 14. Microscopic observations of the 10 IH specimens revealed fine slip marking in the retained ferrite early in the life, which eventually developed into microcracks. At the fatigue limit, microcracks existed only within the retained ferrite. At stress levels $\sigma = 60 \text{ kg/mm}^2$, cracks start in the retained ferrite final fracture being due

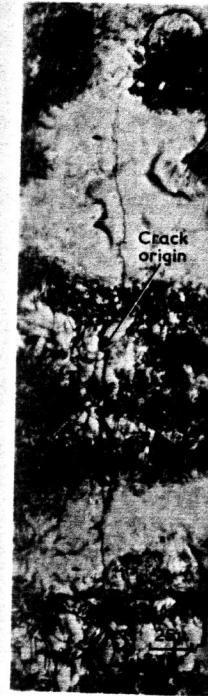
← Surrounding microstructure (martensite) Hv > 750

← Retained ferrite Hv = 200

Fig. 15. Crack in the retained ferrite, began to propagate to cause a final fracture $\sigma = 50 \text{ kg/mm}^2$, $N = 3 \times 10^4$.

to the propagation of cracks in the retained ferrite extending across the surrounding microstructures (Figs. 15, 16). At stress levels above $\sigma = 40 \text{ kg/mm}^2$, cracks which produced the final fracture originated in the microstructures surrounding the retained ferrite (Fig. 17). It was also observed that cracks which originated in the surrounding microstructure began to propagate to cause final fracture cracks began to grow in the retained ferrite. The above condition implies that the fatigue limit of the surrounding microstructures is approximately $\sigma = 60 \text{ kg/mm}^2$. However it can be considered that the 15 IH specimens consist entirely of the surrounding microstructures of the 10 IH specimens, excluding the retained ferrite. Consequently, the S-N curve for the 15 IH specimen could be interpreted as the crack nucleation curve of the surrounding microstructures of the 10 IH specimens. In the 15 IH specimens, the crack propagation period is short, so that it could be considered that the curve in Fig. 14 indicates the crack initiation curve of the surrounding microstructures of the 10 IH specimens. It now becomes apparent that the microstructures surrounding the retained ferrite has a fatigue limit, of $\sigma_{w0} = 40 \text{ kg/mm}^2$. If the fatigue limit of the surrounding microstructures in the 10 IH specimens is $\sigma_{w0} = 40 \text{ kg/mm}^2$, cracks would have been observed in the surrounding microstructures at stress levels in excess of $\sigma = 40 \text{ kg/mm}^2$. However, Fig. 18 which shows the S-N curve of the 15 IH specimens and can be considered the crack nucleation S-N curve of the surrounding microstructure of the 10 IH specimen, within the stress range of $\sigma = 40$ to 60 kg/mm^2 (designated II in the figure), indicates that fracture in the surrounding microstructures may start at a later life than the onset of the growth of cracks from the retained ferrite into surrounding microstructure. Thus, in this stress range, there is a possibility of the initiation of cracks in the surrounding microstructure, although these have not been observed.

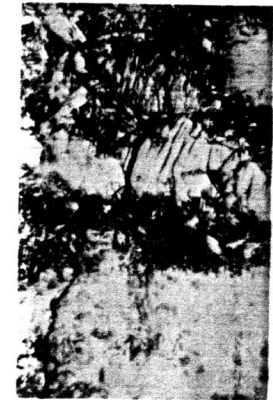
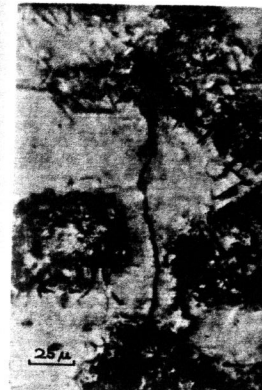
Fig. 16. The commencement of propagation of slip band crack in the retained ferrite into the surrounding microstructure. $\times 270$
 $\sigma = 50 \text{ kg/mm}^2$
 $N = 3 \times 10^4$

Fig. 17. Crack originated in the surrounding microstructure (martensite).
 $\sigma = 74 \text{ kg/mm}^2$
 $N = 1.5 \times 10^3$
 $\times 270$

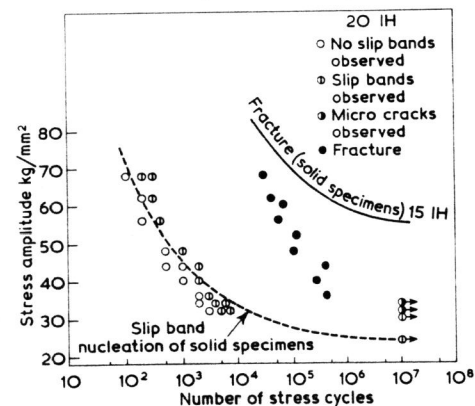
Fig. 21. Rotating bending fatigue test of hollow specimens.

Solid specimens were bored out to release the residual compressive stress. The results of fatigue tests on these hollow specimens are shown in Figs. 20-22 and are summarised in Fig. 23. It is seen that there is little difference between the critical stresses for stage I crack initiation slip band nucleation for both solid and hollow specimens. Consequently, it can be concluded that the residual compressive stresses have no appreciable influence on the origination of either slip bands or micro cracks. However consideration of the number of cycles to fracture shows that the fatigue strength is improved by the suppression of the development of stage II cracks. This was confirmed by the application of an external compressive stress of $\sigma = -30 \text{ kg/mm}^2$ to a hollow specimen tested at the stress level $\sigma = 50 \text{ kg/mm}^2$ by tightening up a through bolt. The specimen did not

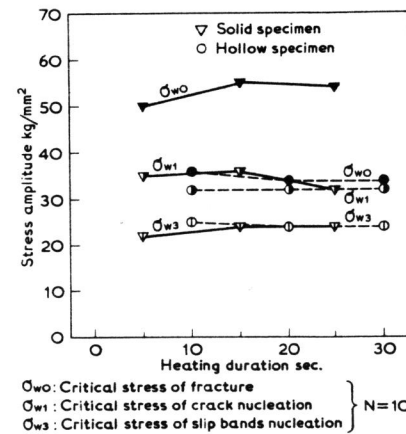
Fig. 23. Result of fatigue tests of both solid and hollow specimens.
