EFFECTS OF OVERLOAD ON HYDROGEN SULPHIDE CRACKING

O. Jonas*

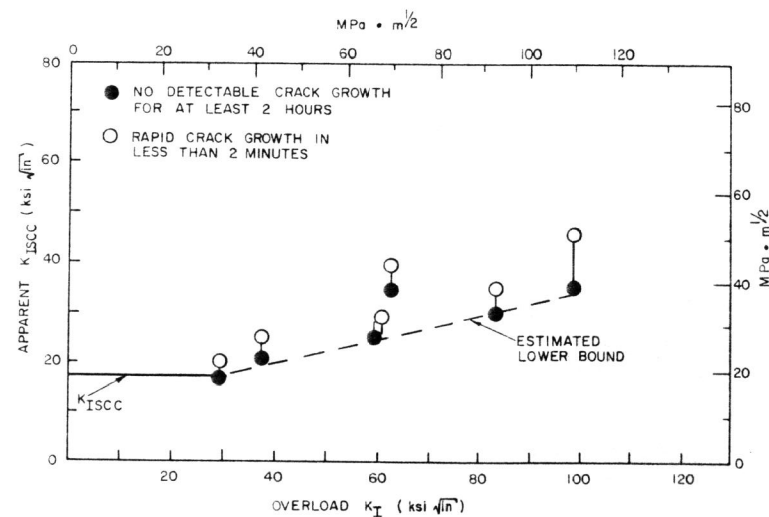
Figure 1 Apparent K_{ISCC} versus Overload K_I Table 1 Influence of Prior Overload on Apparent K_{ISCC}

Prior to the testing of overload effects, K_{ISCC} in R.T. 20.6 to 27.5 kPa pressure hydrogen sulphide was established. It is about 18.6 MPa·m^{1/2}. The results of overload testing are summarized in Table 1 and in Figure 1. Modest increases in the apparent K_{ISCC} were observed after higher overloads. They are represented in the Figure 1 by a lower-bound line. In one experiment (specimen 15), after establishing "no growth" at K_I = 27.4 MPa·m^{1/2} for 104 hours, the specimen was subjected to low amplitude cyclic loading (K_I ranging from 24.5 to 27.3 MPa·m^{1/2}) at 5 Hz. Rapid crack growth occurred following less than 400 cycles of fatigue. This suggests an elimination of the overload effect that increased apparent K_{ISCC} from 18.6 to 27.4 MPa·m^{1/2}.

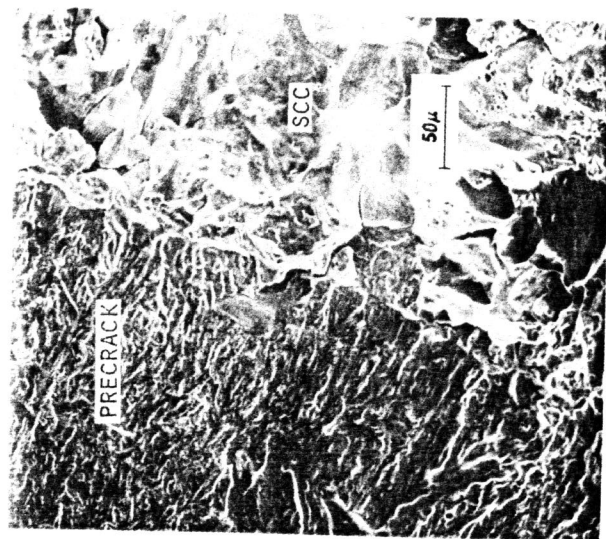
Figure 2 A Typical Fracture Morphology of the Overload Zone with the Subsequent Intergranular Stress Corrosion, Specimen 86 (continued)

specimen
side
←
300 X

SIDE, 100 X

Figure 2 A Typical Fracture Morphology of the Overload Zone with the Subsequent Intergranular Stress Corrosion, Specimen 86

A typical morphology of the overload area with the subsequent stress corrosion crack is in Figure 2. It shows one half of the broken specimen No. 86 with a step (half branch) and/or branching at the overload area and the subsequent stress corrosion intergranular fracture. The angle between the original two branches varies from 90° to 180° and is appar-

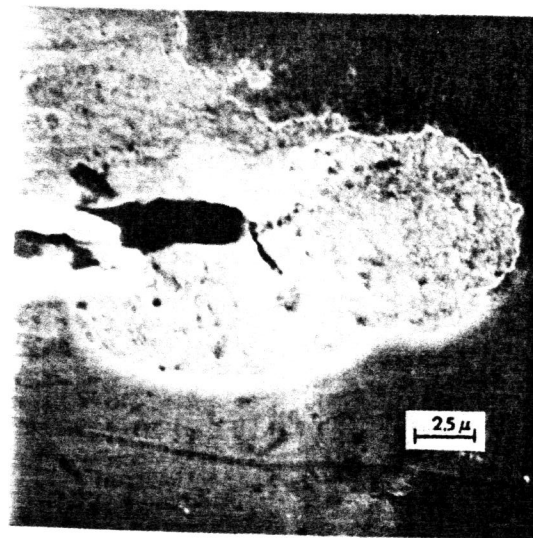
SIDE, 4000 X

MID THICKNESS, 500 X

Figure 3 Crack Front Branching After Overload and Unloading

ently influenced by the grain structure. Additional branching is visible in the stress corrosion area. Figure 3 shows crack branching after overload without stress corrosion, both on the specimen surface and in the mid-thickness. Figure 4 is a SEM picture of overloaded low yield strength (annealed) material, where the crack front branching phenomenon is exaggerated. The angle between two branches of the overload cracks is ~110°.
