EFFECT OF INTERFACE ROUGHNESS ON CRACKING OF
ANODIC OXIDE FILM ON ALUMINUMK. K. Chawla¹ and M. Metzger²

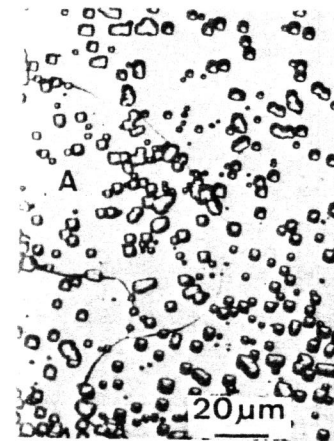
Figure 1 Cracking in Al_2O_3 on Al with a Sharp Pitted Interface. Specimen Axis Parallel to Magnification Marker. (a) $e = 2.3\%$, (b) $e = 8.7\%$, (c) $e = 17.3\%$

(a) *Small pits with Steep Walls and Sharp Edges.* Figure 1 shows three photomicrographs from a series taken with a uniformly pitted interface. Figure 1a shows the initial stage of cracking: a few cracks which are short and run from one pit to another have formed. Figure 1b shows the film at 8.7% elongation: more cracks which are also short and usually run between two pits can be seen. The cracks which had formed earlier do not lengthen but they widen noticeably, as for example, crack A. Figure 1c shows the film at a much higher strain - 17.3%: a few fine cracks have formed. These are short, like the ones formed at smaller strains. Crack A has widened further.
