THE ROUTE OF FATIGUE CRACKS AS DEDUCED FROM DISLOCATION PATTERNS

J. Awatani\*, K. Katagiri\*\* and K. Koyanagi\*\*

ABSTRACT

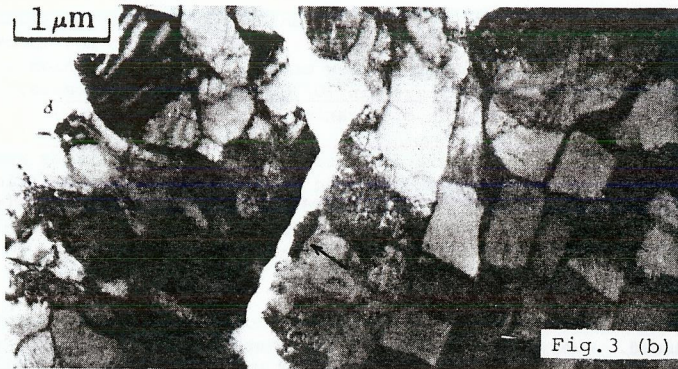
It has been considered that these cells, especially their boundaries, entail some significant consequence for the growth rate of the tensile mode crack in materials with high stacking-fault energy. In the present experiment, however, there were observed a considerable number of cracks growing across cell boundaries. Some of them are demonstrated in (a) and (b) of Fig.3; notice the areas indicated by the

Fig. 3. Transmission electron micrographs showing that the crack propagates across a cell boundary.  $\Delta K = 420 \text{ N/mm}^{3/2}$  in (a) and  $830 \text{ N/mm}^{3/2}$  in (b). (Iron.)

arrows. Also, such a crack was frequently found at the early stage of fatigue in iron: One of them is given in Fig. 4, which shows the crack tip running into a cell after passing through the boundary. Some more micrographs of cracks presenting the similar behavior are given in the references (Awatani and others, 1976a, 1978a, 1979; Katagiri and others, 1979). Besides these, there were sometimes observed the crack route with a serrated profile corresponding to striations of the fracture surface (Fig. 5). However, it seems to be formed independently of the cell structure around there. These results suggest that a cell structure as well as a cell boundary is not necessarily associated with the propagation rate of the tensile mode fatigue crack in materials with high stacking fault energy.

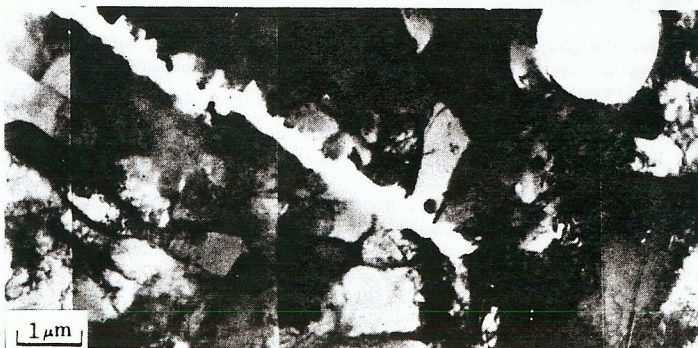
Fig. 5. Crack route with a serrated profile; notice that the profile is formed independently of the cell structure around there. (Iron.)
