THE INFLUENCE OF MICROSTRUCTURE AND BIAXIAL STRESS
ON CRACK PROPAGATION IN STEELS AS STUDIED IN SEM

G.Venkataraman, V.Thyagarajan and A.Srinivasulu
Quality Assurance, Bharat Heavy Electricals Limited,
Tiruchirapalli-620 014,
India.

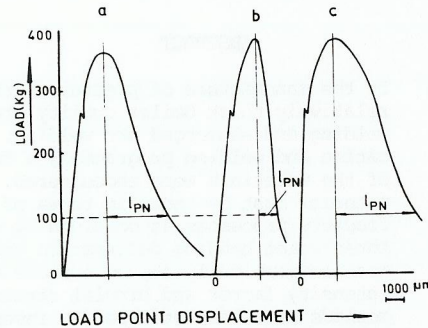
Fig.2 Load vs load point displacement sketches; a-parent metal; b-fusion line of plate PA; c-fusion line of plate PA-N; lpN - notch bend ductility.

The present method uses miniature notch bend (MNB) specimens which can be selected with the notch located at a localised region of interest (Fig.1). The SEM bending stage requires load versus load point displacement calibration of MNB specimen with or without a precrack. The notched specimens are tested in a standard 3-point bend testing machine with load and load point displacement data recorded on a X-Y recorder. The typical tracings are schematically shown in Fig.2 It has been found that the

The chemical composition and mechanical properties are respectively shown in Table 1 and 2. It is seen that Z direction ductility and impact toughness are poor in steel A. The microstructure of steel A indicated coarse bainitic bands which used to get preferentially hardened causing cold cracks. Slow notch bend tests of Charpy 2mm V notch on 7.8x11.8x55.0 samples indicated lower lpN value (Fig.2) in steel A compared to steel B.

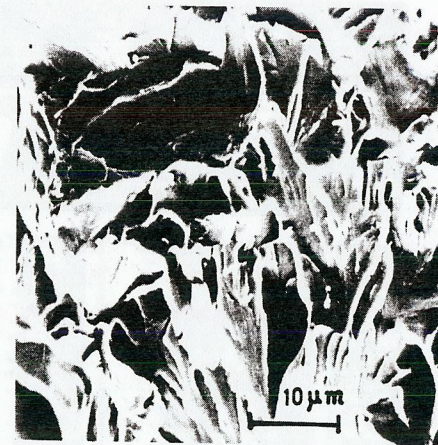
17

Fig.17. Quasicleavage fracture in steel PA—fractograph of MNB specimen after bending.
 Fig.18. Dimple fracture in steel PA-N under similar conditions, compare with Fig.17.
