METALLOGRAPHIC ASPECTS OF CREEP FRACTURE  
IN A CAST Ni-Cr-BASE ALLOY

H R TIPLER  
DIVISION OF MATERIALS APPLICATIONS  
NATIONAL PHYSICAL LABORATORY  
TEDDINGTON TW11 0LW, MIDDLESEX  
UNITED KINGDOM

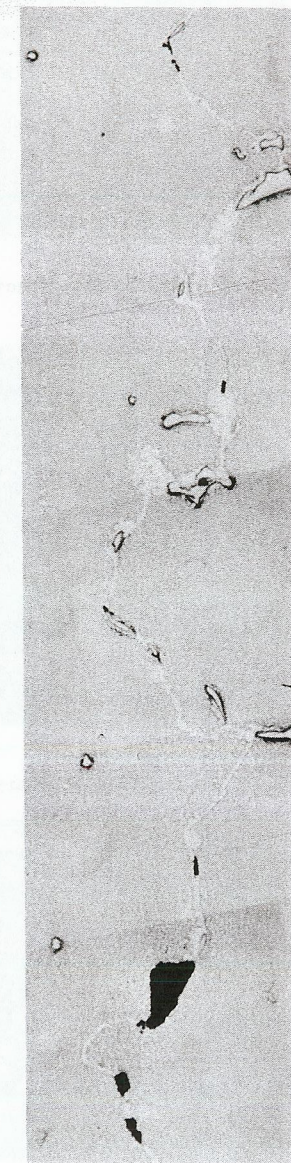
Fig. 1 x480  
Cavitated grain boundary and large pore 30mm from fracture.

The damage generated during the creep tests was always located at grain boundaries and varied in type and intensity depending on the duration of creep or, in a fractured specimen, on the distance from the fracture surface. The examples given in Figs. 1 to 3 are typical of features observed at locations differing in distance from the fracture surface in a specimen which fractured after 1138h. Small cavities observed in an area remote from the fracture are shown in Figs. 1 and 2. In Fig. 1, apart from a triangular shaped pore, a number of cavities

about 1µm in size occur at different points along the grain boundary and adjacent to precipitate particles in some cases. In Fig. 2 it can be seen that the outline of individual cavities remains after they have coalesced but the groups of cavities have not joined up to form a continuous crack. There were many examples where inflections or relatively sharp radii of curvature in the boundary appeared to have assisted cavity nucleation. One example at an advanced stage of growth is seen in the "crack" in the lower part of Fig. 3. In this case, presumably, cavities had nucleated at the region of maximum curvature followed by further nucleation and coalescence in both directions to give the form shown in Fig. 3.

The progress in the growth and coalescence of cavities to form cracks along the grain boundaries is shown by comparing Figs. 1 and 4 which are typical of the damage at 30mm and 10mm respectively from the fracture surface. The intergranular nature of the failure and its propagation from points on the grain boundary well within the specimen is clearly demonstrated. A characteristic frequently observed was the arrest of a crack by a sharp change or reversal in direction of the grain boundary where the orientation changed from being approximately normal to the stress axis to one either at 45° or less to the stress axis. Examples may be observed at a number of positions along the grain boundary shown in Fig. 4. In addition to the advanced state of damage observed in Fig. 4, the same grain boundary also contains damage at an earlier stage, viz, in a number of cavities discernible at the bottom of the micrograph.

Two other forms of internal damage were present, i.e., casting porosity, Fig. 1 (triangular pore), and voids or thin cracks at the matrix/ $\gamma$ - $\gamma'$  eutectic interface, Fig. 5. Neither of these types of defect, which are present at the commencement of a test, appeared to act as sites for preferential growth of cracks. Thus the voids visible in Fig. 5 have not grown to a size comparable to that of the cavities which preceded the cracks visible in Fig. 4 although the former were a similar distance from the fracture. Compared with cavitation the presence of these types of defect does not appear to facilitate the fracture process beyond their contribution to the subsequent inter-linkage of damage.

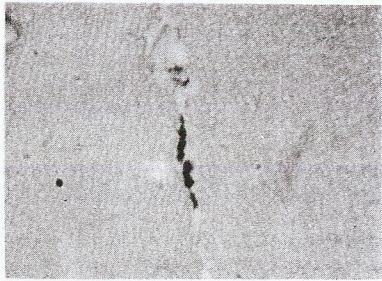
Fig. 2 x1200  
Cavities remote from fracture.

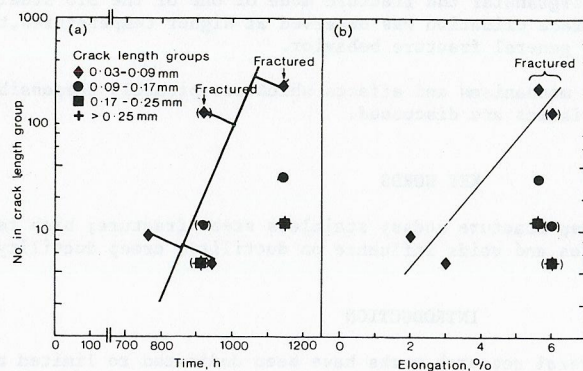
Fig. 8 Effect of (a) creep duration and (b) creep extension on frequency of internal crack lengths for specimens tested at 850°C at 250 MPa

Coalesced cavities which had reached a length of greater than 0.03mm were classified as internal cracks and these have also been measured and divided into various size groupings. The results are shown in Fig. 8. Internal cracks did not appear beyond the gauge length as did the edge cracks, but their length and distribution along the gauge length showed no symmetry either longitudinally or circumferentially, and in this respect their behaviour was similar to that of the edge cracks. In the specimens removed from test prior to failure cracks in only the smallest size group, viz 0.03-0.09mm were observed. For all the results the scatter was considerable and the data points are insufficient to provide a good correlation with either strain or time. The symbols in brackets relate again to the specimen which fractured after 923h and for which only one part was examined.
