TWIN BOUNDARY CAVITATION DURING HIGH TEMPERATURE CREEP OF INCONEL ALLOY X-750

M. C. Pandey* and D. M. R. Taplin**

ABSTRACT

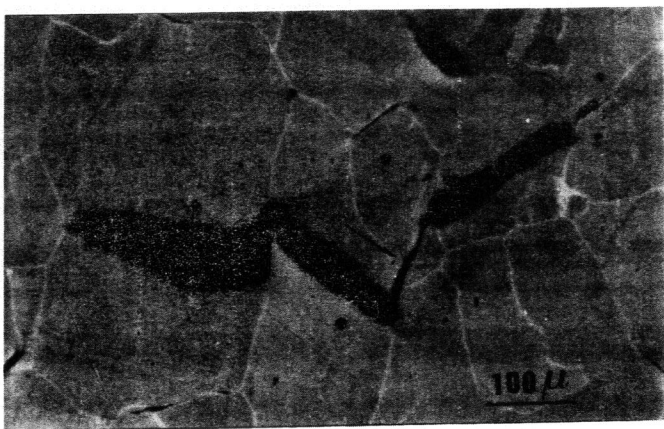
Fig. 5a. Showing twin boundary cracks in the specimen which was heat treated and tested under identical conditions to that of Fig. 4 but interrupted prior to fracture. The specimen would have fractured along the twin boundary if allowed to fail (stress axis vertical).

The twin boundary cracks were also observed in the tensile tested specimens at a cross-head speed of 0.054 mmh^{-1} ($2.16 \times 10^{-3} \text{ h}^{-1}$) at 700°C (Fig. 4). Two specimens were tested: one was interrupted prior to its final fracture (percentage elongation and reduction of area 11.90 and area 21, respectively); the other one was allowed to fracture at percentage elongation and reduction in area of 13 and 24, respectively. Some of the cracks are lying on those twin boundaries which are bent and are at 45° to the stress-axis. As compared to the interrupted one, not many twin boundary cavities/cracks were observed in the fractured specimen. This appears to indicate that the twin boundary cracks are part of the fracture path (Fig. 5a and b). Scanning electron microscopy of the fracture surfaces indicated two modes of fracture: (i) intergranular and (ii) faceted as reported in other nickel-base superalloys (Mills, 1980; Oblak and Gwczarski, 1972). It therefore appears that the faceted zones are in fact twin boundaries. Tensile testings carried out at 550°C, 625°C and 800°C at the cross-head of 0.054 mmh^{-1} showed the twin boundary cracks only in the specimen tested at 800°C. A plot between creep ductility and temperature shows that the ductility minimum occurred at 625°C (Pandey, Taplin and Mukherjee, 1984) (Fig. 6). It was found that very low ductility obtained at 550°C and 625°C are due to oxidation at grain boundaries. The specimen tested at 800°C was interrupted prior to its final fracture. Twin boundary cracks were observed just ahead of the growing crack tip.

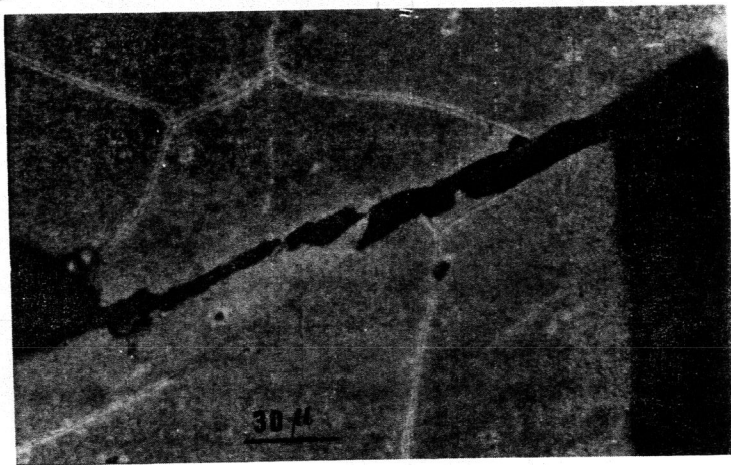
Fig. 5b. Enlargement of the segment of the twin boundary crack of Figure 5a.
