THE ΔK_{th} BEHAVIOUR OF THREE STAINLESS STEELS IN DIFFERENT ENVIRONMENTS

ABSTRACT

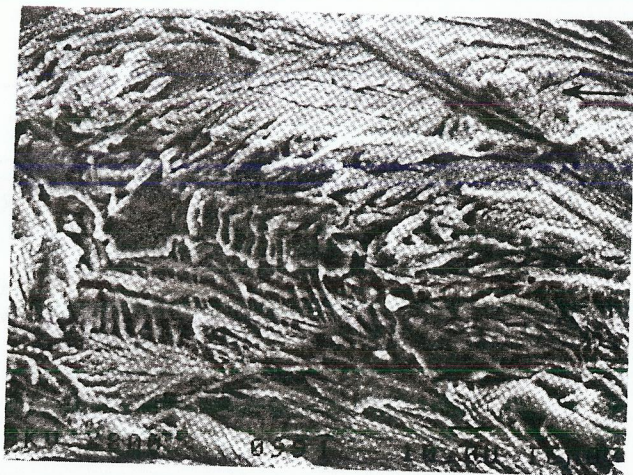
Fig. 3 Near-threshold fracture surface produced on 304 stainless steel in air
