# WELDCRACKING IN FEEDWATER CONTAINERS OF INKOO POWER PLANT

J. Autio, T. Lepistö and P. Kettunen

*Institute of Materials Science, Tampere University of Technology, Tampere, Finland*

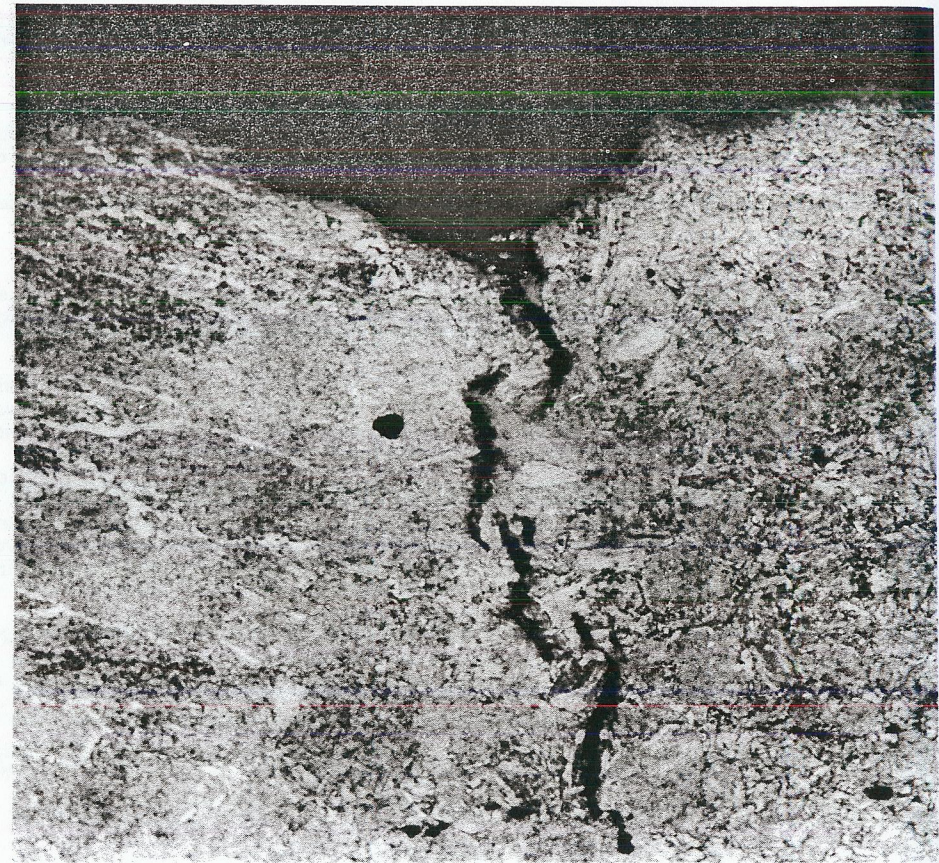
The crack started from a corrosion groove (Fig. 1) in the fusion boundary between the weld and the shell plate. Typical stress-corrosion induced cracking behaviour can be seen in Fig. 1. The role of corrosion in the cracking can be seen from the multiple small lakes in the crackriver where as the stress-influenced cracking continues like a zig-zag veining through different areas where in fact no plastic straining is possible /1/. In Fig. 2 one can detect a corrosion lake from where the crack goes further through three veins. In the isles between the veins a martensitic-bainitic microstructure can be revealed. Using transmission electronmicroscopy on carbon replicas prepared from these sites (Fig. 3) one can see that the non-plastic zone originates not only in the low temperature phase transformations but in the precipitation of secondary carbides, too. This kind of phenomena

Fig. 1. An overall view of the cross section of a cracked weld region. 150x.

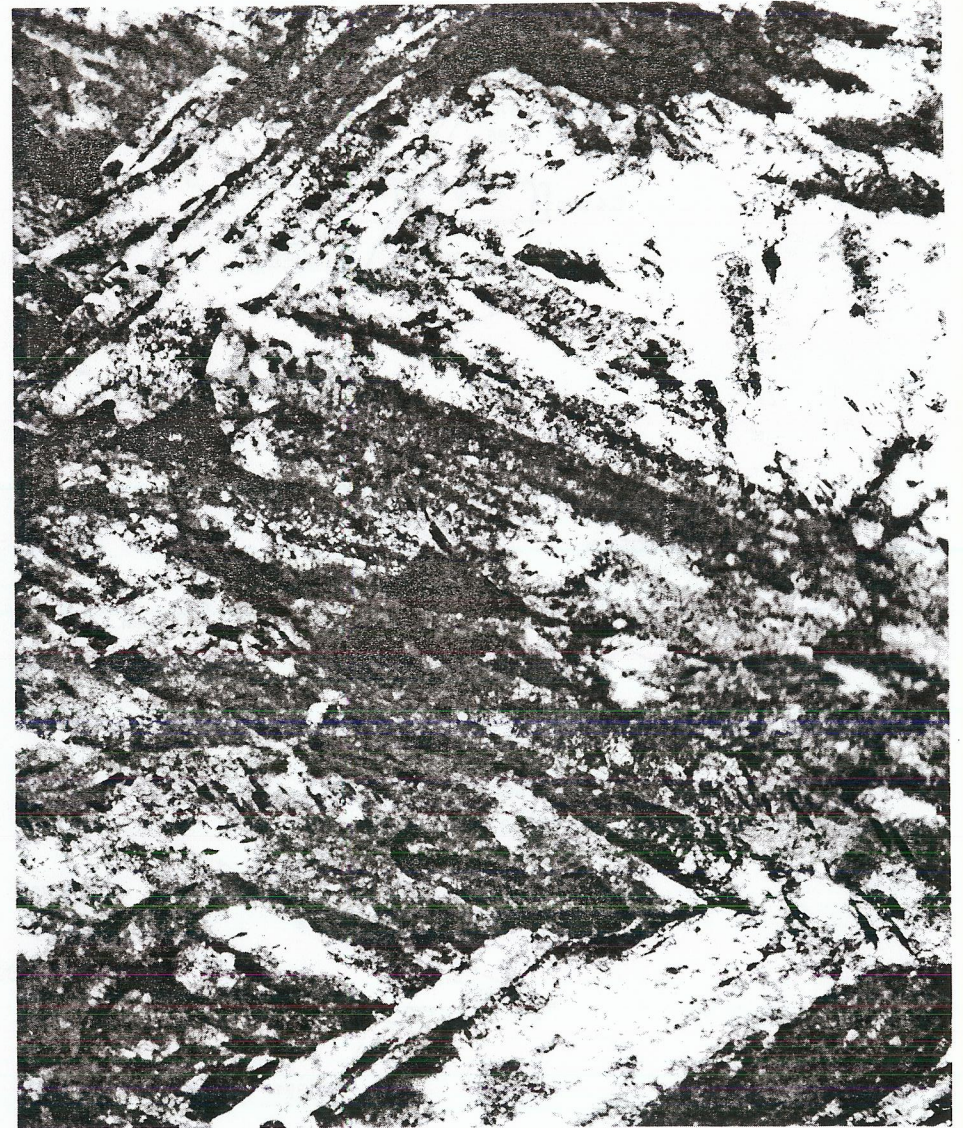
Fig. 3. A TEM picture of a replica of the martensitic bainitic path with secondary precipitates. 60000x.

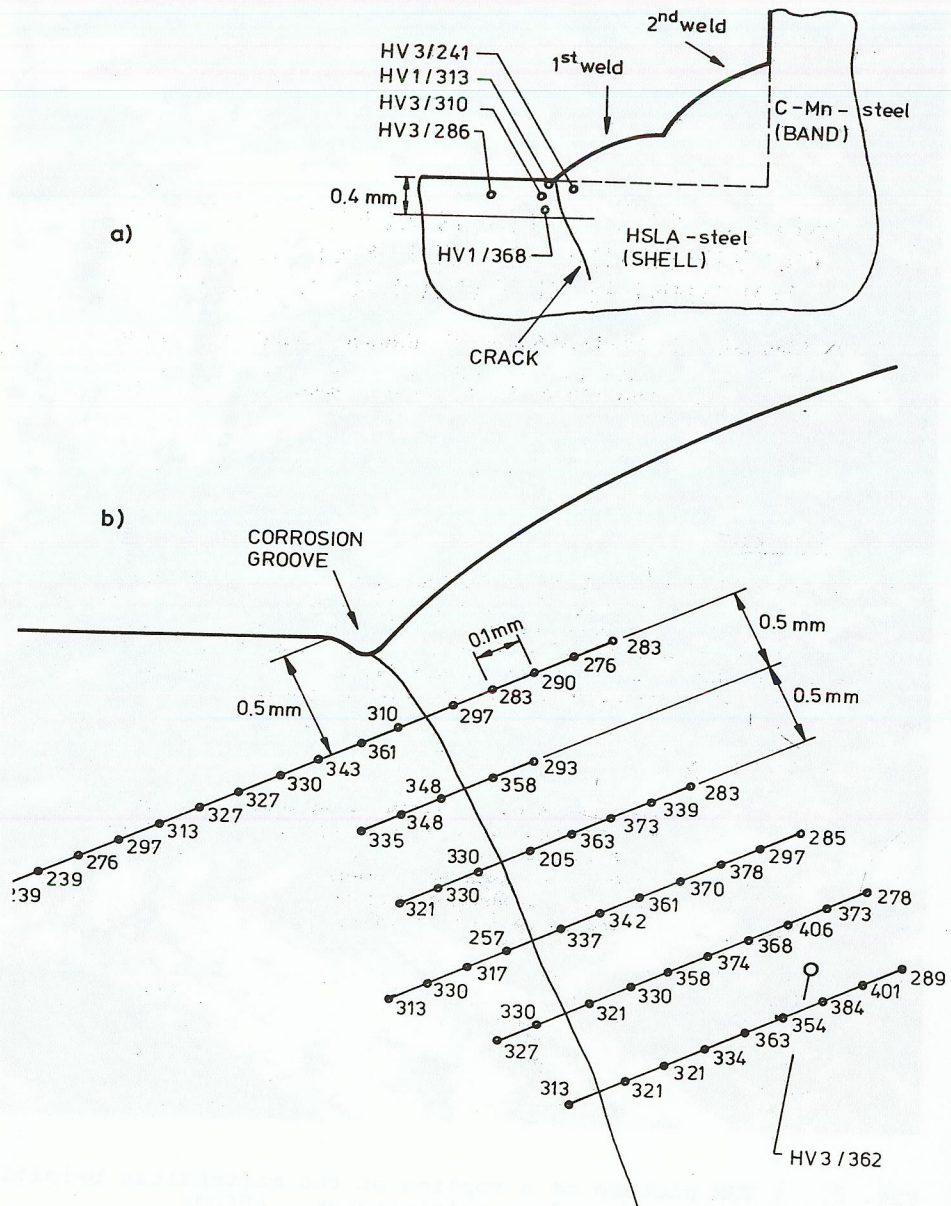
By studying the results the microhardness measurements (Fig. 4) one can see that at first the cracking follows the path of the high hardnessvalues. This path is only 0.1-0.2 mm wide and thus can easily be missed when making traverses to measure Vickers hardness using weights of 3 kg or more.
