Fatigue Crack Growth and Closure in a SiC_p-Reinforced Aluminum Composite

C. P. YOU and J. E. ALLISON

*Scientific Research Lab., Ford Motor Co., 20000 Rotunda, Dearborn,
MI 48121, USA*

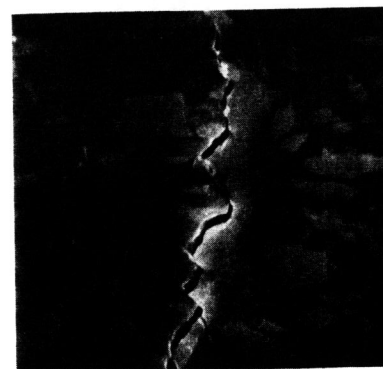
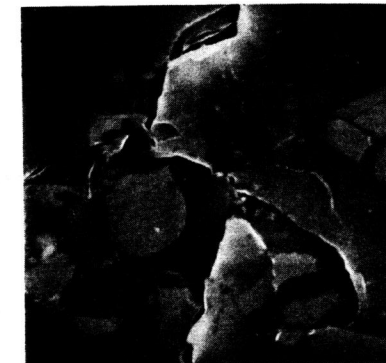
Fig. 4. SEM micrographs of crack profiles showing evidence of (a), (b) asperity-induced crack closure; (c) crack bridging; (d) crack branching.

It appears that over the range of applied K_{max} under investigation, K_{c1} is relatively constant. This type of behavior has previously been attributed to asperity-induced closure (Allison, 1988) (Fig. 3(b)). Evidence of asperity contact was clearly observed in crack profile examinations (Fig. 4). Oxide debris was also observed on the crack flanks close to threshold and, to a limited extent, on the fracture surfaces. The K_{c1} vs K_{max} behavior indicates, however, that the contribution of oxide-induced closure is probably dwarfed by the contribution from surface roughness. This is in agreement with results reported for IM 2xxx monolithic aluminum

alloys (Vasudevan and Suresh, 1982). Evidence for other possible crack tip shielding mechanisms (e.g. crack bridging and crack branching) are shown in Fig. 4(c),(d).
