Comb Cracking in Cemented Carbides

ABSTRACT

Intermittent cutting; Comb cracking; Work material; Hardness; Plain, Coated carbides.

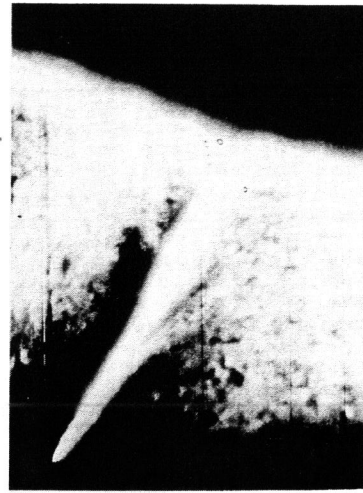
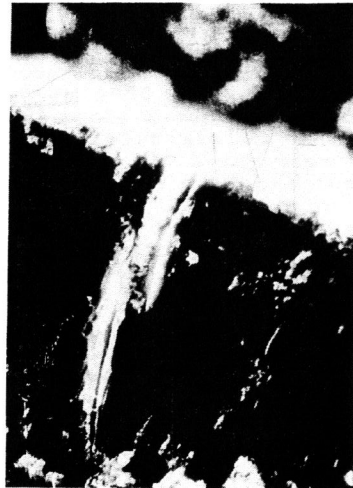
V - Shaped x250

Bell mouth x500

Discontinuous x250

Fig. 4. Typical V shaped comb cracks with bell mouth opening - illustrating the fatigue process during cracking

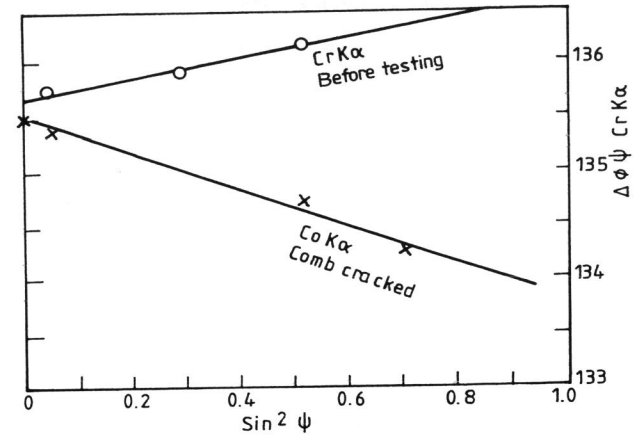
Fig. 5. $\sin^2 \psi$ plot showing occurrence of tensile stress over the rake face during comb cracking

As reported earlier, comb cracks normally occur on the rake face perpendicular to the cutting edge. The occurrence of such cracks would reduce the inherent tool strength, resulting in tool fracture. Fig.3 is a typical illustration of the observed cracking. It is seen that the first comb crack occurs on the primary cutting edge side, (farthest away from the cutting tip zone), where the temperature is maximum. Generally during machining the cutting tool experiences maximum temperature at three distinct zones; they are the depth of cut line zone, the cutting nose zone and the secondary zone immediately behind the cutting tip. Once originated, further cracking occurs nearer to the cutting tip zone. It is known that once the crack is initiated, the tensile surface stress which caused the cracking in that zone, decreases, there by increasing the material resistance to cracking in that zone. With further cutting, the zone of maximum temperature and tensile surface stresses shifts towards the cutting tip, promoting further cracking in that zone. This is illustrated in Fig.3. Fig.4 presents typical Scanning Electron Micrograph of comb cracks. It is seen that the cracks are V shaped, with bell mouth opening at the cutting edge. Some of the cracks are discontinuous, probably due to localised resistance to crack propagation from the tool material matrix. It is reported that the alternate heating and cooling of the tool surface results in establishment of higher order tensile stress, causing cracks. During milling, the surface stress on the cutting tools before and after comb cracking (first) were measured using X-ray (Macherauch 1965). For measuring the surface stresses on the cutting tool, X-ray method ($\text{Sin}^2\psi$) was adopted. The milling inserts were irradiated with Cr radiation in Philips Generator P.W. 1140. The X-ray beam was collimated and allowed to impinge on the tool surfaced (used portion). The back reflected X-ray was made to fall on an X-ray film kept at a suitable distance. This reflection was obtained for different orientation of the insert with respect to the X-ray incident beam (Gonimeted setting og '4'0. For the different settings, the difference in the radii of the emergent beam (on the film) was measured ($\Delta x_\phi, \psi$), This was plotted against $\text{Sin}^2\psi$. The slope on the plot multiplied by the stress constant of the cemented carbide would give the residual surface stress. Fig.5 shows typical $\text{Sin}^2\psi$ plot. From the figure, it is seen that the slope of the $\text{Sin}^2\psi$ plot is positive before comb cracks and is negative after comb cracks. This indicates the presence of surface tensile stress during comb cracking.
