INVESTIGATION OF WELD FAILURE IN SUPERAUSTENITIC UNS S31245 STAINLESS STEEL

ABSTRACT

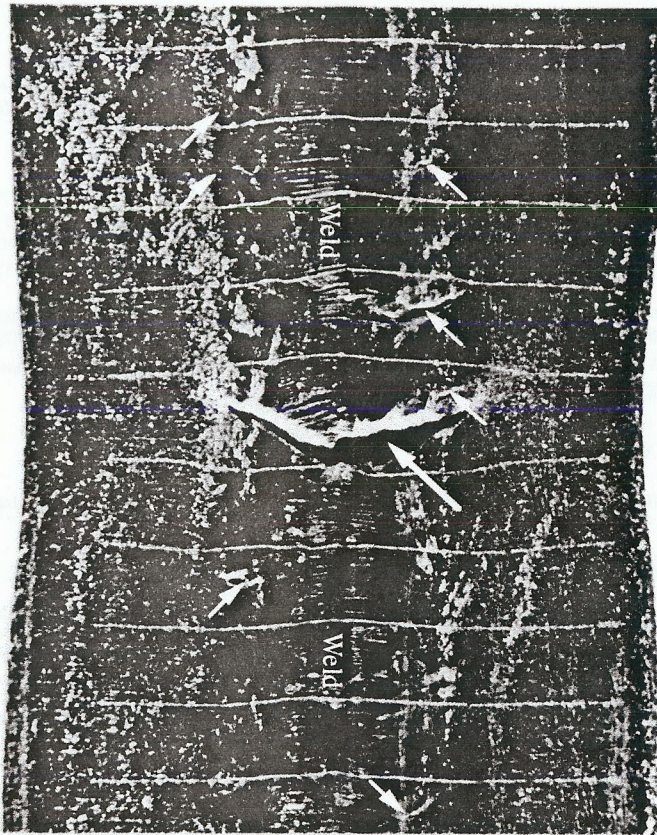
Figure 1 Central region of a flat dumbbell type tensile specimen of UNS 31245 stainless steel having a plasma arc weld down the centre. The test has been arrested after approximately 21% elongation. This specimen shows a large transverse crack (large arrow) in the weld and a number of smaller cracks (small arrows) at the weld toes.

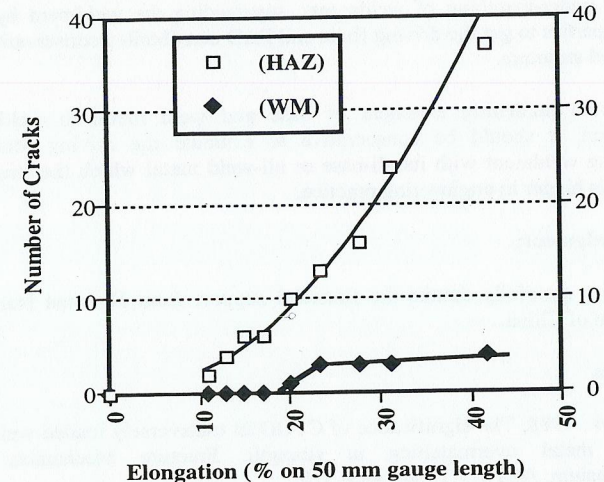
Figure 2 Extent of surface cracking in the weld and heat affected zones during tensile testing of one specimen. The number of HAZ cracks increased exponentially as straining was applied.

Results of tensile testing for one plate are shown in Figure 2. It is evident that HAZ cracking initiated after about 10% elongation and that the number of cracks increased as the tensile strain was increased. All of the welded plates showed a similar behavior. The unwelded plates showed no evidence of cracking up to failure at 49% elongation.

The transverse cracking induced by tensile strain is extensive (e.g. see Figure 2). Inspection of the fracture surface in Figure 4 shows that it is largely confined to the weld zone and is associated with minimal surface deformation. Where cracking has extended into the parent metal, the crack growth is associated with significant deformation, suggesting that the weld metal has low ductility compared with the parent metal.

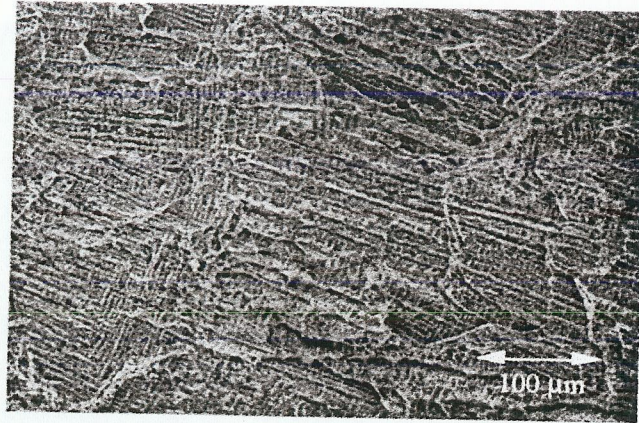
Figure 5 Fracture surface of weld metal in Figure 4. The fracture appearance is low ductility dimples with fracture along cell interfaces.

Figure 5 confirmed that failure occurred by low ductility fracture and also illustrated that the weld metal fracture path occurs along cell interfaces, that is, at the location where grain boundaries were found in the metallographic section (Figure 3). This suggests that either cell interfaces or grain boundaries offered the easiest path for crack growth.
