Hyun-Woo Lee, Se-Jong Oh and Woo-Hyun Choi

Damage Estimates Under Biaxial Random Load Spectrums by Considering Crystal Structure Dependence

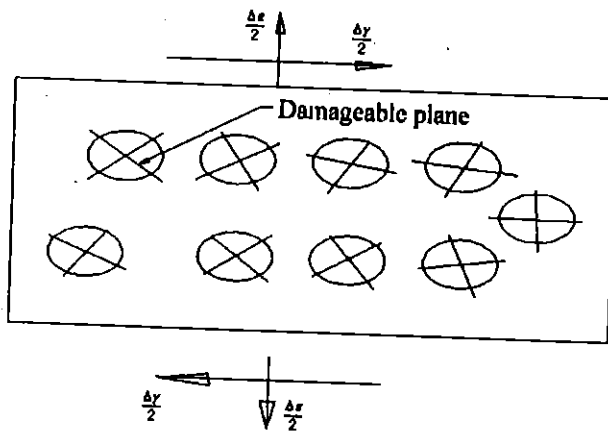
Fig.3 State of the damageable plane

to these crystals, and all crystals receive maximum damages, because the direction of maximum shear strain was rotated with the applied load. So, every damageable plane receives a maximum shear strain. It is the reason for which the extra damage causes on the materials. To account for this additional damage, a new damage mechanism was proposed [Fig. 1-3].

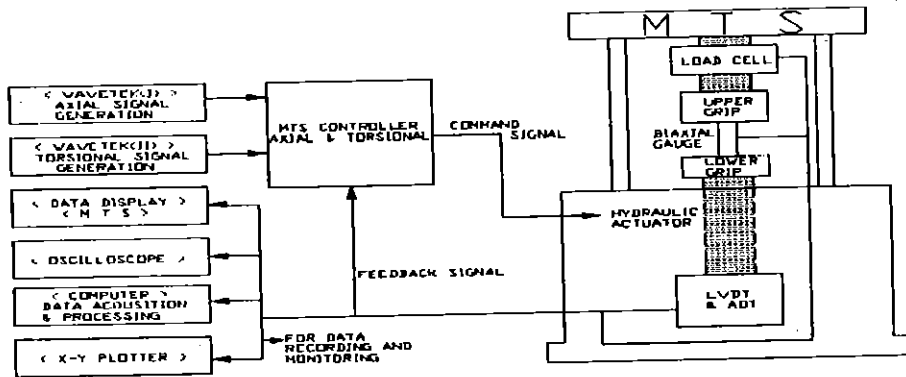
Fig.5 (a) Geometry of tubular specimen. (b) MTS fatigue test system.

The materials used were tempered A17075-T651 alloy and hot-rolled 1045 steel. The grain direction of the specimens is longitudinal. Tests were conducted on a servo-controlled closed loop tension torsion machine[Fig.5]. A processor/interface was used for computer control, data acquisition and data reduction. The operating frequency for biaxial tests ranged from 0.05 to 1.0 Hz. The thin-walled tubular specimens with 12.5mm(9mm inside diameter and 1.75mm wall thickness) were used[Fig. 5]. The both sides of each specimen were polished. Standard machine collects were used to grip the ends of each specimen. Tests were performed at room temperature. These materials are commonly used for aircraft and mechanical structures. The mechanical properties of the material tested are given in Table 2. Failure was defined as 10%(A17075-T651, cyclic hardening) or 50%(1045 steel, cyclic softening) axial load drop in the axial and combined axial-torsional tests, while 10% or 50% torque drop was defined as final failure in the torsional tests. Fatigue tests were conducted under axial, torsional, biaxial in-phase, biaxial out-of-phase, designed biaxial equivalently damageable and biaxial random load path. The test data under axial, torsional and biaxial in-phase and 90 degree out-of-phase loading condition of A17075-T651[10] were obtained from pre-study and these of 1045 steel were obtained from reference[11].

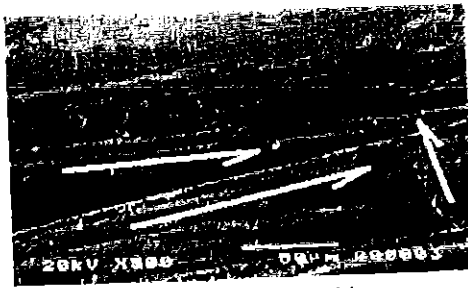
(a) Torsion, $\Delta\gamma/2=0.005$, $N_f=40,000$

(b) In-phase, $\lambda=1, \Delta\epsilon/2=0.004, \Delta\gamma/2=0.004, N_f=1443$

Fig. 10 Slip lines under torsional & in-phase loaded specimen

To account for crystal structure dependence of a material damage, the pictures of damaged specimen surface were obtained by SEM(Scanning Electron Microscope)(Al7075-T651 : Fig.6-9, 1045 steel : Fig.10-11). The pictures were sampled at the specimen's outside surface of uncracked position. To clarify the crystal structure dependence on biaxial low cycle fatigue, three different circular load paths and three different rectangular load paths(Fig. 12) were applied to the tubular specimen of Al7075-T651. These load path were designed to get the same amount of fatigue damage. These designed load path were obtained from the proposed damage mechanism and the relative angles between appeared slip lines(damage lines). Biaxial variable sinusoidal and random load paths were applied to the tubular specimen of 1045 steel. The variable sinusoidal load paths were obtained from the Eq.(6) and Eq.(7). The variable random load paths were obtained from the Eq.(8) and Eq.(9).

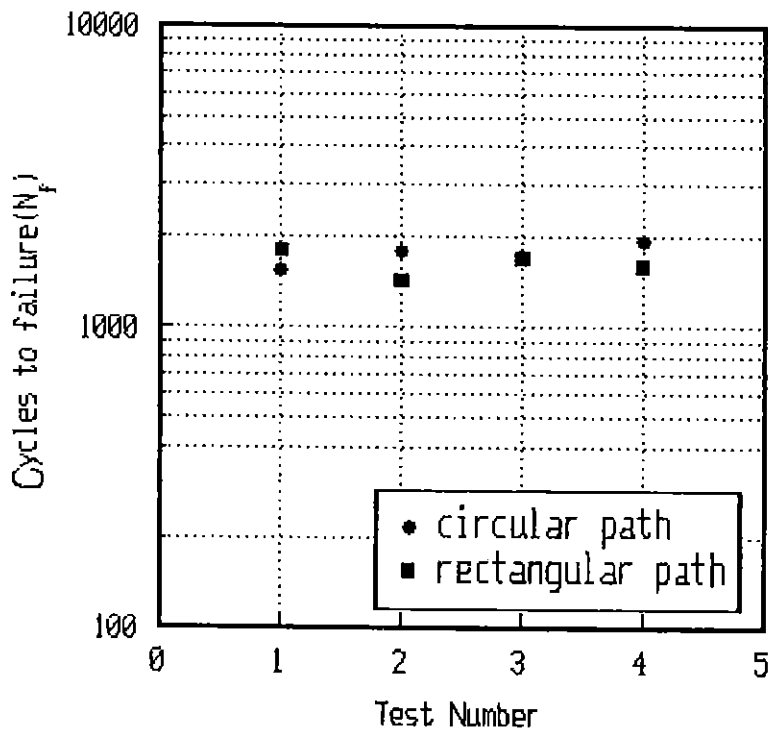
Fig.16 Comparison of tested lives by equally damageable load path

gives the same damage on each damageable plane. It was almost identical to the rectangular load path [Fig.15]. The circular and rectangular load path was designed to give the same damage to the tubular specimen. The test results are given in Fig. 16. The test data show the same damage in the statistical point of view. It is concluded that the proposed damage mechanism is reasonable.

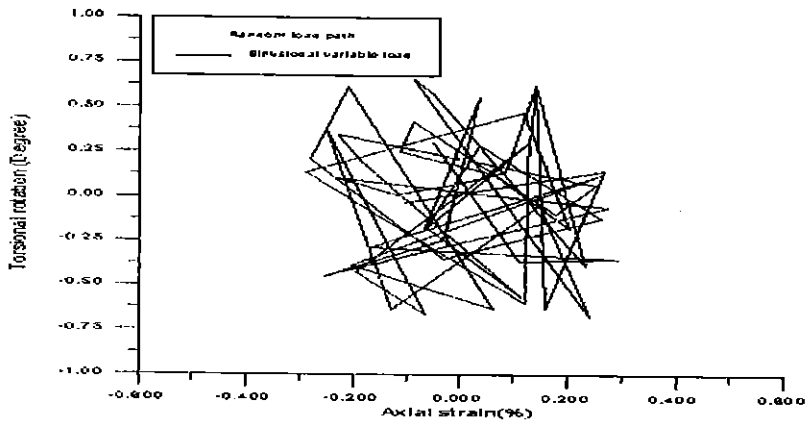
Fig.20 Plot of axial and torsional strain variation on xy-plane under biaxial variable random load path

Biaxial variable sinusoidal and random load paths were applied to the tubular specimen of 1045 steel. Biaxial variable sinusoidal load components variations and loading spectrum components are shown in Fig.17 and resultant plot of strain locus is shown in Fig.18. Biaxial variable random load components variations and loading spectrum's frequency scatters are shown in Fig.19 and resultant plot is shown in Fig.20. Fatigue lives prediction results are shown in Fig.21. In the case of variable sinusoidal load path, fatigue lives were predicted by maximum shear strain theory. The accuracy of fatigue life prediction results appeared to be conservative(predicted fatigue lives are 0.5-1 fold of experimental fatigue lives). In the case of variable random load paths, the accuracy of fatigue life prediction results appeared to be nearly 0.5 fold of experimental fatigue lives.
