Correlation between road public usage and experimental fatigue curves on brazed heat exchanger

Anne-Gaëlle Villemiane¹, Josselin Paturaud¹, David Delaux¹, Aurélien Buteri²

¹VALEO Engine cooling, 8 Rue Louis Lormand, 78321 La Verrière Cedex, France, Fax : 0130135399, anne-gaelle.noumet-villemiane@valeo.com, david.delaux@valeo.com, josselin.paturaud@valeo.com

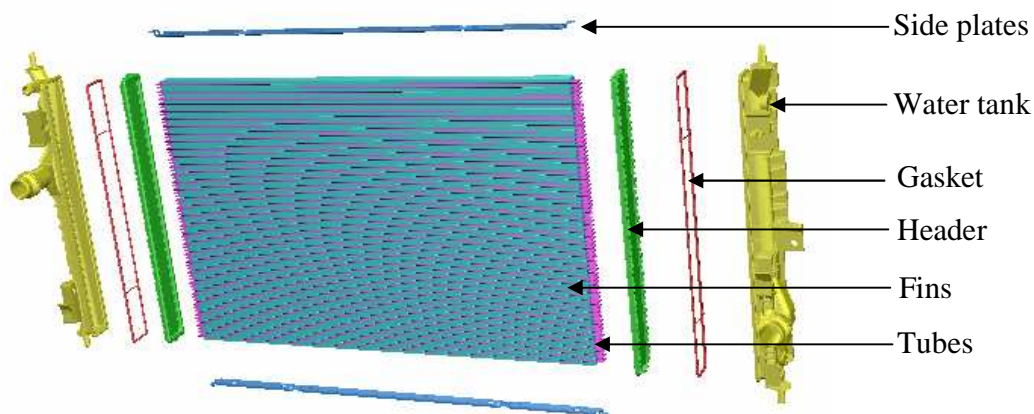
Figure 1: Structure of a brazed exchanger

All thermal car exchangers have the same type of structure based on two technologies: tubes or plates. These tubes or plates are linked by headers and fins as we can see on Figure 1. Tubes ensure the coolant liquid passage, fins increase the exchange surface with air temperature, headers allow coolant distribution in the tubes or plates and side-plates give core mechanical rigidity.

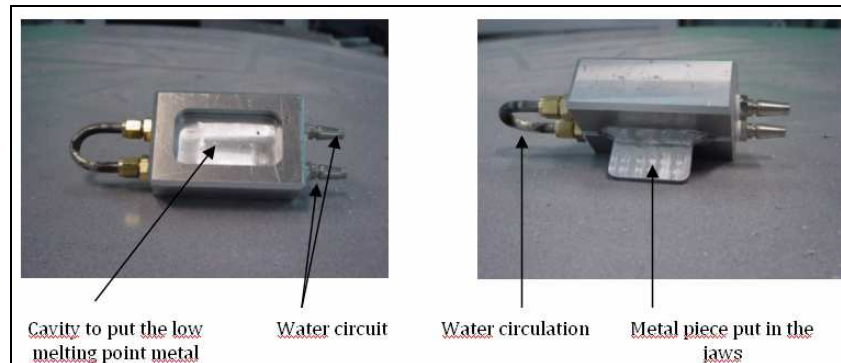
A prototype fixture (Fig 3) has been especially created for this study to allow us to perform a fatigue test on the mock-ups (tube+header) and a complete protocol has been done to obtain reliable results.

Figure 3: Universal fixture for fatigue tests

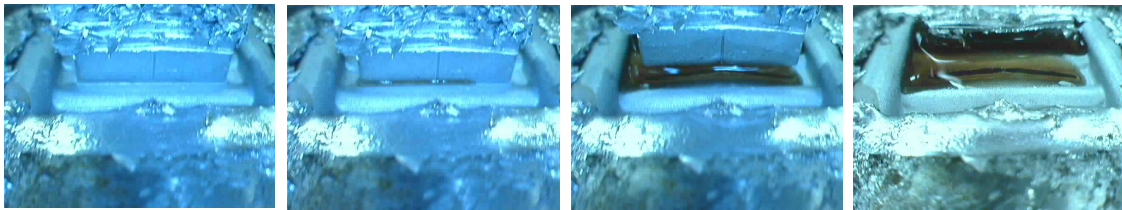
Mocks-ups were sampled on a complete heat-exchanger and cut with a band-saw to obtain a single tube and a header part. In order to follow the initiation of the crack (when the tube is leaking), we filled the tubes with a coloured liquid and monitored the fatigue test with a webcam (fig 4).

Figure 4: Following of the crack

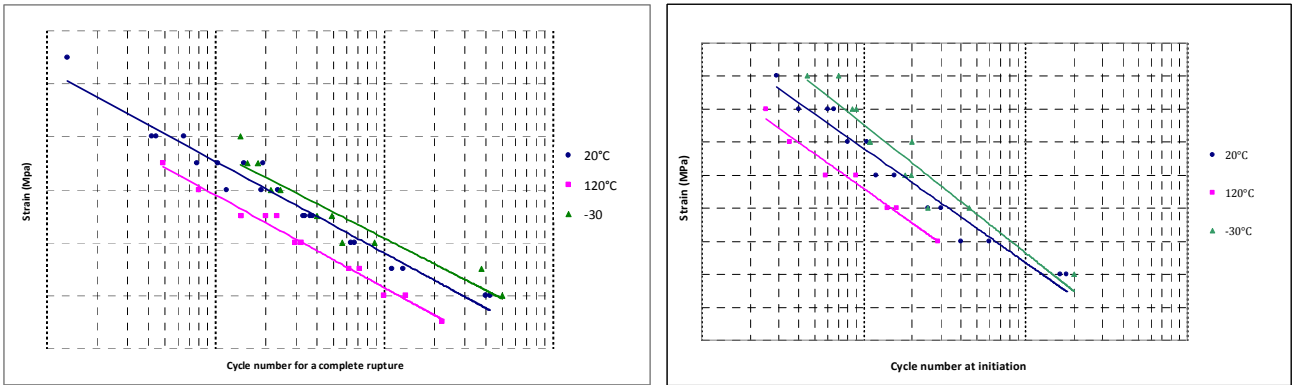
Figure 5-a presents Wölher curves at room temperature, -30°C and 120°C for a complete rupture (tube completely torn-off of the header). First of all, fatigue test on mock-ups allowed us to obtain a very high reproducibility of the result ($0,9 < R^2 < 0,98$). As we can see, fatigue resistance on mock-ups is better at low temperature in comparison with those at room temperature or at 120°C .

Same type of results was observed at rupture initiation (Fig 5-b).

Figure 5: a- Wöhler curves at final rupture, b- Wöhler curves at initiation of the rupture

The parallelism between curves on figure 5-a and figure 5-b indicates a proportional relationship between the initiation of the rupture and the final rupture. Indeed, if we study the Basquin coefficient, we can observe some very similar values for each temperature (Fig 6-a). The temperature does not affect the propagation mode: initiation of the rupture appears systematically at 40% of the total life expectancy of the tube (Fig 6-b).

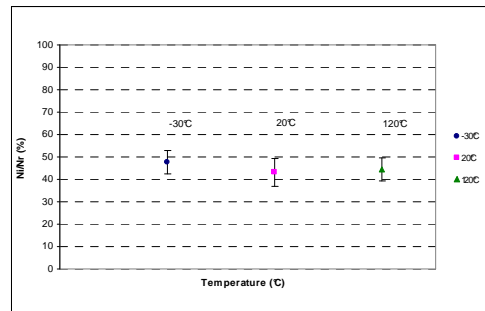
Température (°C)	-30	20	120
1/b (fissuration)	5,8	6,3	6,4
1/b (rupture)	6,2	6,5	6,7

Figure 6: a- Correlation between Basquin coefficient as a function of temperature for final rupture and initiation of the crack, b- Proportional coefficient between the cycle number at rupture initiation and final rupture

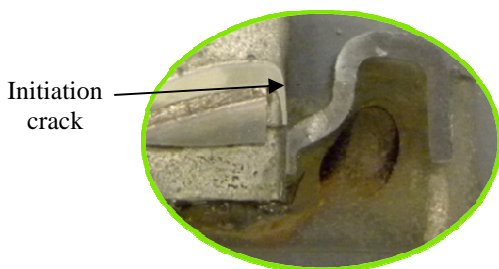
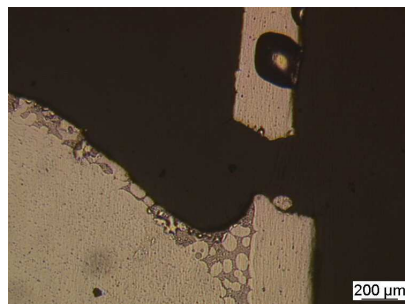
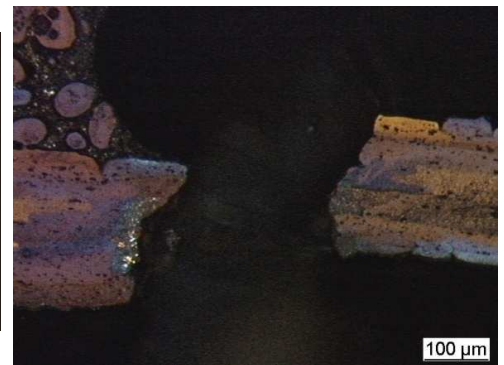
Figure 7: a- Localisation of the crack on the tube, b- Cross-section of the tube-header joint, c- Tube microstructure

Figures 7-a and 7-b present the failure mode after a fatigue test on a mock-up. This reproduces perfectly what happens on a car. The study of the microstructure shows (Fig 7-c) an intergranular crack in the residual clad then a transgranular crack in the core.

In deed, the test is pushed up to failure on bench with gage measurement in parallel. All failure modes are similar to the sample fatigue test (Figure 7.a). We confirm the Basquin's coefficient of 5 for heat exchangers in aluminium in the range 10.000 cycles to 500.000 cycles. This point is correlated with samples fatigue already seen above.

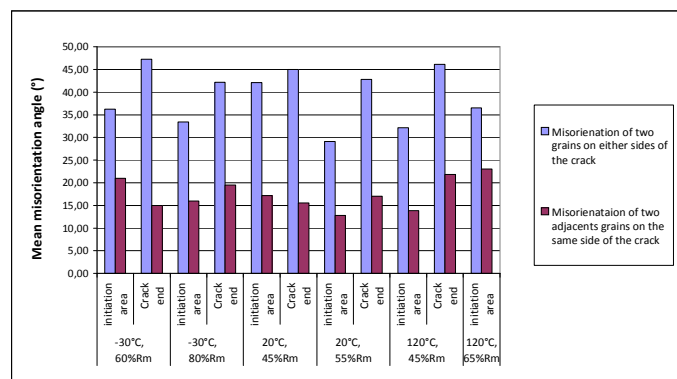
Figure 9 shows some sample results. Moreover, we can see that the difference between the misorientations of adjacent grains on the same side, and two grains on either sides of the crack, is higher on the crack end area than on the initiation area. The misorientation between two grains on either sides of the crack is higher on the crack end area than on the initiation area.

Figure 9: Misorientation of the grains around the crack for some samples

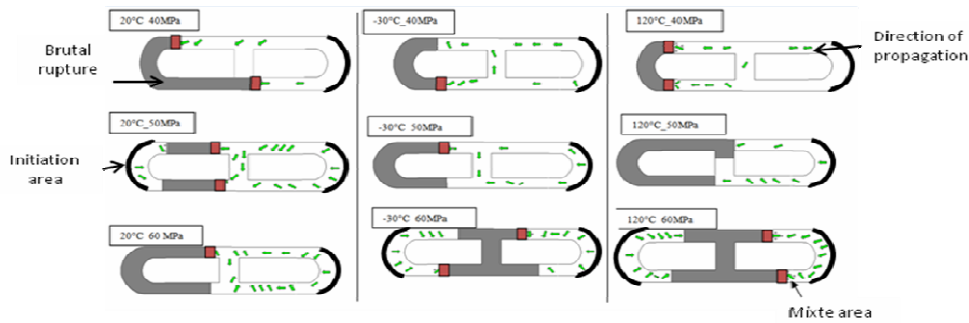
Figure 11 shows the different rupture morphology observed as a function of temperature. Grey areas represent the final rupture, green arrows show the propagation direction and red areas are the mixed areas. Rupture initiation systematically appears on one external side or two sides of the round of the tube and propagates to the internal tube face. It confirms the fact that the brutal rupture areas improve with an increase in stress.

We can logically expect that the rupture should happen from two sides of the tube because we perform symmetric tensile solicitations but we suppose that a microstructural or geometrical defect or a incorrect parallelism of the sample can promote the initiation of the crack on a side.

Figure 11: Summary of the rupture morphology observed as a function of temperature
