DAMAGE FORMATION OF A 2304 DUPLEX STAINLESS STEEL UNDER HOT WORKING CONDITIONS

A. Piñol-Juez, A. Iza-Mendia and I. Gutiérrez.

CEIT and ESII, Univ. Navarra. Pº Manuel Lardizabal 15,
20018 Donostia-San Sebastián. Basque Country, Spain.

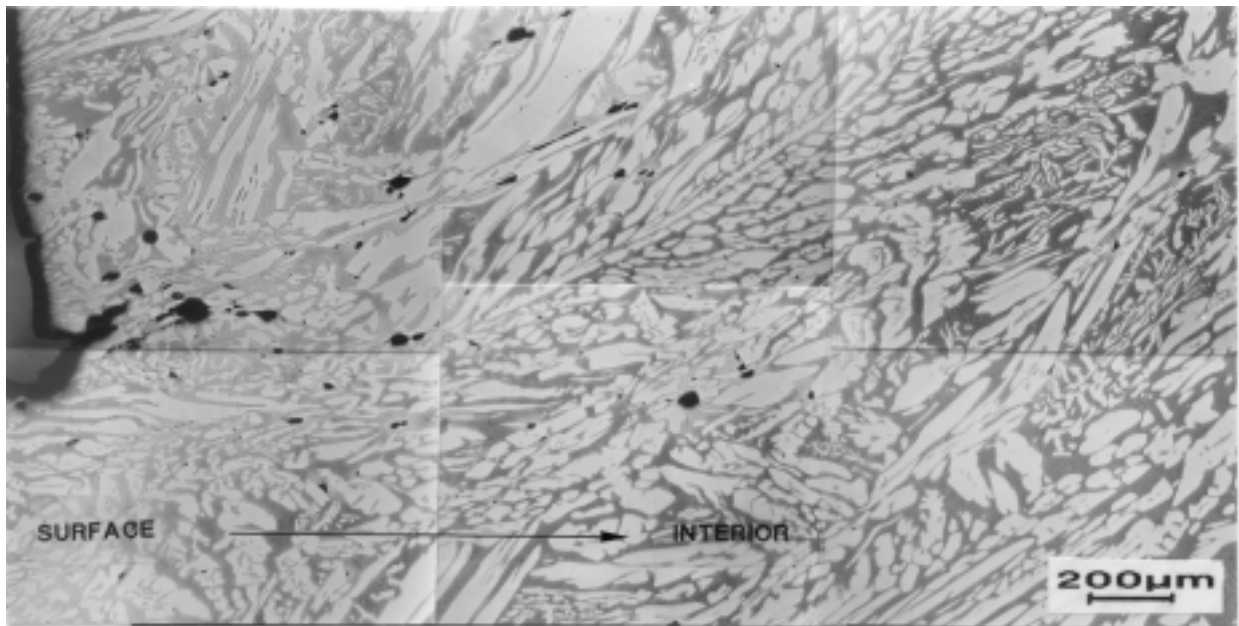
Figure 5: Optical micrograph of the as-cast duplex stainless steel deformed by hot torsion at 1000°C, showing cracks running parallel to the δ/γ .

The ductility of the as-cast duplex stainless steel decreases, as the deformation temperature approaches to 1000°C, see Table II. Additionally, damage is formed well before the final fracture of material takes place. The torsion samples show a large number of cracks on the surface and these cracks continue through the section of the specimen, running parallel to the δ/γ interface, as can be seen in Figure 5.

With the aim to study the initial shear strain for which cracks appear, several torsion tests have been carried out at 1000°C and 1 and 5.4 s⁻¹ and different strains. As cracks concentrate at the δ/γ interface, (see Figure 5) the fraction of damage, D, has been determined according to the following equation:

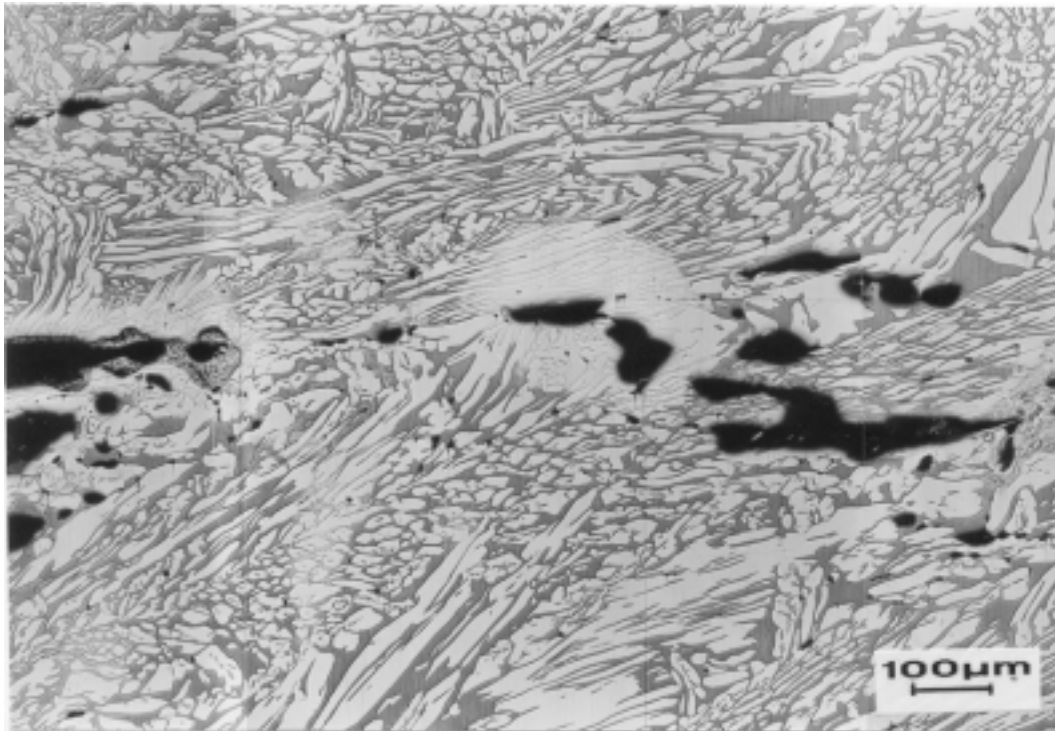
Figure 7: Optical micrograph of the as-cast duplex stainless steel deformed by hot torsion at 1000°C, 1 s⁻¹ to ε=1.6.

It is to be mentioned that these expressions have been obtained using mean damage values. But, in reality, most of the times, damage has been found to concentrate on certain areas of the torsion sample. These areas can have very high local damage fraction as shown in Figure 7. Consequently, it would be expected that from relatively low macroscopic deformations local areas exhibiting a high damage concentration can be produced around 1000°C. Additionally, the change on the conditions of contiguity at the sample surface seem to enhance the crack formation. Surface cracks are the most deleterious because further rolling will not be able to close them due to oxidation
