# EFFECT OF GRINDING ON THE FATIGUE STRENGTH OF A BEARING STEEL IN THE SUPER LONG-LIFE FIELD

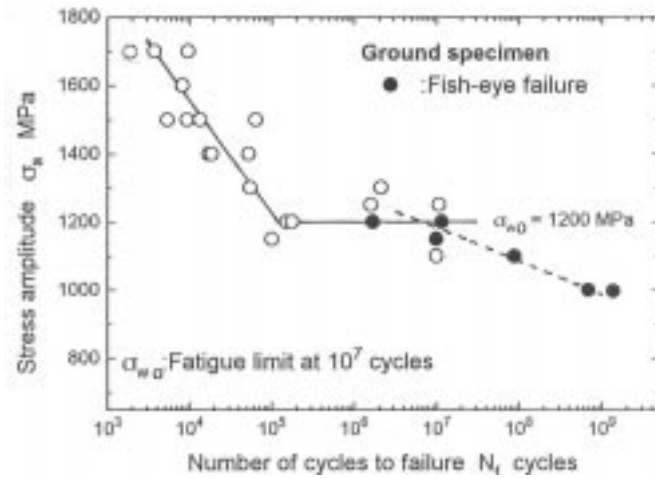
**Figure 3:** S-N Characteristics of EP-0 (ground) specimen

Ordinary fatigue tests were conducted to get the S-N characteristics of the EP-0 specimen. Fatigue limit stress was calculated by the staircase method using ten specimens. The number of cycles for run-out was  $10^7$  cycles. The specimens survived after  $10^7$  cycles were fatigued uninterruptedly at the same stress amplitude. Figure 3 shows the S-N curve. The fatigue limit stress at  $10^7$  cycles:  $\sigma_{w0}$ , which is characterized by a horizontal line in the figure, is 1200 MPa ( $s = 31.08$  MPa,  $s$ : standard deviation). At the number of cycles in excess of  $10^7$  cycles, fatigue strength exhibits a decreasing trend. For example, a specimen fatigued under  $\sigma_a$

= 1000 MPa was fractured over giga-cycles ( $N_f = 1.36 \times 10^9$ ). This indicates that the peculiar S-N characteristics exists in the long life field in excess of  $10^7$  cycles.

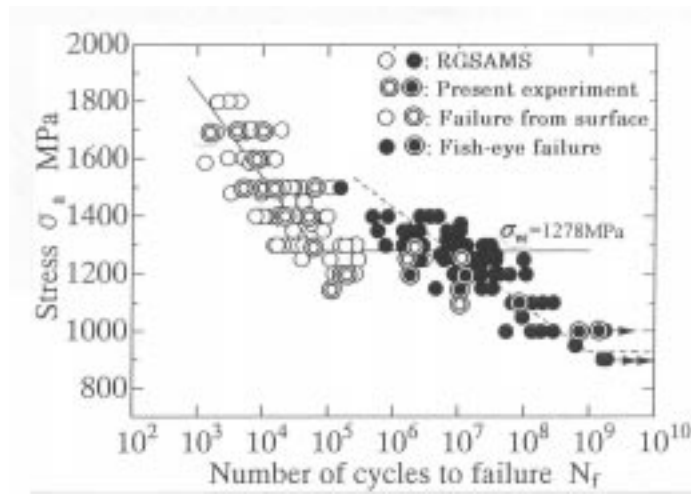
**Figure 5:** S-N characteristics given by the RGSAMS (○, ●:present experiment)

Figure 5 shows the S-N characteristics of the ground specimen by RGSAMS (Research Group of Statistical Aspect of Material Strength) [4]. For the sake of comparison, the present data (Fig.3) are also plotted by the ●,● symbols. The RGSAMS is proceeding the projects on the super high-cycle fatigue of the high-strength steels. Over 30 institutes join the project to gather the large volume of super high-cycle fatigue data, and the RGSAMS supplies the same specimen and fatigue machine. The present experiment of the ground specimen is included in the project. Figure shows that there are no significant difference in fatigue strength between the present experiment and the RGSAMS. In general, it is found that the fatigue strength of ground specimen exhibits large scatter and it tends to drop again in the long-life field in excess of  $10^7$  cycles. In such a long-life field, a crack tended to initiate from an interior non-metallic inclusion (the fish-eye pattern was left on the fracture surface).

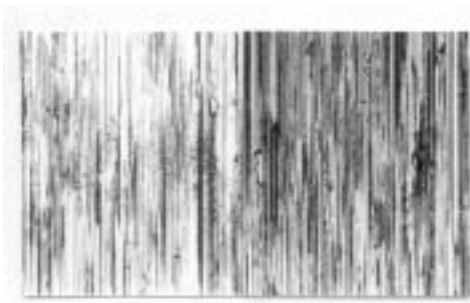
EP-0 (Ground)

EP-0 specimen,  $R_{max} = 6.36 \mu\text{m}$

EP-3 (3  $\mu\text{m}$  electropolished)

EP-3 specimen,  $R_{max} = 1.96 \mu\text{m}$

EP-15 (15  $\mu\text{m}$  electropolished)

EP-15 specimen,  $R_{max} = 0.64 \mu\text{m}$

**Figure 6:** Surface morphology and roughness for each specimen

Figure 6 shows (a) the micrograph of surface and (b) the surface roughness measured along the axial direction. The  $R_{max}$  values are 6.36, 1.96 and 0.64  $\mu\text{m}$  for EP-0, EP-3 and EP-15 specimen, respectively. The surface roughness is averaged by electropolishing, in other words, the scatter in geometrical shape of surface tends to be reduced with an increase in electropolishing.

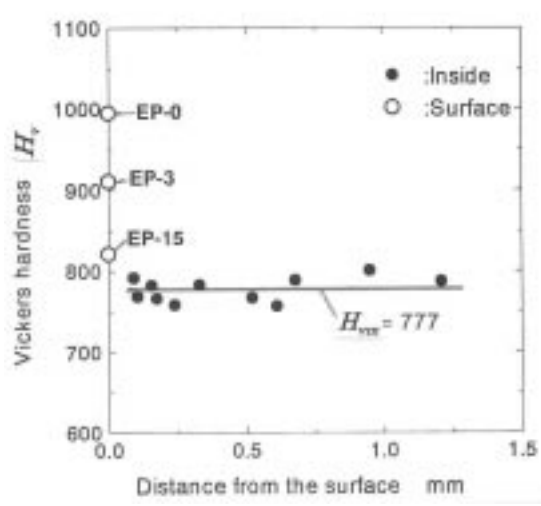
**Figure 7:** Distribution of the hardness

Figure 7 shows the Vickers hardness number measured over the cross section and at the surface. The load used was 2.94 N. The hardness of cross section distributes flat from 0.1 mm below the surface to the centre of the specimen. The average hardness is  $H_{vm} = 777$ . On the other hand, the surface hardness for each

specimen is  $H_v = 995, 910$  and  $821$  for EP-0, -3 and -15, respectively. This suggests that the surface layer less than  $20 \mu\text{m}$  is strengthened strongly by the grinding.

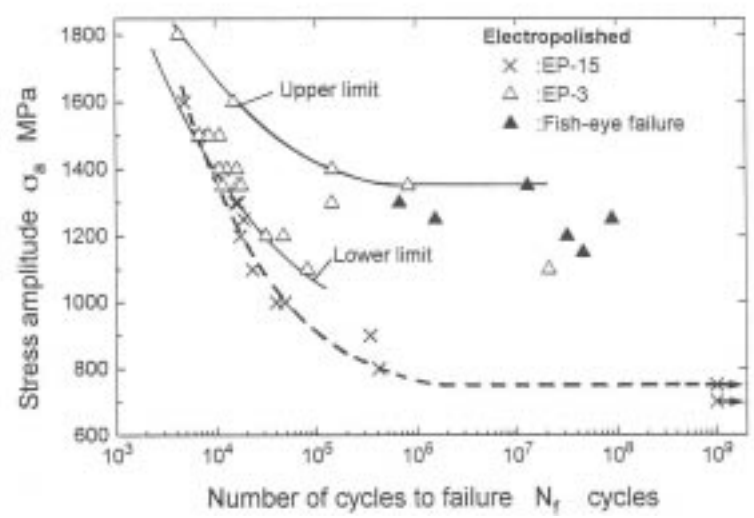
**Figure 8:** S-N characteristics of electropolished specimens

Figure 8 shows the S-N characteristics of EP-3 and -15 specimen. The fatigue strength of EP-15 specimen is dramatically decreased when compared to EP-0, and distinct fatigue limit stress exists ( $\sigma_{w15} = 750 \text{ Mpa} \cdot 0.63\sigma_{w0}$ ). The scatter in fatigue data is relatively small. This indicates that the scatter in material property caused by the heat-treatment was not large. Therefore, tremendously large scatter in S-N plots for EP-0 specimen is derived from the grinding finish. Figure 9 (a) shows the fracture surface of EP-15. All the cracks of EP-15 were initiated from the surface. On the other hand, the scatter in S-N plots of EP-3 specimen is larger than EP-15. Figures 9 (b), (c) and (d) show the fracture surfaces of EP-3. All the fracture origins in the short-life field ( $N_f < 10^5$ ) were at the surface: (b). In the long-life field ( $N_f > 10^6$ ), however, the fracture origins were inside the specimen: (c), excepting one specimen fractured from the surface grinding flaw ( $N_f = 2.102 \times 10^7$ , depth of flaw is  $2.5 \mu\text{m}$ ): (d). In Fig.8, the  $\bullet$  symbol means the fish-eye failure and the two full lines indicate the upper and lower limits of S-N plots for EP-3. Lower limit line is close to the S-N curve of EP-15. Figure 10 shows the crack initiation site of EP-3 specimen fractured at the lower limit line. Although the grinding flaws exist over the whole surface, no extraordinary rough flaws and defects are observed at the crack initiation site.

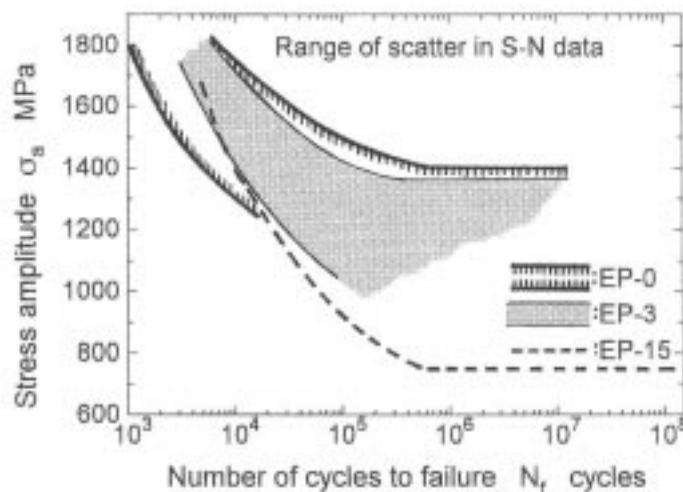
**Figure 11:** Comparison of scatter band of S-N data between the EP-0 and EP-3 specimens

Figure 11 shows the comparison of the scatter band (the upper and lower limits of S-N plots) between EP-3 and EP-0 specimen. The range of scatter in fatigue strength is smaller in EP-3 than EP-0. This narrowed scatter may be related to the decreased surface roughness of EP-3. The geometric shape of surface is averaged by electropolishing. This indicates that the scatter in fatigue strength is decreased in EP-3 than EP-0. On the other hand, no significant large difference in average fatigue strength between EP-3 and EP-0 was observed (both the S-N plots roughly overlap each other, whereas its scatter is slightly smaller in EP-3). Removing surface layer by electropolishing produces the decreased surface hardness and compressive residual stresses, which decrease the fatigue strength. However, it produces the reduced surface roughness, which increases the fatigue strength. As the result of such opposite two actions, the fatigue strength of EP-3 specimen may roughly coincide with EP-0.
