Determining the condition of material for tension bar bucket wheel excavator operating under dynamic working conditions

Abstract

Since the bucket wheel excavator SRs 1200 had crashed with bucket wheel boom heavily damaged, there was an opportunity to analyze the real structure that was in operation for past 40 years. As there are 4 more SRs 1200 bucket wheel excavators in RB Kolubara, obtained results can be of great benefit for 4 running bucket wheel excavators, as well as the revitalization of the damaged one.

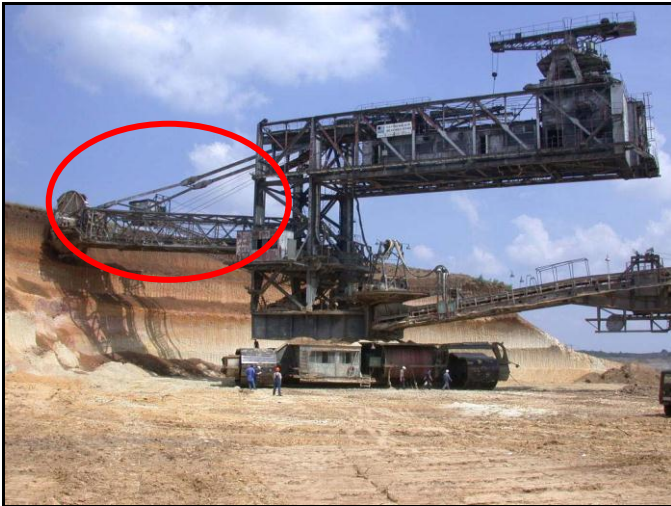
Figure 1 Bucket wheel Excavator SRs 1200

and in some cases, it resulted in significant damages. Those damages were especially noticed within the area of the bucket wheel boom as shown on the figure 1.

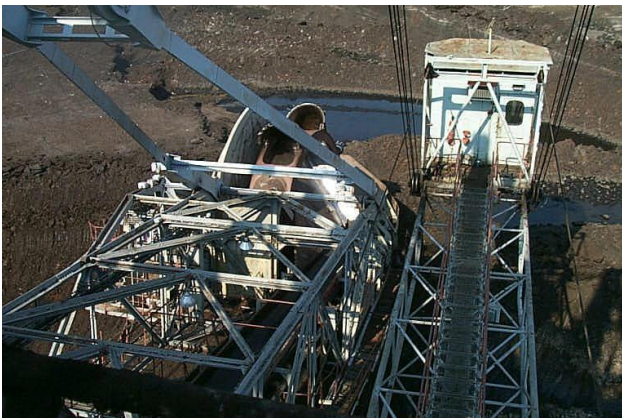
As it has been said within the introduction, the purpose of these examinations was to calculate an actual deformation and tension condition at the characteristic point of the bucket wheel excavator, which are, according to experts' experiences from OCMs, and based on technical technological documents, the most loaded (figures 5, 6 and 7).

Figure 5. Bucket Wheel Boom with the tension rod Figure 6. Strain Gauges

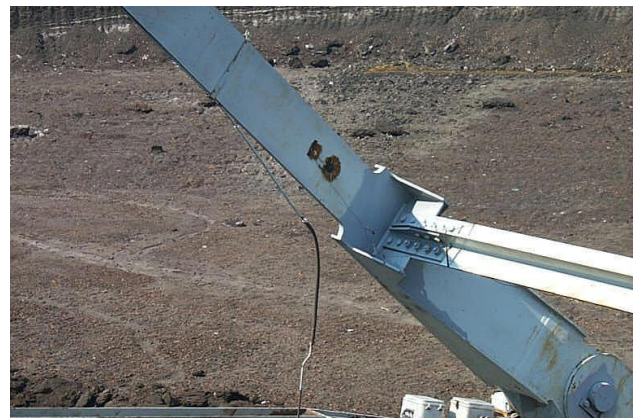
For the purpose of defining deformation and tension conditions within the bucket wheel excavator steel structure it has been used rosettes 10/120 RY 11, and individual measuring of belts 10/120 LY 11 and 10/350 LY 11. Measuring belts are glued together as it can be seen in the figure 4. In order to eliminate side effects during the procedure, like temperature changes, compensation measuring belt has been used. Compensation of temperature changes has been performed by measuring of belts 10/120 LY 11 and 10/350 LY 11. Measuring points on which belts has been located have been protected against atmospheric influences, as well as against mechanical damages, which should enable tension check to be performed as well after a certain period of time.

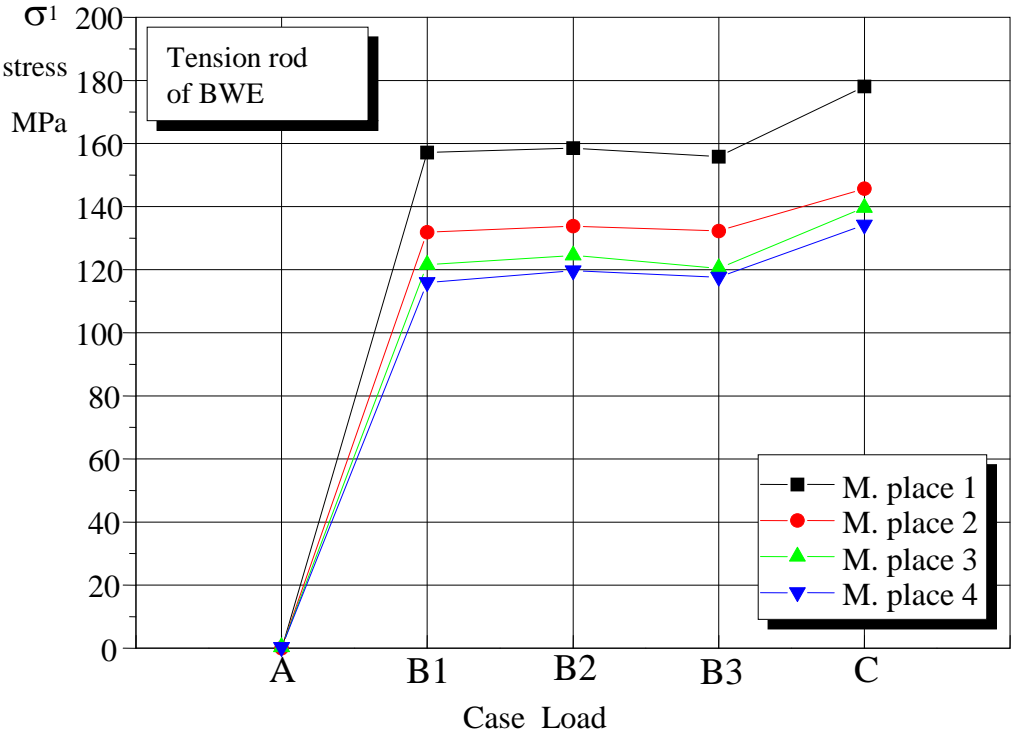
Figure 8. Tension dependence – load case for measuring points on the bucket wheel boom clamps

Measured micro deformations at the strain gauges on the tension rod of the bucket wheel boom, and calculated tension indicate that yield stress has not been exceeded not even at the single measuring point, that is, tension are at the linear flexibility area. The highest calculated main tension on the rod of the bucket wheel boom is on the measuring point 1 (178,1 MPa, figure 8). This point is located near to the bucket wheel axis, that is, gearbox and bucket wheel own weight have more load on the left then on the right side of tension rod. Other calculated tension values are relatively high, but still within linear flexibility area.

In general, all measuring points on the left side indicate higher load value, that is measured deformations and calculated tensions are higher than on the right side. This is directly related with the gearbox position and the bucket wheel boom position.
