FATIGUE CRACK INITIATION MECHANISMS IN AIR AND IN VACUUM
IN POLYCRYSTALLINE COPPER

J. Mendez, P. Violan and C. Gasc*

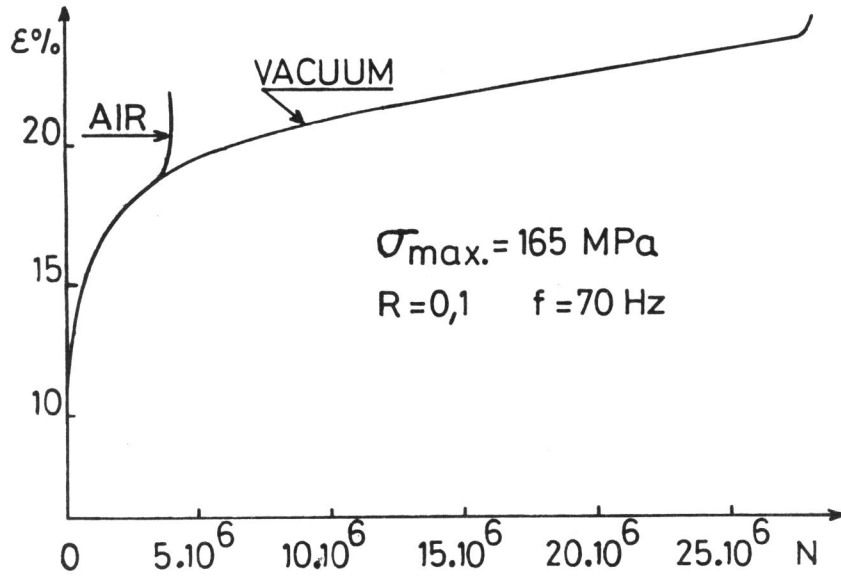
Figure 1 Cyclic creep curves in air and in vacuum. $\sigma_{max} = 165 \text{ MPa}$

Fig. 1 illustrates the relationship between the cyclic creep and the number of cycles in air and in vacuum for a maximum engineering stress of 165 MPa.

The cyclic creep curves reveal the following features

- i) the initial parts of the curves are the same in both environments.
- ii) the curve in vacuum shows a steady-state stage of plastic deformation while this stage is not observed in air.

It can be noticed that in these experimental conditions and for all the tests, the maximum true stress increases with the reduction in diameter of the specimen due to monotonic deformation. In the example illustrated by Fig. 1 σ_{\max} reaches a value of 180 MPa at the end of the loading sequence, 196 MPa at the rupture of the specimen in air and 224 MPa at the rupture in vacuum.

At a maximum engineering stress of $\sigma_{\max} = 165$ MPa, for which significant differences in fatigue lives are observed in air and in vacuum (see Fig. 1), some specimens have been cycled up to $0.5 \cdot 10^6$, 10^6 , $2 \cdot 10^6$ and $4.3 \cdot 10^6$ cycles in both environments and up to $6.3 \cdot 10^6$, $9 \cdot 10^6$ and $11 \cdot 10^6$ in vacuum.

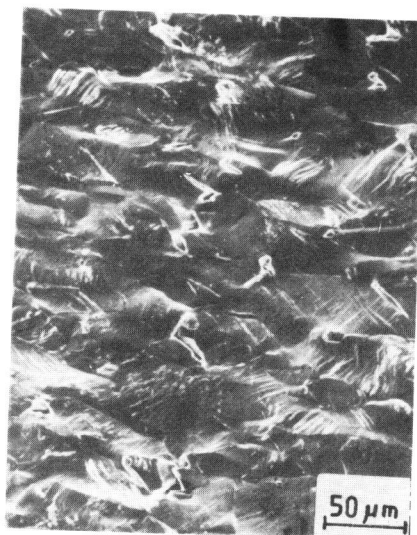
Figure 4 Grain boundary microcracks-vacuum, $4.3 \cdot 10^6$ cycles.

In vacuum, the number of microcracks at the grain boundaries increases with the number of cycles. The density of wedge cracks at isolated triple points increases without any propagation (Fig. 4). At about 10^7 cycles these microcracks link together over a range of 2 or 3 grain diameters (Fig. 6)

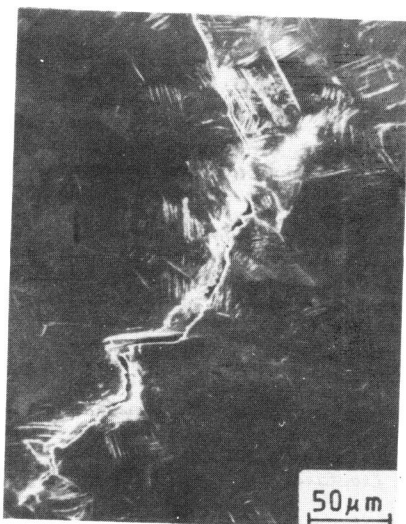
Figure 5 Stage II fatigue-crack air, $2 \cdot 10^6$ cycles.

On the surface of specimens tested up to failure in air a few secondary cracks can be observed extending over about ten grain diameters (Fig. 5). Some microcracks which did not extend beyond grain boundaries are also visible in persistent slip bands. Observations of secondary cracks features indicate that in air, stage II fatigue cracks start from microcracks initiated in slip bands and grow transgranularly under the action of normal stresses.

With an increase in the number of cycles, the general aspect of the surface does not evolve much in air. A few deep microcracks are formed in the grains in persistent slip bands (Fig. 3) and some of them propagates in stage II localizing the deformation in a few zones (Fig. 5).

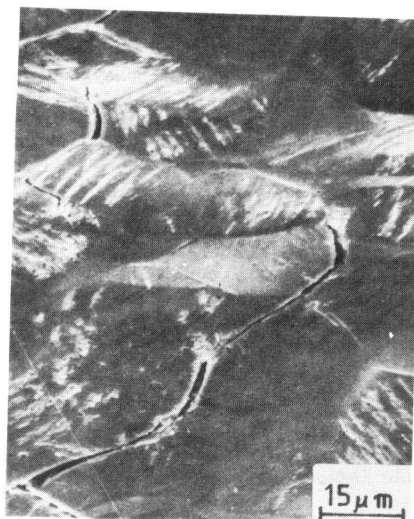
Figure 6 Coalescence of G.B. microcracks-vacuum, $9 \cdot 10^6$ cycles.

On the other hand, examination of the surfaces of specimens tested in vacuum (Fig. 6) reveals a great number of cracks 3 or 4 grain diameters long distributed all along the gauge length. These microcracks are localized at grain boundaries, with a mean direction perpendicular to the loading axis.
