EFFECT OF MICROSTRUCTURE ON CRACK GROWTH IN A HIGH STRENGTH ALUMINIUM ALLOY.

Fatigue crack growth measurements in the low rate range and at near threshold level were made in air and in vacuum on a 7075 aluminium alloy in four aged conditions, viz. T351, T651, T7351 and 24 hours at 200 °C. Important differences were observed depending upon environment and aging conditions. The results obtained are discussed on the basis of microfractographic observations and specific mechanisms are proposed to describe each crack growth behaviour.

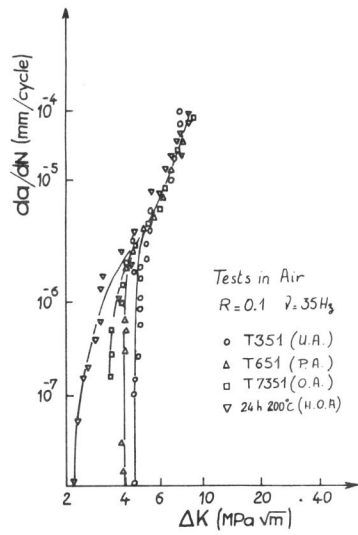
The propagation curves da/dN vs ΔK in air (about 60 % R.H.) are illustrated in figure 1 for the four different aged conditions.

In the mid rate range the propagation appears to be independent of microstructure, but in the low rate range ($da/dN < 10^{-5}$ mm/cycle) a substantial effect is observed leading to different threshold levels. A change in crack growth behaviour is observed at a crack growth rate called $(da/dN)_k$ corresponding to a kink in the curves, except perhaps for the H.O.A. condition for which a more progressive evolution is observed without a well defined kink.

Figure 1 da/dN vs ΔK curves in air

- for $\frac{da}{dN} > (\frac{da}{dN})_k$, in all cases the crack growth is essentially governed by the effect of water vapour adsorption, independantly of microstructure.
- for $\frac{da}{dN} < (\frac{da}{dN})_k$ there exists evidence of oxide deposits on the cracked surfaces which increase in thickness with aging and correspond to decreasing threshold level. Such a result is not consistent with the expected effect of the "oxide induced closure" mechanism proposed by Ritchie (4). Thus a new mechanism was proposed in ref. 3, by which the existence of an oxide layer could tend to inhibit the effect of water vapour at the crack tip as shown previously on a 2618 alloy (5), and leading to a crack growth process essentially controlled by the microstructure.

On the overaged specimen a flat growth path is observed corresponding to a mode of failure controlled by the precipitation hardening as in vacuum. However, the replica presented in fig. 8 shows a pronounced decohesion process at the interface of the M precipitates (10) which suggests a residual effect of environment in this case, which is not observed on the O.A. specimen and is in accordance with the crack growth data (Fig. 1 and Fig. 2).

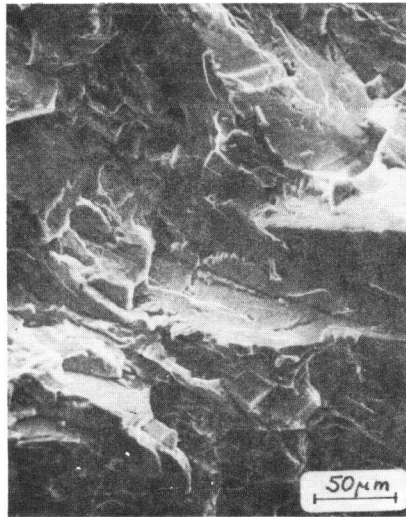
- a very rough fracture surface consisting of crystallographic facets (Fig. 3), with some evidence of intergranular failure and ob branching, observed on the U.A. specimen in all the explored rate range and on the P.A. specimen near threshold. Striations are observed on these facets as shown on a replica presented in the fig. 3 ; the interstriation is not coherent with the crack growth rate.

Figure 3 UA specimen in vacuum
 $da/dN \approx 3 \cdot 10^{-6}$ mm/cycle

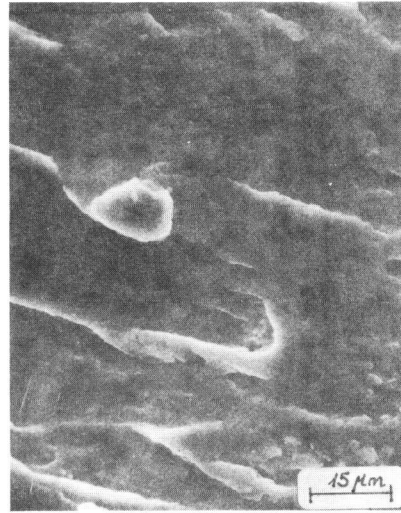
- a very flat and transgranular crack growth path, only marked by the wake of the intermetallic constituent particles of some μm in diameter (Fig. 4), observed on the overaged specimens in all the explored rate range and on the P.A. specimen only in the mid rate range ($> 10^{-5}$ mm/cycle). Replica of the cracked surface near threshold shows evidence of a propagation mechanism controlled by the hardening precipitation (Fig.6).

Figure 4 HOA specimen in vacuum
 $da/dN \approx 2 \cdot 10^{-6}$ mm/cycle.
