EFFECT OF PRIOR COLD WORK ON LOW CYCLE FATIGUE BEHAVIOUR OF AISI
TYPE 304 STAINLESS STEEL

K. Bhanu Sankara Rao, M. Valsan, R. Sandhya, S.L. Mannan and
P. Rodriguez *

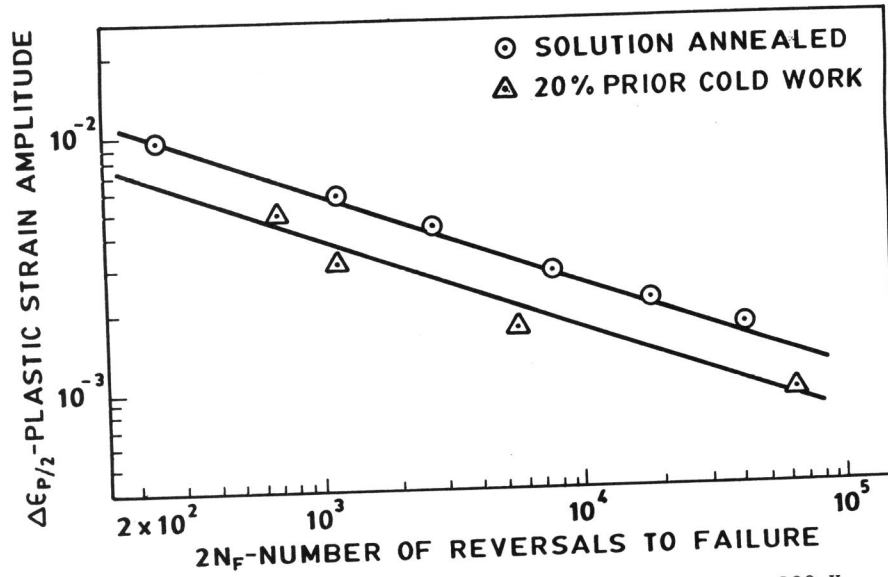
Figure 1 Influence of prior cold work on fatigue life at 300 K

SA material was found to harden during cycling, followed by a saturation behaviour, while PCW material softened continuously during cycling. Plots of plastic strain amplitudes $\Delta\epsilon_{p/2}$ corresponding to the saturation stress strain curve of SA material and those corresponding to half the fatigue life of PCW material versus number of reversals to failure ($2N_F$) are shown in Figs.1,2 and 3 at 300, 823 and 923 K respectively. Coffin-Manson relationship is obeyed at all the temperatures by SA as well as by PCW materials.

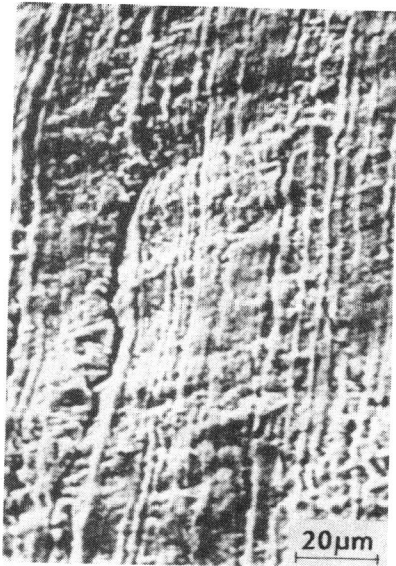
Fig.6a Oxidation of PSB's
(20% PCW, 923 K, $\frac{\Delta\epsilon_t}{2} = 0.25\%$)

Oxidation has been found to influence crack initiation and propagation modes at 923 K. SA material in general exhibited transgranular crack initiation. PSB's in PCW material were found to be heavily oxidised (Fig.6a) and aided in crack initiation on the surface. The ridging of the surface grain boundaries and the associated intergranular crack initiation were also observed in PCW material (Fig.6b). Coffin (12,13) and McMohan and Coffin (14) have made similar observation in superalloys and suggested that chemical segregation and carbides at the grain boundaries cause selective oxidation and intergranular cracking.

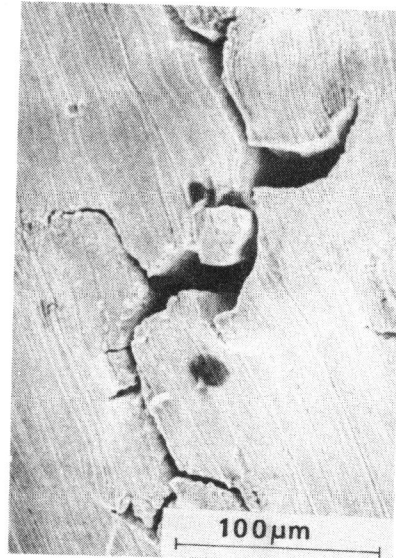
Fig.6b Grain boundary cracks
at ridges (20% PCW, $\frac{\Delta\epsilon_t}{2} = 0.6\%$)

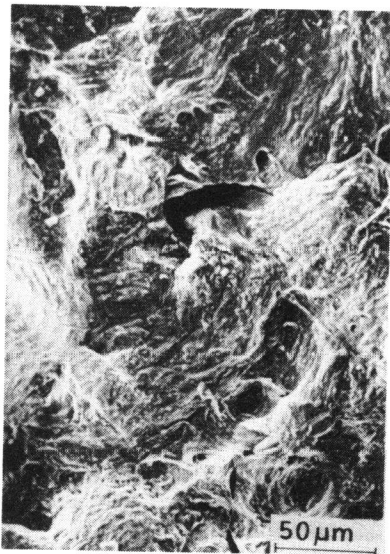
Fig.6c Fracture surface of 20%
PCW (923 K, $\frac{\Delta\epsilon_t}{2} = 0.6\%$)

The recovery in fatigue life at higher PCW levels observed at 923 K is now discussed. As seen in Fig.6c, intergranular cracks have propagated only to a very limited extent in 20% PCW material in comparison with 10% PCW material (Fig.6d). 30% PCW material also exhibited restricted intergranular crack growth. TEM studies on fatigue tested samples (15), 20% and 30% PCW materials have been found to show extensive recovery. As pointed out in (3) the structural recovery leads to increased fatigue life at high temperatures in austenitic stainless steels. More extensive recovery observed in 20% and 30% PCW may be responsible for higher observed life compared to 10% PCW. Extensive TEM studies are underway on samples deformed to various fraction of fatigue life on different PCW material to assess the influence of PCW on substructural recovery. Further the increased life observed for 30% PCW material at low strain range is in agreement with influence of recovery on crack propagation.

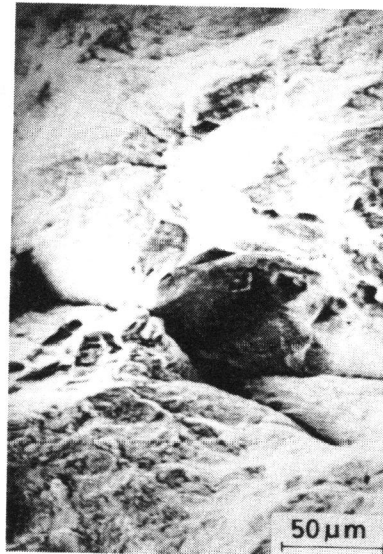
Fig.6d Fracture surface of 10%
PCW (923 K, $\frac{\Delta\epsilon_t}{2} = 0.6\%$)
