Fatigue Behaviour of a Sharply Notched Carbon Steel under Torsion

B. Atzori¹, P. Lazzarin² and M. Quaresimin²

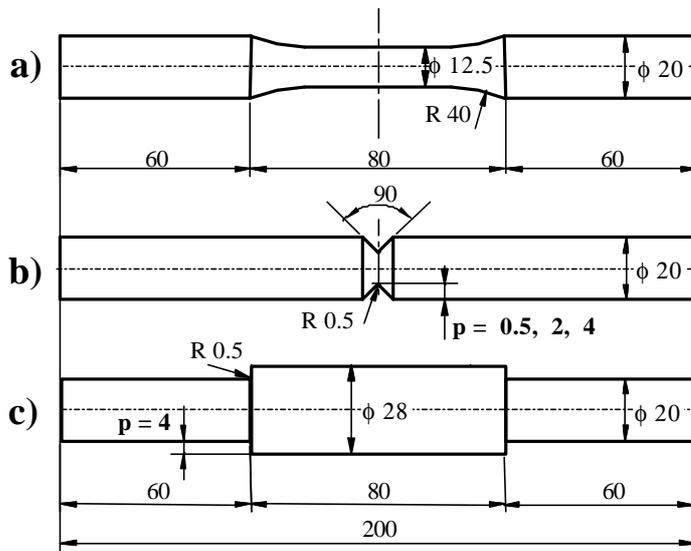
Figure 1. Geometry of the specimens.

The geometry of smooth and notched specimens is shown in Fig. 1. With reference to V-shaped notches (Fig. 1b), the V-notch depth ranges from 0.5 to 4 mm. The height of the shoulder (Fig. 1c) is 4.0 mm. In all notched specimens the notch tip radius was kept constant and equal to 0.5 mm. Such a value makes it difficult any correlation between the theoretical stress concentration factor K_t and the fatigue strength reduction factor K_f , since the notch sensitivity index exhibits a large scatter. Finite element analyses carried out by using the ANSYS® code gave a theoretical stress concentration factor (referred to the net area) equal to 1.94, 2.03 and 1.73 for the symmetric V-notches with a depth equal to 4.0 mm, 2.0 mm and 0.50 mm, respectively. On the other hand, the geometry with shoulders is characterised by a $K_{t,net} = 1.82$.

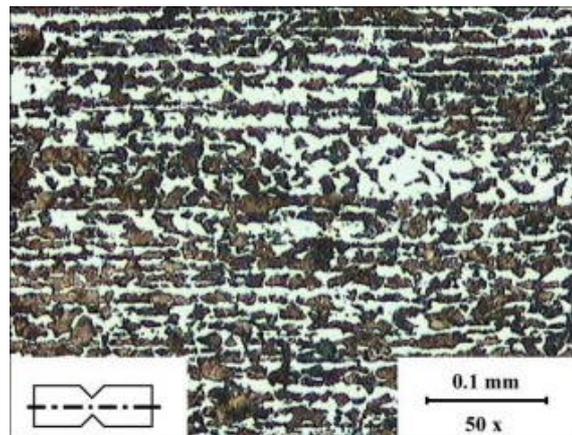
Figure 2. Microstructure of the C40 steel (normalised state).

In parallel, microstructural analyses showed that, due to the normalisation treatment, two phases are present: ferrite (white zones in Fig. 2) and pearlite (black zones). Due to the drawing process used to obtain the bars, the two phases are forced to dispose in alternate bands whose main direction coincides with the specimen longitudinal axis. As discuss later, early phases of fatigue damage evolution have been strongly influenced by the particular microstructure.

Crack initiation was observed in the early fraction of the fatigue life: specimens appeared to be cracked before 5 % of the cycles required for the specimen failure. The observation of damage mechanism put in evidence a different strength to crack initiation of the two maximum shear stress planes. In fact, cracks started in the plane aligned with specimen's axis due to the anisotropic microstructure made by alternate bands of ferrite and pearlite already shown in Fig. 2.

The nucleation of the cracks on the plane of maximum shear stress parallel to the specimens axis is ascribable to the steel microstructure characterised by alternate bands of ferrite and pearlite oriented along the specimen axis (see Fig. 2).

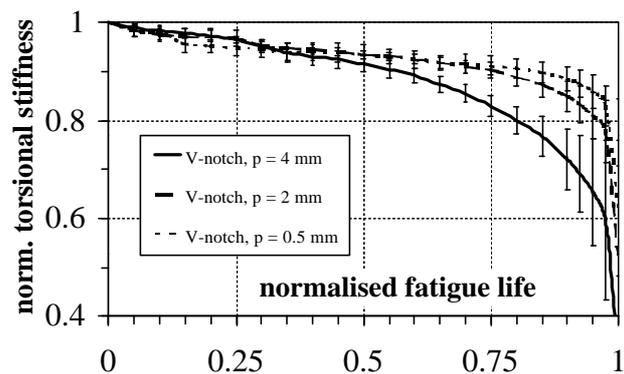
Figure 3. Normalised stiffness trends for V-notched specimens.

During torsion fatigue tests, the stiffness (torque to twisting angle ratio, the angle being measured with respect to the specimen ends) was monitored. Figure 3 shows mean trends of the torsional stiffness for the symmetric V-notches specimens. The plots, are normalised with respect either to the initial stiffness value (on the vertical axis) or the number of cycles to failure (on the horizontal axis). The scatter bars, referred to ± 1 standard deviation, are also drawn.

It is important to note that, kept constant the notch depth, the stiffness plot does not vary with the load level and, consequently, with the number of cycles to failure. More exactly, the 3 curves show a standard deviation within a 1÷2 % range until 85 percent of fatigue life is spent. On the contrary, the notch dept influences the trend of the stiffness curve: with $p = 4.0$ mm the stiffness is equal to 90% of the initial value at about half of the fatigue life. On the contrary, specimens with $p = 0.5$ mm show a stiffness greater than 90% of the initial value for a number of cycles equal to 85% of the final life. These effects mainly depend on the different value of the net sections. Kept constant the crack depth, the smaller the net section, the more the stiffness reduction is. As shown in Fig. 4, the stiffness variation for the smooth specimens was much more pronounced, in particular at the high stress levels. However, in the fatigue tests the final number of cycles was always referred to complete separation of the specimen.

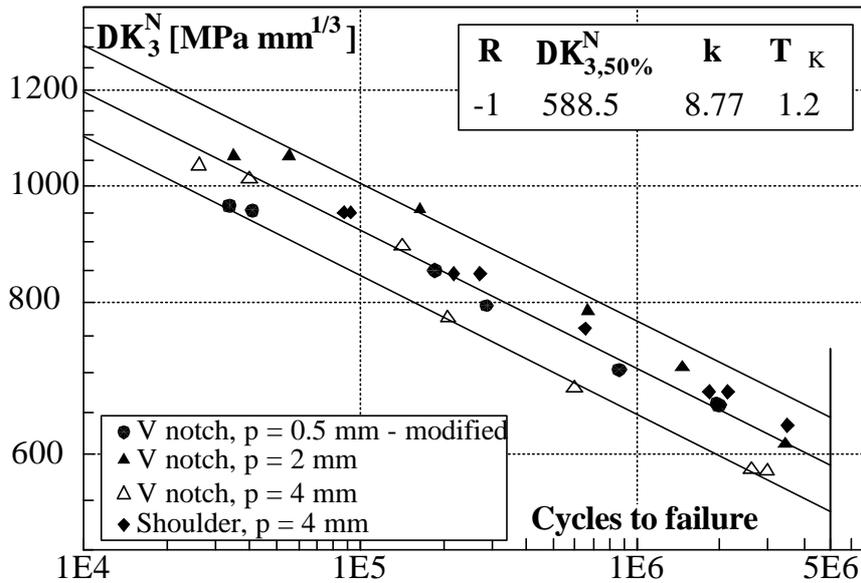
Figure 5. Fatigue strength data re-analysed in terms of the mode III N-SIFs.

Figure 5 shows all fatigue strength data of notched specimens re-calculated in terms of the N-SIF parameter. It is evident that a band of limited width is able to summarise together all data. The scattered of the band is $T_{K,10-90\%} = 1.2$, even lower than the stress-based scatter pertaining the two series of specimens with $p = 2.0$ and 4.0 mm.

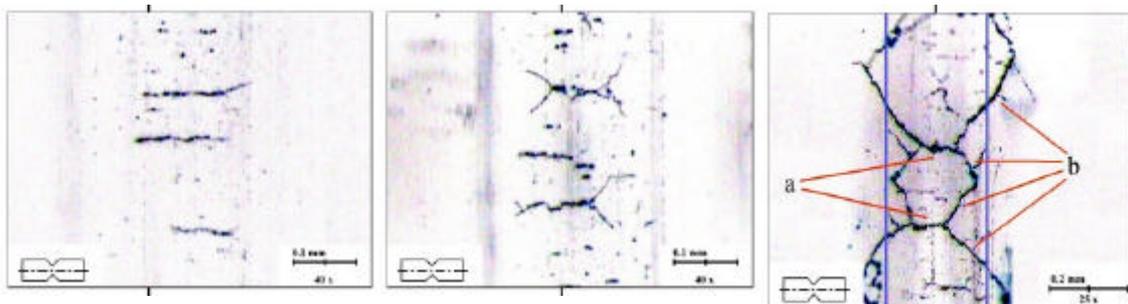
Figure 6. Fatigue damage evolution for high cycle fatigue (V-notch $p = 2$ mm, $\tau_{a,nom} = 140$ MPa, $N = 3453000$).

The micrographs reported in Fig. 6 document typical damage patterns for a high cycle fatigue failure. Cracks nucleate before of 5% total life on planes parallel to torsion axis (Fig. 6.1) due to shear stress components. After a short propagation in the direction of the maximum shear stress, cracks change their direction and branch. The new directions are inclined $\pm 45^\circ$ with respect to the previous one (Fig. 6.2) and coincide with the direction of the maximum normal stress. This change of direction is well documented in the literature, with reference to specimens with small superficial notches [6,8], smooth specimens [7], V-notched specimens [2].

1. cracks nucleated on the planes parallel to the specimen axis (5% of the fatigue life);
2. branching ($\pm 45^\circ$) on the planes of maximum principal stress (10% of the fatigue life);
3. notch root at 70 % of the fatigue life;
4. fracture path at final failure.

Main cause of the phenomenon is the friction present between the surfaces of a crack nucleated on the maximum shear stress plane. The friction decreases the driving force and provokes a reduction of the strains acting on the crack tips. Obviously the friction force increases as the crack length increases until mode III stress component drops below a threshold value. The propagation changes its direction due to the presence of normal stresses. Such stresses tend to separate the crack surfaces, strongly reducing the friction influence.

The typical damage evolution at low cycle fatigue is shown in Fig. 7. With respect to the case shown in Fig. 6, the number of cracks is now strongly increased and the branching inclined ± 45 degrees is disappeared. The cracks propagate on the initiation planes until they occupy the entire semicircular arc that describes the notch root. Then they stop in correspondence of the two lines where the curved surface of the semicircular arc intersects the inclined flanks of the notch. Afterwards a second phase of propagation begins with a nucleation of cracks on the other (second) plane of maximum shear stress. The plane can be considered normal to the specimen axis (Fig. 7.2), although not exactly coincident with the minimum transverse section.

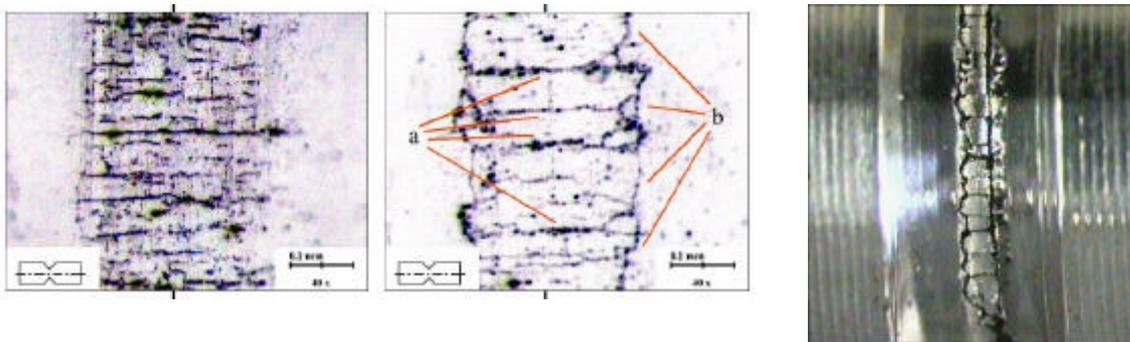
Figure 7. Fatigue damage evolution for low cycle fatigue
(V-notch $p = 2$ mm, $\hat{\sigma}_{a,nom} = 240$ MPa, $N = 35274$).

1. Cracks nucleated on the planes parallel to the specimen axis (28 % of the total fatigue life);
2. Cracks nucleated on the maximum shear stress planes, parallel (a) and normal (b) to the specimens axis (85 % of the fatigue life);
3. Notch root image with fracture surfaces on the plane of maximum shear stress normal to specimen axis (final failure);

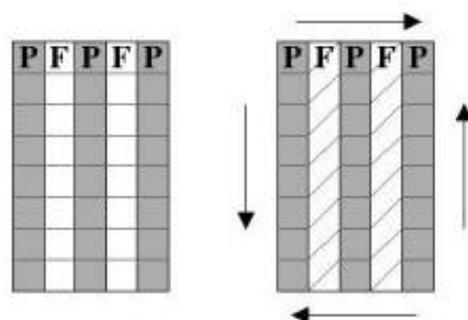
Figure 8. Strain concentration on the ferritic bands.

Local strains measurements carried out by means of SEM analyses [4] demonstrated that the ferritic bands are more susceptible to deformation than pearlitic bands (see Fig. 8).

This results in very localised concentration effects for the strains and, consequently, the nucleation of cracks parallel to the bands, localised either at the phase interface or inside the ferritic bands. As above said, in the low cycle fatigue first cracks were parallel to the specimens axis followed by a number of cracks which nucleate and propagate in the transverse direction on the second plane of maximum shear stress (see Figs 7.1 and 7.2). Therefore, the final fracture surface appears to be substantially normal to the specimen axis, due to the coalescence of cracks propagating on the net transverse section as shown in Fig. 9a.

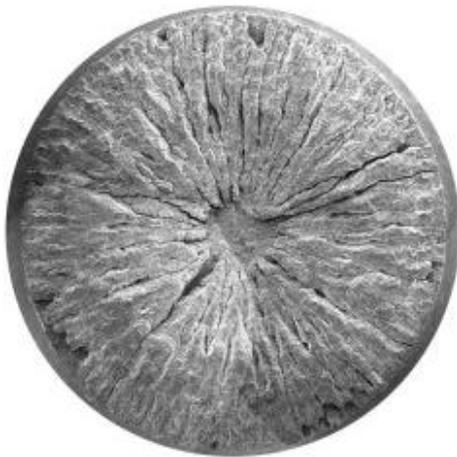
a) $d = 16$ mm V-notch $p = 2$ mm;
 $\hat{\sigma}_{a,nom-net} = 240$ MPa; $N = 35.274$

Figure 9. SEM fracture surfaces under low and high cycle fatigue conditions.

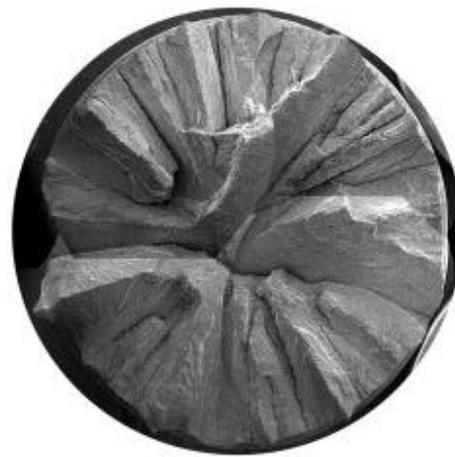
Under high cycle fatigue conditions, fracture surfaces are very different, exhibiting the typical “factory roof”[2], with a quite small number of surfaces inclined $\pm 45^\circ$ with respect to the specimen axis (see Fig. 9b). Such surfaces are the result of the crack branching and propagation towards the core under normal tensile stresses.

b) $d = 19$ mm; V-notch $p = 0.5$ mm;
 $\hat{\sigma}_{a,nom-net} = 165$ MPa; $N = 1.979.392$

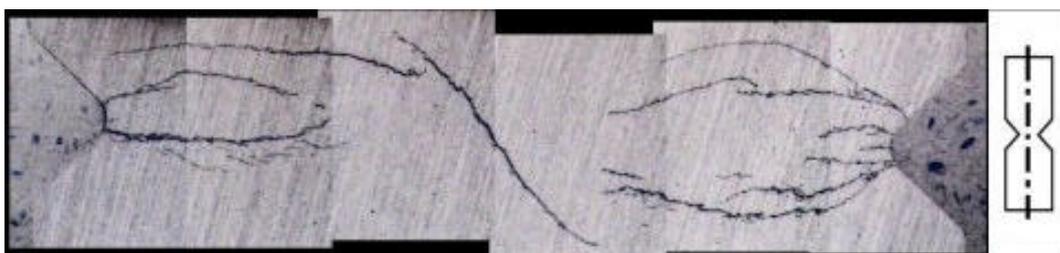
Figure 10. Longitudinal section embracing the V-notch
 ($d = 16$ mm V-notch $p = 2$ mm; $\tau_{a,nom-net} = 160$ MPa; $N = 1.465.000$).

Figure 10 shows crack paths on a longitudinal section of a specimen subjected to high cycle fatigue. On the right and left hand side of the figure is clearly visible the V-shaped notch. The transition between the two fracture modes happens gradually.

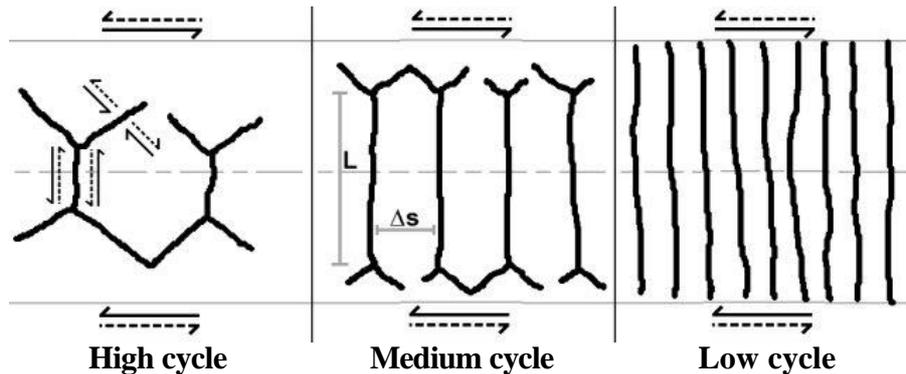
Figure 11. Damage patterns for different fatigue lives (specimen axis thought of as coincident with the vertical direction).

More precisely, from low cycle fatigue to high cycle fatigue, nucleation and propagation phases change as illustrated in Fig. 11:

- The distance Δs between the cracks parallel to the specimen axis increases;
- The crack length L before branching decreases. Under the highest load levels, the branching disappears simply because the length L becomes greater than the arc describing the notch root.
