Ultra High Cycle Fatigue

Analysis of the Premature Failures of some Sonotrodes Made in Al Alloy for Ultrasonic Welding

M. Carboni, M. Annoni

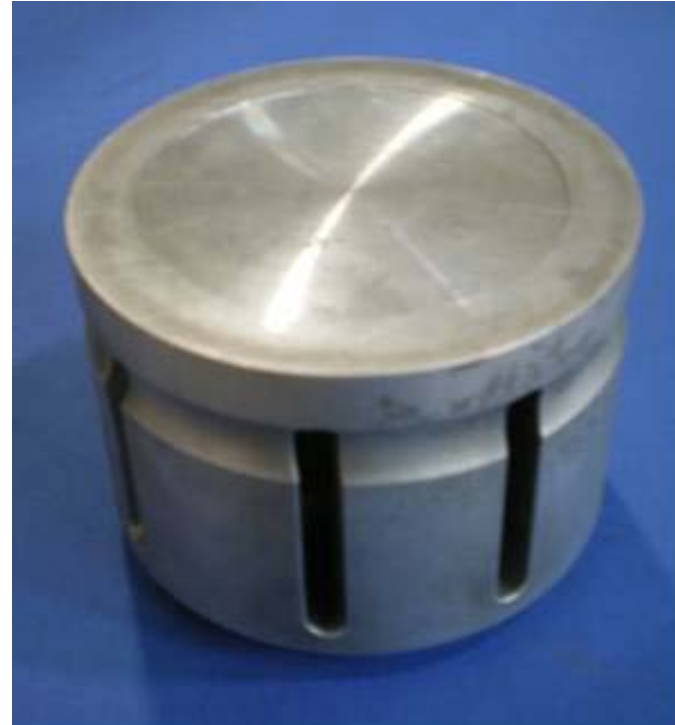
Between all the collected failed sonotrodes, **two** were investigated

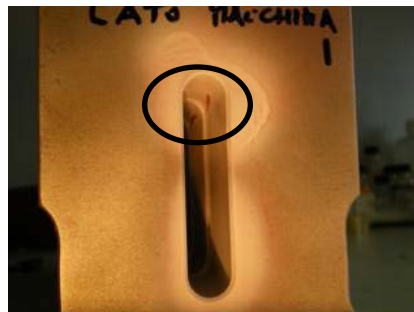
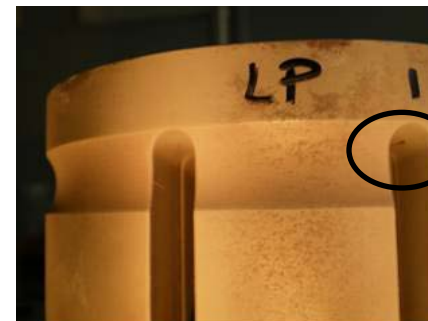
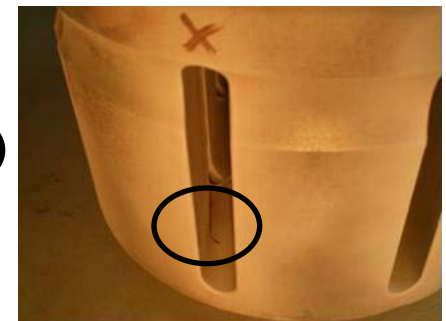
Liquid penetrants were applied

- Numerous cracks could be observed at stress concentrations even if typical geometries are involved
- Relevant dimensions of cracks ([cm]!)

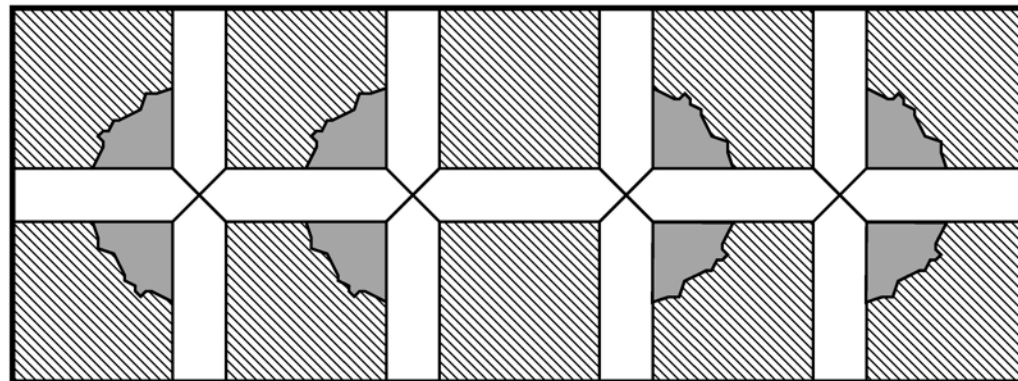
SEM analysis

Fracture surfaces from the cylindrical sonotrode were completely ruined

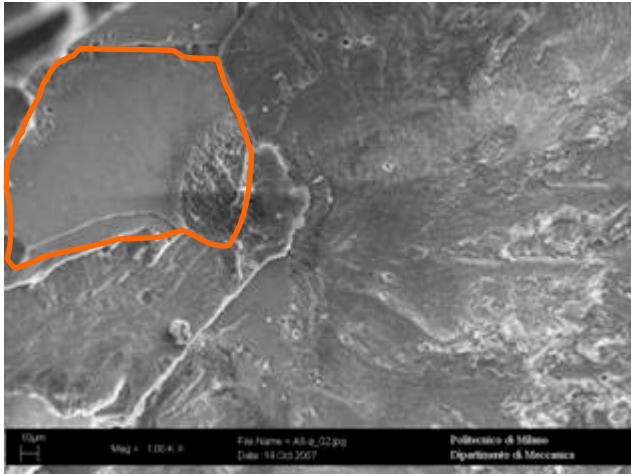
$$\sigma_w = \frac{1.56(H_V + 120)}{(\sqrt{area})^{\frac{1}{6}}}$$

→ $\sqrt{area} = 150\mu m$ → $\sigma_w = 100MPa$

Analysing all the nucleation points corresponding to each fracture surface, the lowest endurance stress for 5×10^9 cycles was:

95 MPa
