Identification of contact regimes in mechanical components for the evaluation of fretting damage

V. Cuffaro, F. Curà, A. Mura

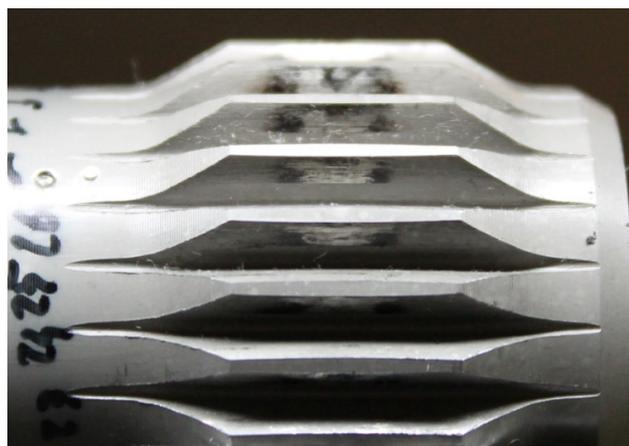
Figure 7: Face weight of the specimen MB2 after the test.

On the contrary, Fig. 7 shows wear area; in particular, the upper part of the tooth is worn.

This fact is probably due to a profile error causing the translation of the contact area on the upper part of the face width.

The wear zone has an elliptic form, with the central part more damaged that the boundary one.

The black zones near the ellipse boundary are the amalgamation of debris due to the sliding of the contact area during a complete rotation of the spline coupling.
