# Damage of protective coating due to unstable engine running

## Abstract

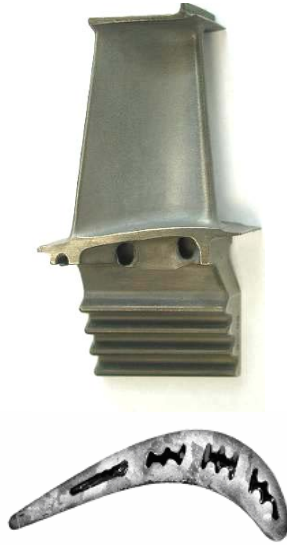
The subject of study was the cooled rotor blades of the first stage of the high-pressure turbine (Fig. 1). Polycrystalline rotor blades are made of nickel-based superalloys JS6K (Table 1) by a precise casting. Their heat and chemical-thermal treatment is described in the Table 2. AlSi coating is used for service temperature in the range 815-1150 °C.

Fig. 1 The rotor blade

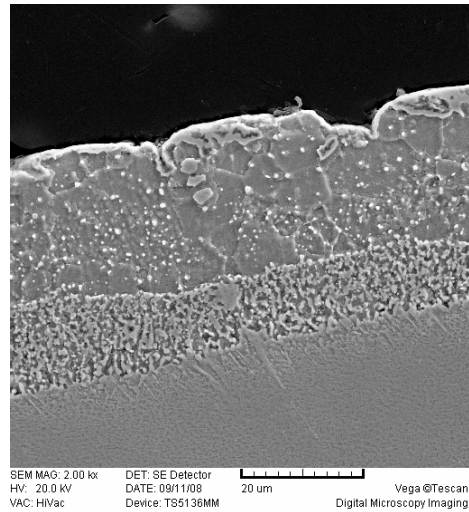
The microstructure of AlSi layer is shown in the Fig. 2 and it is composed of two sublayers. The outer Al-sublayer is created by NiAl with content of Al<50 at.% and lower amount of phases containing refractory elements. The inner Si-sublayer creates Ni-Al matrix and higher amounts of phases of elements as: Si, Cr, Mo, Ti, W and Co. The thickness of layer varies in the range of 20–50 µm.

Fig. 2 Microstructure of AlSi layer
