ADIABATIC SHEARING AND ASSOCIATED CRACKS IN BALLISTIC STEEL TARGETS

ABSTRACT

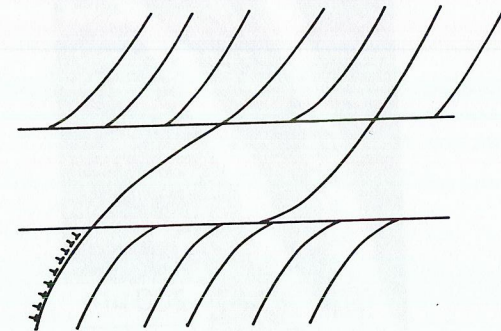
Fig. 4 Schematic explanation of the crack initiation, propagation and termination in a shear band.

the crack to be nucleated. Such a situation is schematically shown in Fig.4. It must be noted that the slip lines indicated in the Fig.4 will generally tend to follow the macroscopic flow lines.
