Fractography of Corrosion Fatigue Cracks in RPV Steels in Pressurised Water Reactor Environments

A. N. GREENWOOD and D. R. TICE
*UKAEA Northern Research Laboratories, Springfields, Salwick,
Preston PR4 0RR, UK*

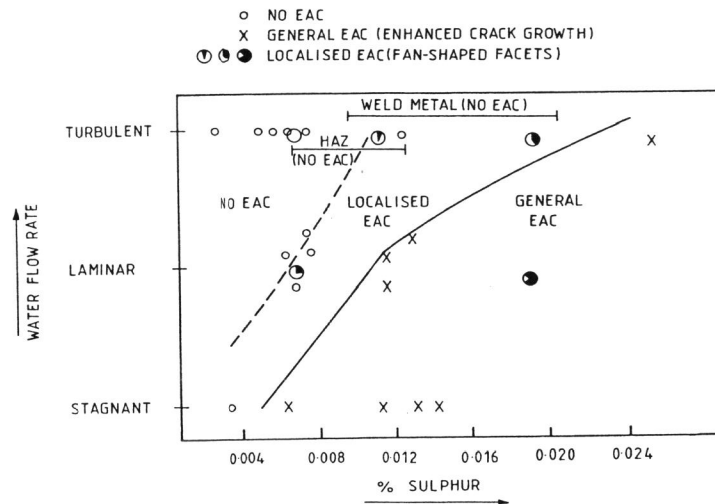
Fig. 4. Influence of steel sulphur content and water flow rate on environmentally assisted cracking (EAC)

the one test amongst the present specimens in which sulphate was known to have been present at around the 2 ppm level (specimen C1) did show significantly faster crack growth rates than would have been predicted from the other tests reported here. The much greater environmental enhancement for specimen D2 was probably due to an increase in the specimen potential due to the presence of an oxidant in the test environment. Evidence for the presence of an oxidising agent during at least part of the test is provided by X-ray diffractometry measurements (Congleton, 1982).

Fig. 4, due to Tice *et al* (1986), illustrates schematically the influence of steel sulphur content and water flowrate on environmentally assisted cracking susceptibility, based on the observation of enhanced crack propagation rates in 0.0167 Hz corrosion fatigue tests. Superimposed on the figure are data points for the specimens examined here which had been tested in good quality water. The extent of the shading of the data points indicates the degree of influence of the test environment, based on the extent of fan-shaped features indicating localised environmental cracking. (None of the specimens showed an overall enhancement of crack growth.) It is obvious from this presentation that localised environmental cracking occurs over a wider range of steel sulphur contents and water flowrate than general enhancement of crack growth, but the same parameters influence cracking susceptibility. Contamination of the test environment with sulphur anions or oxidants increases further the extent of environmental enhancement.
