# DESIGN ANALYSIS AND VALIDATION FOR A BONDED COMPOSITE REPAIR TO PRIMARY AIRCRAFT STRUCTURE

L.R.F. ROSE

*Aeronautical and Maritime Research Laboratory, Melbourne, Australia*

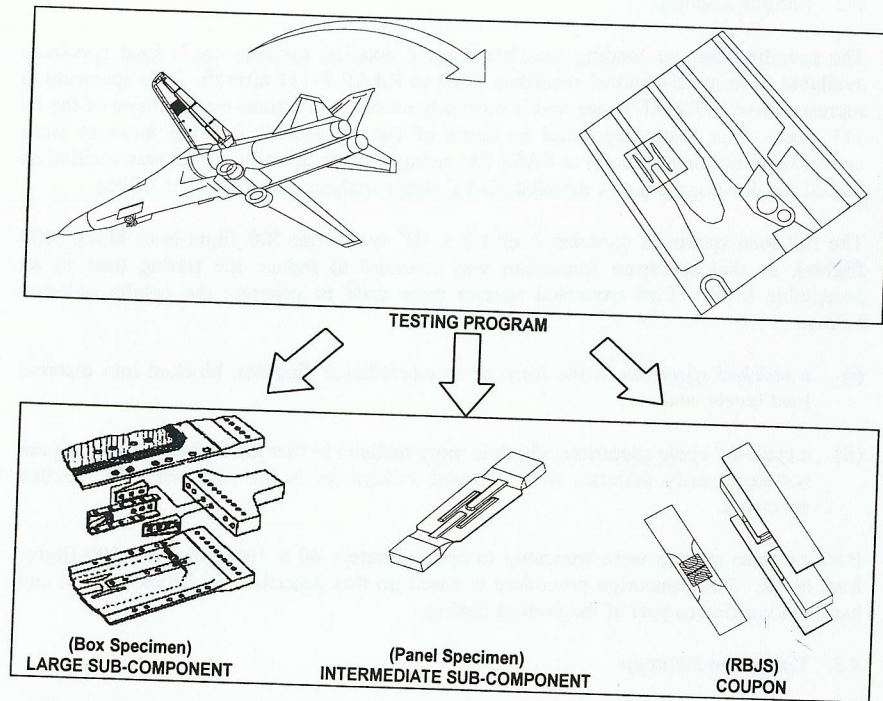
Figure 2 Three levels of structural testing undertaken for repair substantiation of a bonded composite repair to primary aircraft structure

The formulation and successive refinement of a three-dimensional finite-element (FE) model of the cracked wing skin and of the supporting spar (Fig. 2) are reported in detail by Callinan *et al.* (1996). The main results and conclusions can be summarised as follows.
