Investigation of Corrosion Assisted Crack Growth in an Intermediate Size Pressure Vessel at Elevated Water Temperatures

Kusssmaul, K., D. Blind, R. Gillot, and W. Burr, MPA Stuttgart

3rd International Conference on Biaxial / Multiaxial Fatigue, April 3 - 6, 1989, Stuttgart, FRG

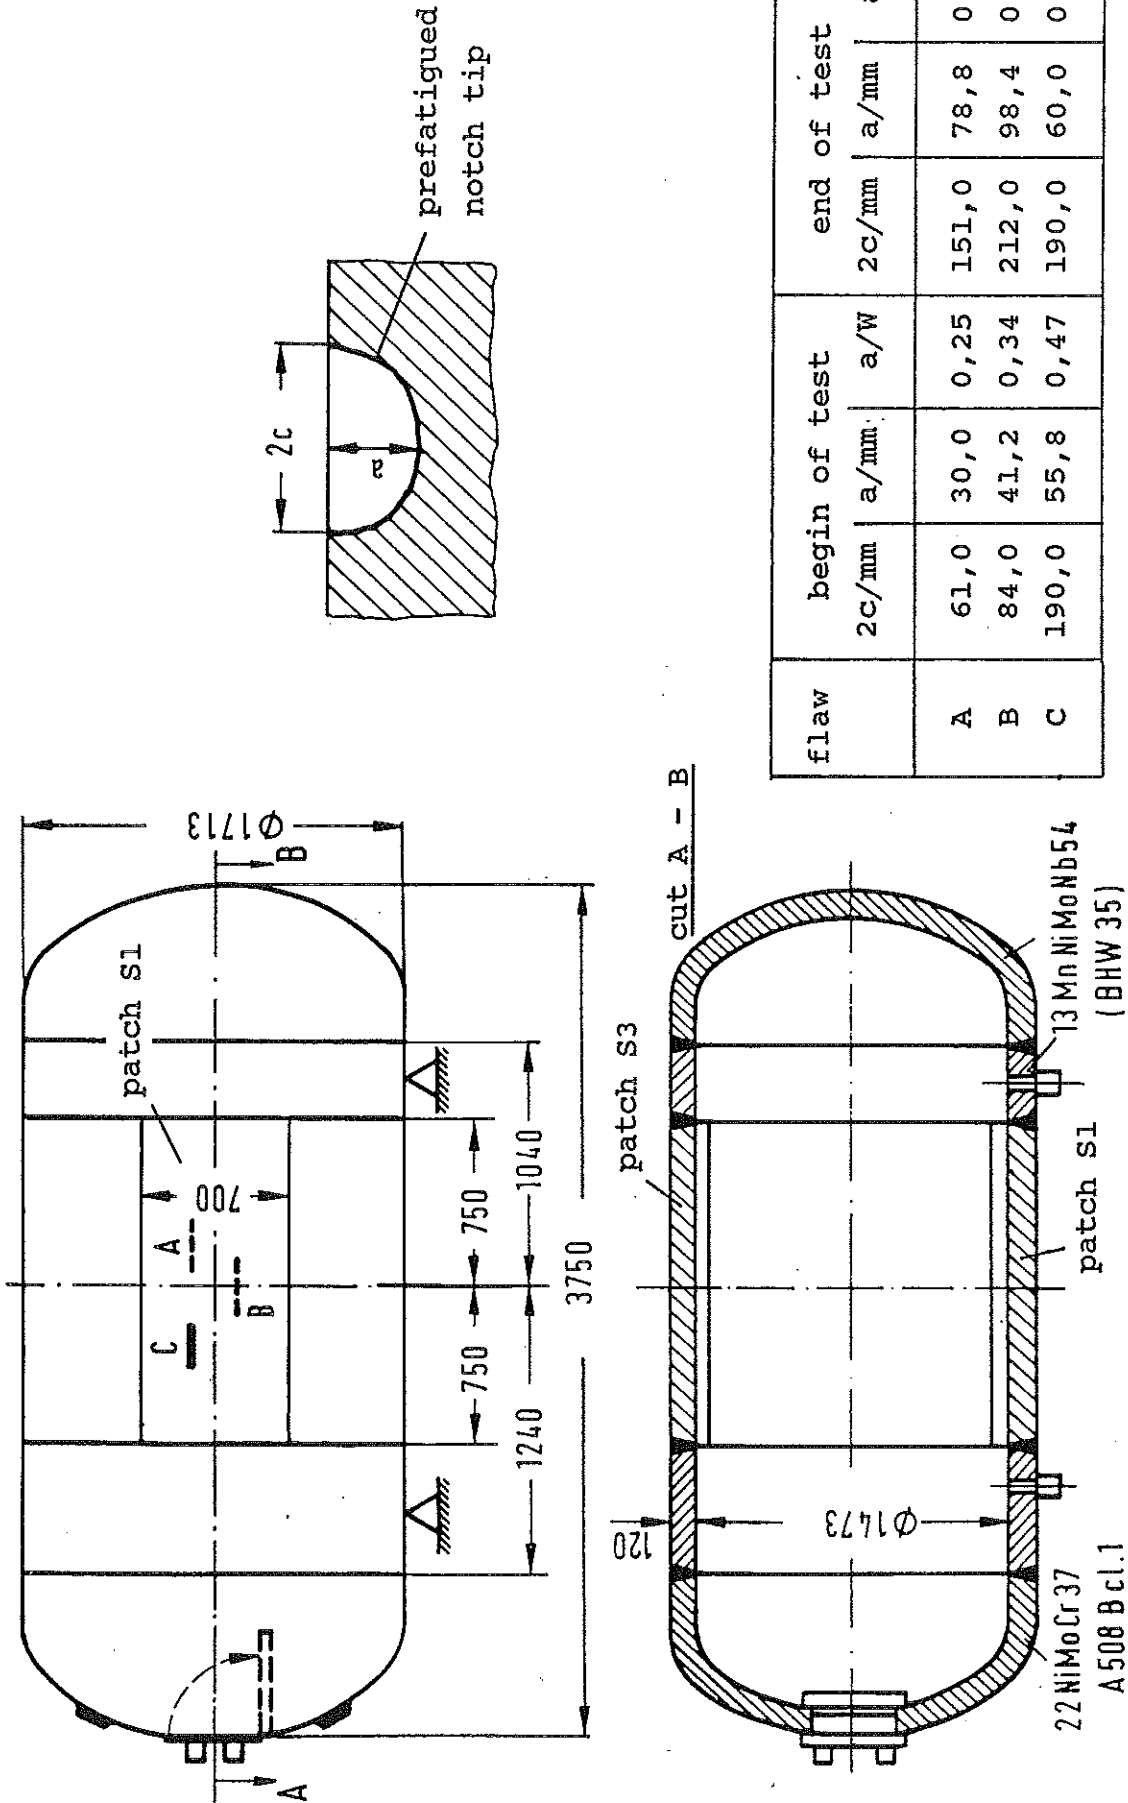
The overall dimensions of the intermediate size test vessel and the prefatigued notches are shown in Fig. 1. The material of the rectangular patch S1 containing the three notches was machined from a plate of A 533 B Cl.1 /2/, the other patch S3 was made of the material 20 MnMoNi 5 5 (similar to A 533 B Cl.1). The wall thickness of 120 mm was about 15% smaller than the one of a pressure vessel of a boiling water reactor (BWR). When the test was started, the relative depth of the three flaws A, B, and C ranged from $a/W = 0,25$ to $0,47$.

According to the table in Fig. 1 the total crack propagation was 48,8 mm for flaw A, 57,2 mm for flaw B, and 4,2 mm for flaw C. The flaws A and B were located on the inner surface, flaw C on the outer surface of the vessel. As an example for the others, flaw B will be presented in detail in this paper.

Fig. 1: Intermediate size pressure vessel ZB 1, dimensions of the vessel and the longitudinal flaws A, B, and C

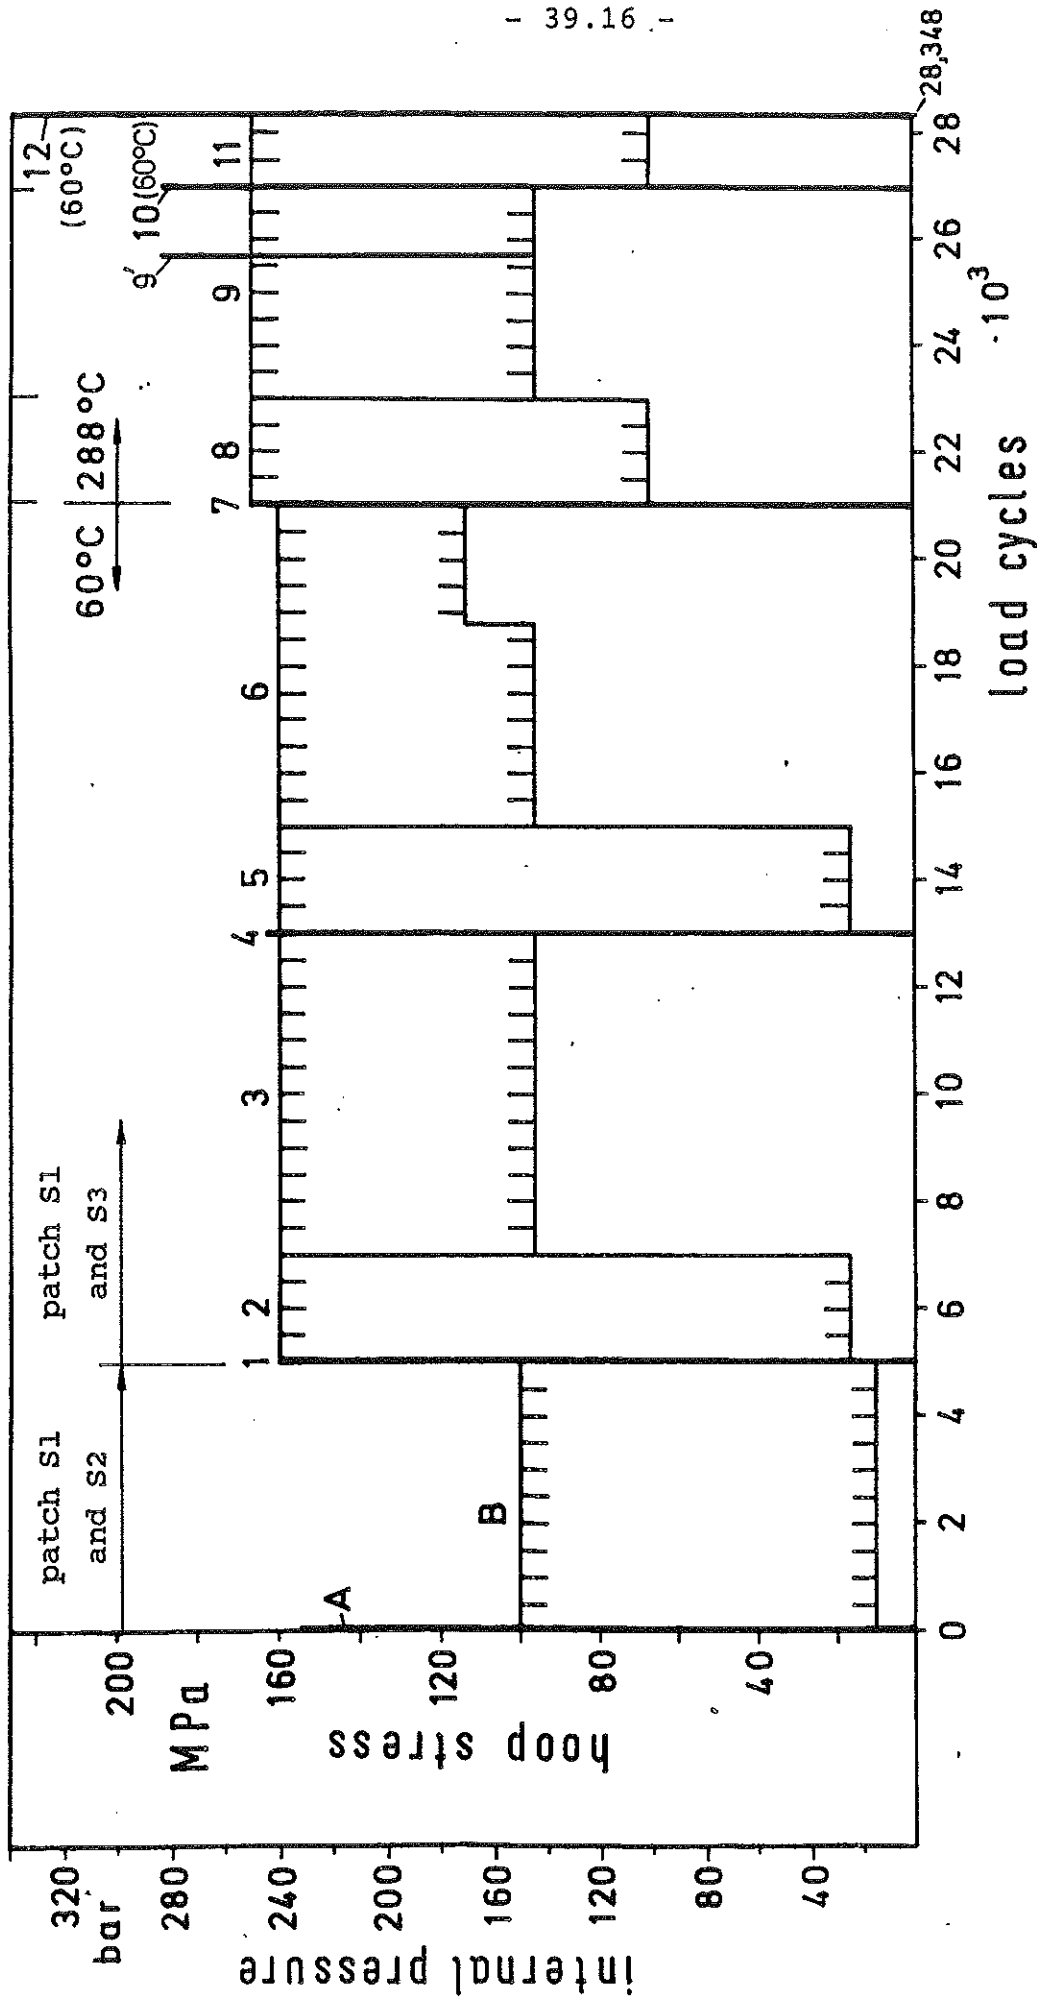
The test vessel was loaded by 8 hydrotests and 21.000 load cycles at 60°C , and by 7.340 more load cycles at 288°C /3/. The load spectrum is shown in Fig. 2. The internal pressure of 240 bar caused a hoop stress in the cylindrical vessel wall of 160 N/mm^2 , which corresponds to the hoop stress in a BWR vessel at operating conditions. The time needed for each load cycle was between 0,5 min at 60°C and 3 min at 288°C . The load steps A, B, and 1 through 7 (A, 1, 4, and 7 are hydrotests) were conducted in a period of 6 weeks, it took 26 more weeks to complete the tests at 288°C .

Fig. 2: Load spectrum of the ZB 1 pressure vessel tests, hydrotests A, 1, 4, 7, 10, and 12 at 60°C, hydrotest 9' at 288°C
