# Influence of Galvanizing Process on Fatigue Resistance of Microalloyed Steels

**ABSTRACT.** This paper presents the fatigue life behaviour of galvanized rear axles made of microalloyed steel. The main objective of this study is to predict the influence of the zinc protection layers on the steel fatigue life. The results show that the galvanized rear axles exhibited a lower fatigue limit as compared with the non galvanized ones. This was attributed to the cracking in the galvanized layer caused by the presence of zinc penetrating beneath the sheet surface.

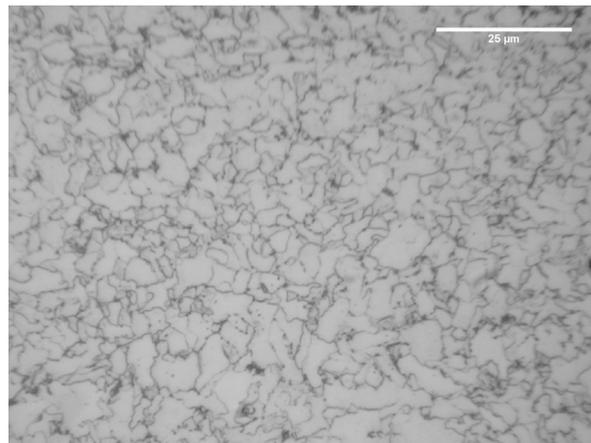
Fig. 5 shows the three intermetallic sub-layers forming the hot-dip galvanized coating between  $\eta$  (made of pure zinc) and the steel. The coating thickness was measured and varied from 90 to 130 micron. The microstructure of the steel is completely ferritic as shown in Fig. 6.

Figure 6: Microstructure of the steel.

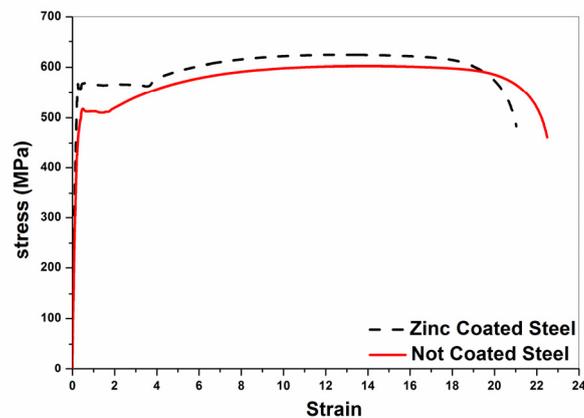
Figure 7: Stress-strain curves of coated and not steels.

Tensile tests were performed on galvanized and not-galvanized specimens. The stress-strain curves are displayed in Fig. 7. Both galvanized and not-galvanized specimens show Luders plateau at yield point. Yield and tensile strengths are, respectively, 50 and 20MPa higher for the galvanized specimens, and the Luders plateau is longer. Elongation have about the same values for galvanized and not-galvanized specimens.

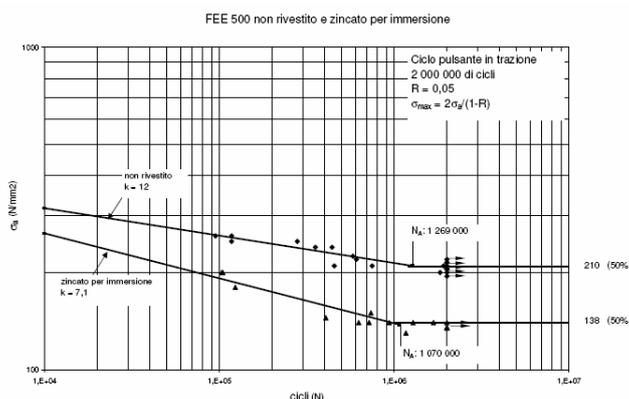
Fig. 8 displays the results of fatigue tests. The fatigue limit decreases from approximately 210 to 140 MPa for not-galvanized and galvanized specimens, respectively.

Figure 8: Stress life prediction for smooth specimen galvanized and not.
