Some Experiences with Crack Path Issues

L. P. Pook¹

¹ University College London

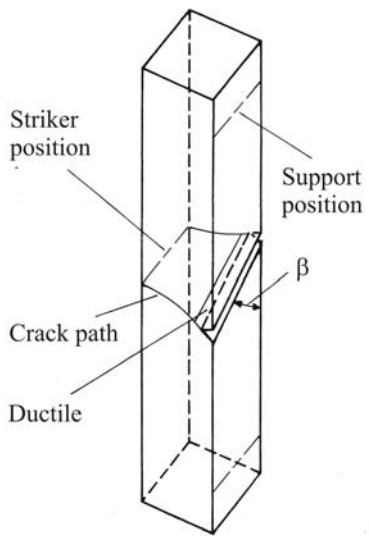
Figure 3. Angle notch Charpy specimen, crack initiation along notch tip.

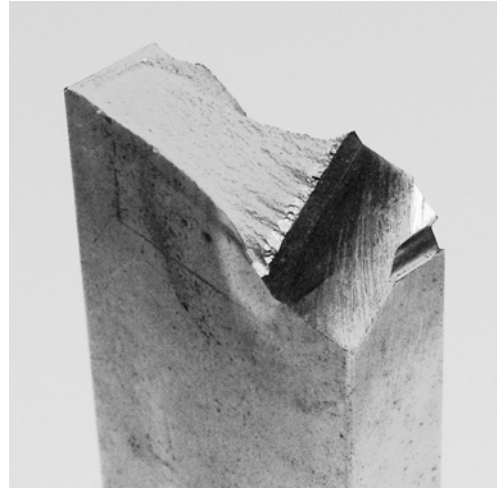
Figure 4. Fracture surface of DTD 5050 5½ Zn aluminium angle notch fracture toughness test specimen, initial $\beta = 45^\circ$.

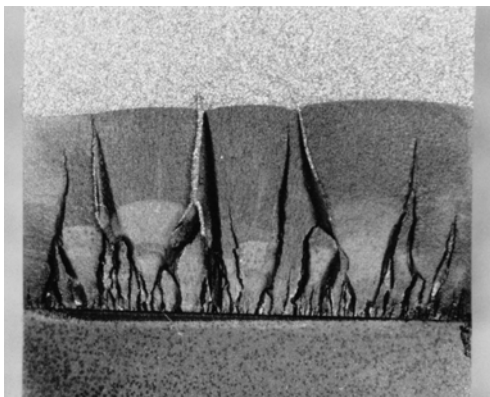
Some fatigue tests were carried out in 1989 on 20 mm thick medium strength structural steel angle notch specimens [12] with initial β values of 75°, 60° and 45°. Figure 5 shows the fracture surface of one of the specimens, initial $\beta = 60^\circ$. The light area at the top is where the specimen was broken open in liquid nitrogen.

Figure 5. Fracture surface of medium strength structural steel angle notch fatigue test specimen, initial $\beta = 60^\circ$.

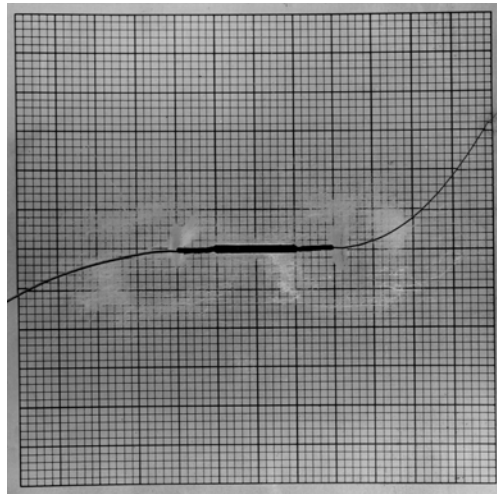
Figure 6. Crack path in a Waspaloy sheet under biaxial fatigue load. The grid is 2.54 mm.

Therefore, in 1974 some tests [14], were carried out at room temperature on Waspaloy, a nickel based gas turbine material, in order to determine the conditions under which a fatigue crack path became unstable under biaxial loading. The specimens were 254 mm square and 2.6 mm thick. The material had been cross rolled during production to ensure that its properties were reasonably isotropic. Tests were carried out using sinusoidal constant amplitude loading at a stress ratio (ratio of minimum to maximum load in fatigue cycle), R , of 0.1. In each test the fatigue load perpendicular to the crack was kept constant. Cracks were first grown from each end of an initial slit under uniaxial loading. An in phase load was then applied parallel to the crack, and crack path behaviour observed. Figure 6 shows the crack path for a load parallel to the crack of twice the load perpendicular to the crack. The crack path became unstable and deviated from its initial path as soon as the load parallel to the crack was applied. At the time the tests were carried out it wasn't possible to do more than describe the results. However, reanalysis of these and other results in 1997 [4, 15] showed it was possible to correlate crack path stability in terms of a parameter called the T -stress ratio.

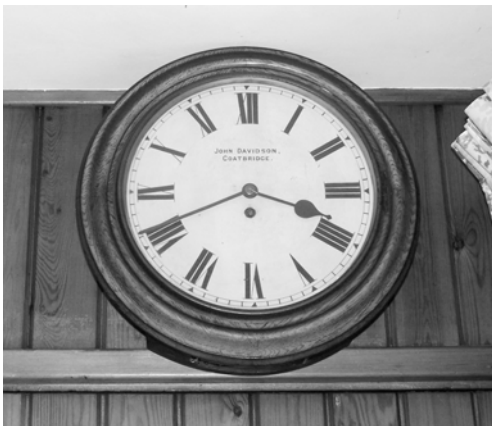
Before the days of quartz clocks, spring driven wall clocks were widely used in public buildings. The example shown in Figure 9 was originally used in a school, but since 1968 it has been in use in the author's kitchen. In 1994 the mainspring failed while the clock was being wound. Examination showed that this was the final failure following fatigue crack growth. A general view of the failed mainspring is shown in Figure 10. Fatigue has been a problem in clock mainsprings for centuries, and traditionally they are designed using rules of thumb based on experience [16], rather than by detailed analysis. The total fatigue life is not known, but the clock is wound weekly so it must be thousands of cycles.

Figure 9. Wall clock by John Davidson, Coatbridge. Figure 10. Failed wall clock mainspring.

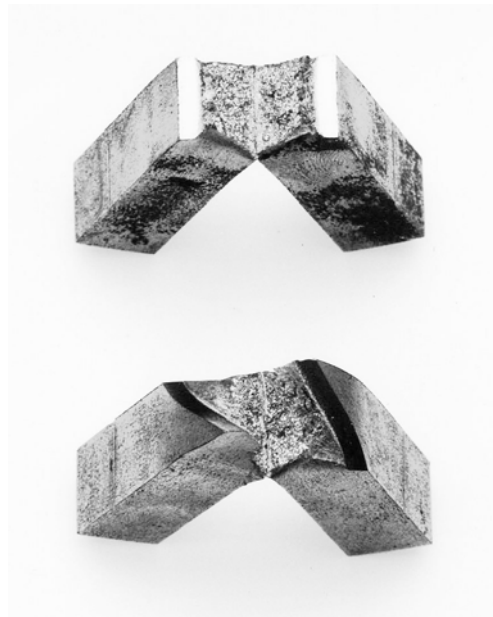
Figure 12. Fracture appearance of mild steel Charpy specimens tested at 10° C.
Top, standard specimen, $\beta = 90^\circ$.
Bottom, angle notch specimen, $\beta = 45^\circ$.

appearance of the standard Charpy specimens ($\beta = 90^\circ$) is typical of mild steel. In the lower shelf region, that is at below about -15°C , fracture surfaces are crystalline, and in the upper shelf region, above about 30°C , they are ductile. In the transition region fracture surfaces are initially ductile, and the amount of crystalline crack growth decreases with increasing temperature. Shear lips appear at above about -15°C , and increase in size with increasing temperature. The fracture appearance transition temperature (50 per cent crystalline) is about 25°C . In the upper shelf region fracture surfaces are ductile.

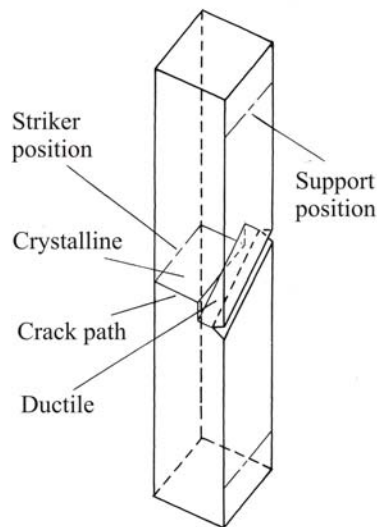
Figure 13. Angle notch Charpy specimen, abrupt transition to crystalline crack growth.

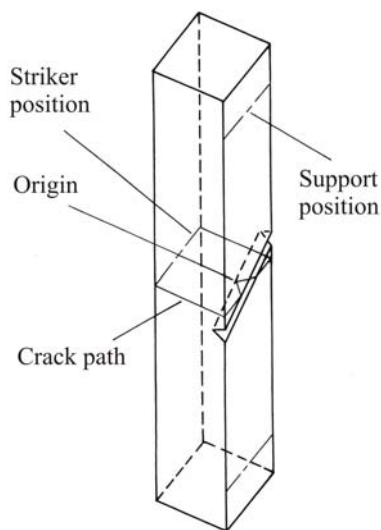
crack twists as it approaches the striker position. For $\beta = 45^\circ$ the tendency to Mode I crack growth is so marked that the crack path is not constrained by the notch. At intermediate absorbed energy levels there is one crack origin at the centre of a notch, and crack growth is Mode I throughout (Figure 14). At high absorbed energy levels there are crack origins at both notch corners. The cracks follow curved, apparently Mode I paths, as shown schematically for a single crack in Figure 15. The two paths merge as they approach the striker position.

Figure 14. Angle notch Charpy specimen, crack origin at centre of notch.

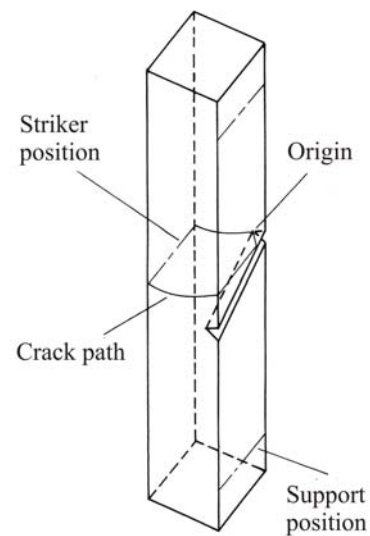
Figure 15. Angle notch Charpy specimen, crack origin at notch corner.
