# Fatigue Crack Paths in Shafts Subjected to Bending and Torsion

T. Lassen<sup>1</sup> and A. Spagnoli<sup>2</sup>

**ABSTRACT.** *In the present article an in-service fatigue failure of a large propeller shaft is analyzed and discussed. Observed crack growth path and fatigue life are compared with fracture mechanics calculations for various loading modes to determine the most likely fatigue damage mechanism. It was found that the fatigue crack leading to failure of the shaft emanated from a flaw on the surface. The initial flaw had a depth in the range of 0.5-1.0 mm. The subsequent crack shapes were revealed from crack front beach marks. Larger cracks had approximately a semi-elliptical shape with an average aspect ratio near 0.8. Although the design stresses in the shaft were fluctuating shear stresses due to torsion, unforeseen rotating bending stresses may have occurred due to misalignment of the shaft bearings. Based on the observation of the crack front shapes, it was shown that the fatigue failure of the shaft was driven by a multiaxial stress situation dominated by rotating bending stresses at an early stage.*

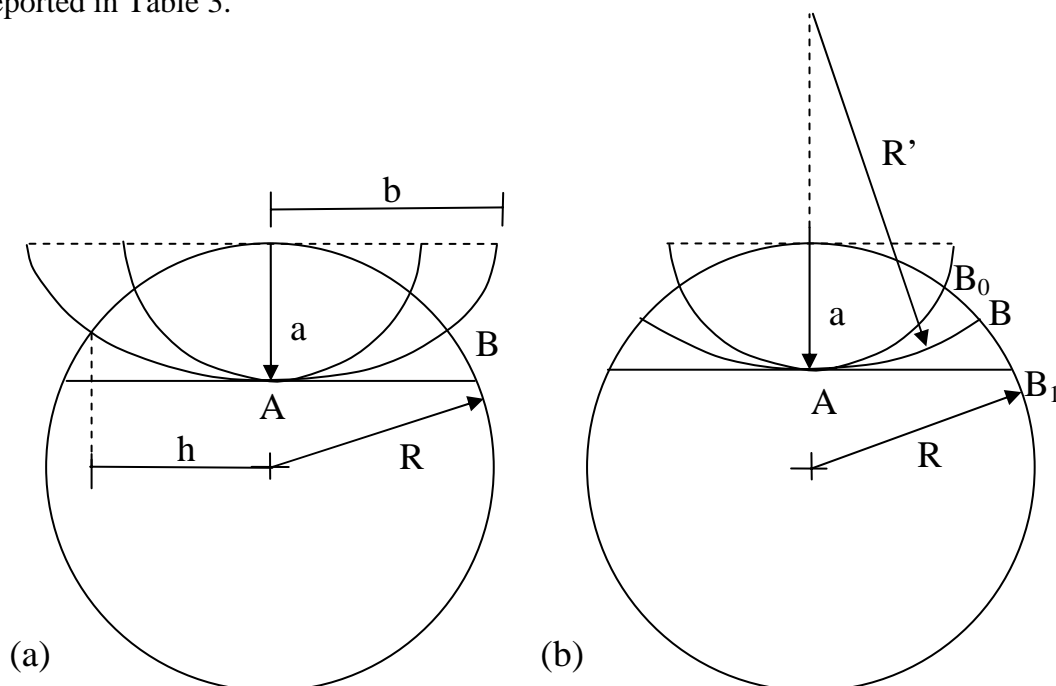
Figure 3 – (a) Crack front shape modelled as a semi-ellipse [3]; (b) Crack front shape modelled as a part of a circle [4].

For a given cracked component in order to determine the dimensionless SIF  $F = K/(\sigma\sqrt{\pi a})$ , the crack geometry must have a clear definition. Carpinteri [3] defined an elliptical-arc surface crack in a round bar, as it is shown in Fig. 3a. It is assumed that the shape of the crack front is part of an elliptical arc with half minor axis equal to the crack depth and with half major axis measured along the tangent at the shaft surface. The length of the two half-axes is denoted by  $a$  and  $b$  respectively. The SIF can be calculated at any point along the crack front but we are particularly interested in the deepest point A and the surface point B. In Fig. 3a, a general ellipse with half-axes  $a$  and  $b$  together with two special cases is shown. These cases are a straight fronted and a semi-circular crack.

Levan and Royer [4] chose to describe the surface crack front as a circular arc with a constant radius  $R'$ , see Fig. 3b where the two special cases from Fig. 3a are recognized. The intermediate crack geometries between these two limit cases are defined by a shape parameter  $\alpha = B_0B/B_0B_1$  ( $\alpha=0$  is for the semi-circular crack and  $\alpha=1$  for the straight fronted crack).
