# An experimental investigation on crack paths and fatigue behaviour of riveted lap joints in aircraft fuselage

A. Skorupa<sup>1</sup>, M. Skorupa<sup>1</sup>, T. Machniewicz<sup>1</sup>, A. Korbel<sup>1</sup>

**ABSTRACT.** *Effects of variables related to design and production of riveted lap joints representative of longitudinal sheet connections for a pressurized transport aircraft fuselage were experimentally investigated. The specimens from an aircraft Al alloy D16 Alclad sheets of three different thicknesses (1.9, 1.2 and 0.8 mm) were assembled under load control using round head rivets and rivets with the compensator from a P24 Al alloy. For the joints from 1.9 mm thick sheets fatigue tests indicated a dependency of the crack initiation site and crack path on the squeeze force level and on the rivet type. At the same time, increasing the squeeze force led to improved fatigue properties of the joints, specimens assembled using the rivets with the compensator showing fatigue lives consistently longer than joints with the round head rivets. All observed trends have been explained based on hole expansion and load transfer measurements. For thin sheets connected using the round

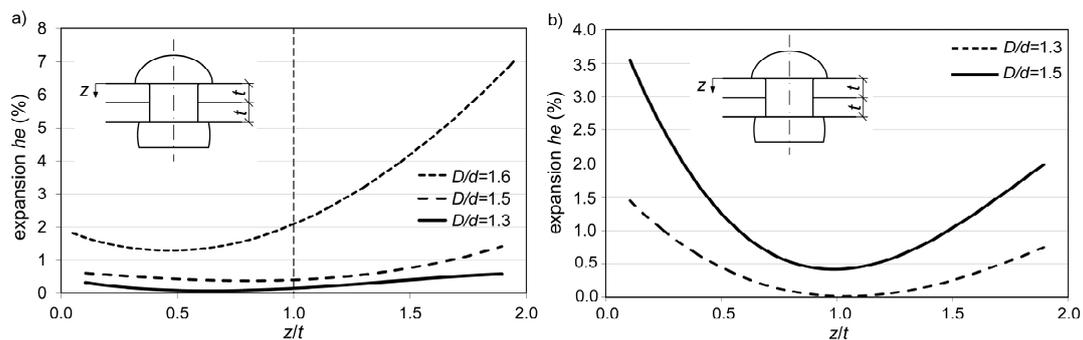
It is seen in Table 2 that the specimens with  $D/d$  of 1.5 and 1.6 always failed in the sheet adjacent to the rivet manufactured head, while in the case of  $D/d \leq 1.4$  the crack nucleation and failure occurred in the sheet under the driven head. The above behaviour can be explained based on rivet hole expansion measurements shown in Fig. 5 and load transfer measurements shown in Fig. 6. In Fig. 5a, hole expansion is defined as  $he = (d_e - d_o) / d_o$ , where  $d_e$  is the expanded hole diameter. As shown in Fig. 5a, for  $D/d$  of 1.5 and, especially, 1.6,  $he$  in the sheet next to the rivet driven head considerably exceeds that in the sheet next to the manufactured head. At the same time, Fig. 6 demonstrates that loads transferred by the end rivet rows are almost equal. Consequently failure occurs in the sheet with smaller hole expansion, i.e. under the manufactured head. For  $D/d \leq 1.4$   $he$  in both sheets is relatively small and only slightly larger under the driven head (Fig. 5a). In that case, the negative influence of a much higher transfer load in the sheet adjacent to the driven head (Fig. 6) dominates and determines the failure location. A more uniform load transmission distribution for  $D/d$  of 1.5 compared to  $D/d$  of 1.3 shown in Fig. 6 stems from lower flexibility of rivets installed with a higher squeeze force [1].

Figure 5. Hole expansion measurement results for sheet thickness  $t=1.9$  mm: (a) round head rivet; (b) rivet with the compensator.

Fig. 5b shows measurements results on  $h_e$  for the rivet with the compensator for two  $D/d$ -values. From a comparisons with Fig. 5a is seen that due to the compensator  $h_e$  in the sheet next to the manufactured head becomes considerably larger than for the standard, round head geometry. Fig. 5b indicates that  $h_e$  below the manufactured head of the rivet with the compensator is larger than below its driven head, which explains why in all fatigue tests on specimens assembled using this type rivets fatigue failure occurred in the sheet adjacent to the rivet driven head. Similarly as in the case of specimens with the round head rivets, a higher squeeze force yielded an increase in the fatigue life. For a given  $D/d$  ratio, fatigue lives of specimens assembled using the rivets with the compensator observed at  $S_{max}=120$  and 100 MPa were by 40 to 90% higher than for specimens with the round head rivets.

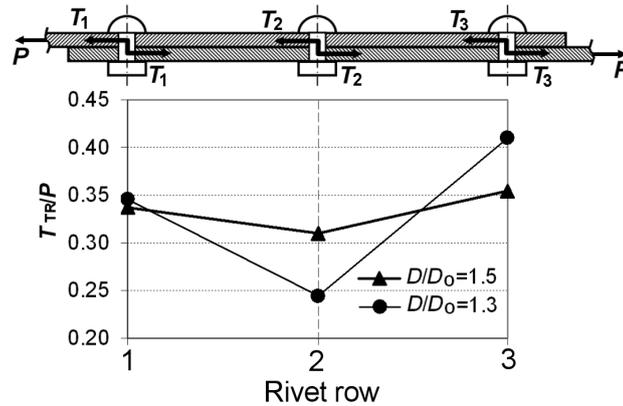
Figure 6. Load transfer distribution in riveted joint for two squeeze force values: round head rivet, sheet thickness  $t=1.9$  mm.
