BRITTLE FRACTURE DURING FATIGUE LOADING AT -10°C OF A FULL-SCALE TUBULAR X-JOINT. INFLUENCE OF AGEING.

J.J.W. Nibbering* and Ren Zijin*

A full-scale cross connection between two tubes has been subjected to high-stress low-cycle fatigue loading at -10°C . A brittle fracture developed after a small number of load cycles. The yield point of the material which originally was equal to 810 N/mm^2 , had obtained a value of 885 N/mm^2 after 5 years of rest. Therefore special attention has been paid to the ageing characteristics.

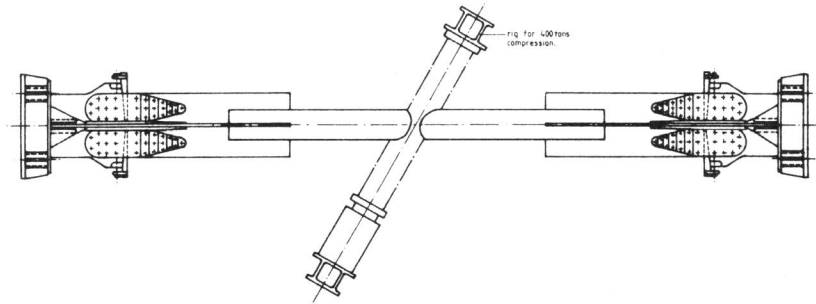
Figure 1. Top view of the test rig.

Figure 1 shows the specimen in the test rig. The special topic in this case was that the two tubes were not mutually perpendicular but positioned at an angle of 60° . The member, which is mainly under compression in the actual structure was the continuous one.

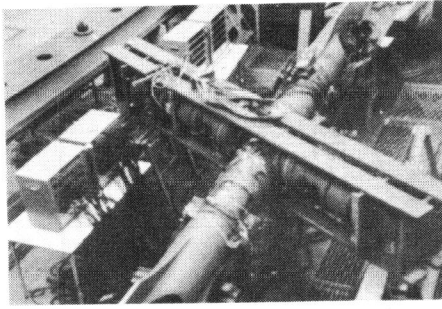
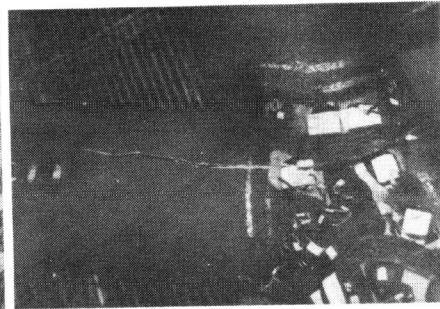
Figure 5. Crack I (key Fig. 3).
Figure 6. Crack IV (key Fig. 3).

After fracturing of the specimen inspection of the crack surface revealed that there were several points where cracks had started (Figures 5 and 6). This is of interest because it shows that the low fatigue result was not caused by a single, incidentally serious defect. For all cracks started - as usual in defect-free welds - at the fusion line of the welds. Therefore the fatigue result of the specimen may be considered as rather characteristic for this material in its longitudinal direction (crack path). Not any fatigue crack has initiated at the fusion line on the side of the welds in the interrupted tube. Apparently cracks did not develop as easily transverse to the tube axis as they did in line with it; the resistance to crack initiation seems to be better. But it should be acknowledged that the stresses at the fusion line of the interrupted tube were some 20% lower than those at the fusion line of the transverse continuous tube (Ren Zijin (6)).

The test ended with a spontaneous brittle fracture. Figures 5 and 6 show the crack paths on both sides of the specimen. Figure 7 shows how far the brittle fracture extended in the transverse tubes. This is astonishing bearing in mind that in the greater part of the transverse tubes hardly any stresses were present perpendicular to the crack path. The starting point(s) of brittle fracture can be seen in Figures 8 and 9. The fracture probably did not develop in one moment but in stages. This can be seen in Figure 8. It seems that at least four partial fractures developed prior to the final one. The strain gauge records confirm this more or less. Of six strain gauges a continuous record was made during the fatigue loading at low temperature. Unfortunately they were not situated close (enough) to the part of the structure shown in Figure 8. But the gauge near point A II-4 in Figure 8 was connected to a peak detector (double amplitude of strain) which became active once in 12-13 load cycles. The result is shown in Figure 10. (The number of cycles refers to those effectuated at -5°C and -10°C). At 1000 there is a clear change in slope which might be due to a
