IN-SERVICE CRACKS GROWTH IN SHAFTS OF AIRCRAFT STRUCTURES
UNDER SIMULTANEOUS ROTATION OR TORSION AND BENDING

A.A. Shaniavski* and A.L. Toushentsov*

Several cases of aircraft shafts failures produced in service under bending-torsion condition were studied. There were three situations of the mode I, III, and mixed I/III failures of shafts depending on the shear stress value. Various mechanisms of cracks development which caused structure failures in service under combined bending-torsion are discussed.

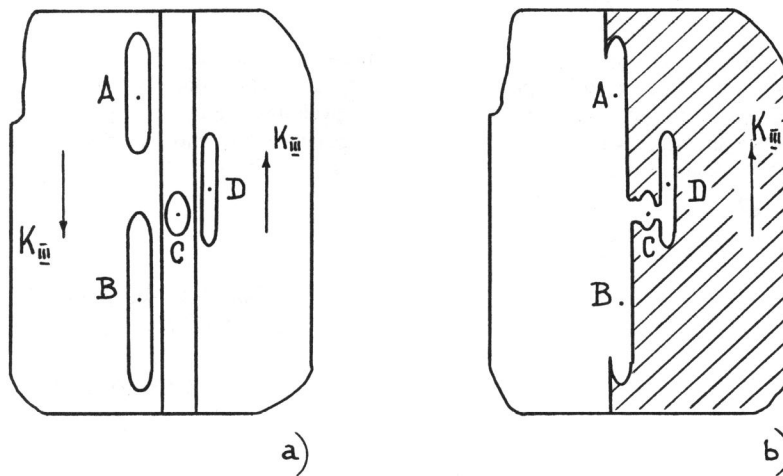
Figure 2 Schemes of the fracture process developing under torsion cyclic loading (a) before and (b) after pores coalescence, courtesy from (1)

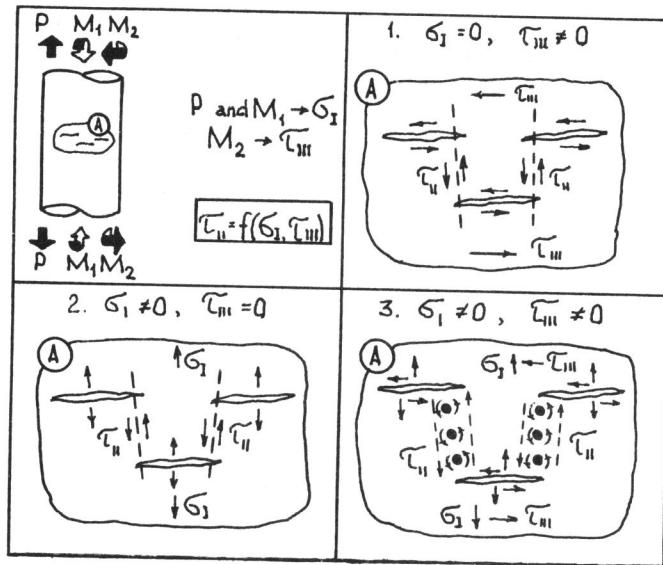
Therefore, the fracture process of the shaft was developed in the next consequence. The static fracture zones were created first and a big stress concentration was introduced. The highest stress existed around of the shaft face from the bending-torsion loading. The crack growth rate along the face under this loading was higher than for any place in the depth direction from the face. That is why the crack front had S-shaped form. This was the same situation as shown for the steps formation in Fig.3, but in the case of cyclic loads.

Figure 3 Schemes of fracture processes produced similar patterns under various biaxial tension-torsion loads for (1, 2) static or (3) fatigue fracture cases
