The Analysis of Fracture Surfaces by  
Electron Microscopy

by Regis M. N. Pelloux\* and J. C. McMillan\*\*

The fracture surfaces of metals and alloys exhibit markings and a topography which are characteristic of the mechanisms of fracture operating during the initiation and the propagation of the crack. These markings can be easily and best differentiated by electron microscopy.

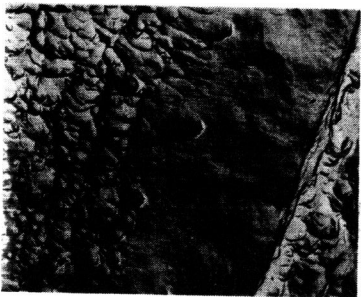
Figure 8 - PLASTIC FRACTURE -  
TEAR MODE - Elongated dimples  
resulting from a tear plastic  
fracture in a 4340 steel. See  
Sketch 5c.  
3000X

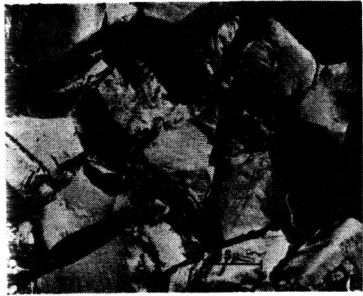
Figure 14 - INTERGRANULAR FRACTURE - Brittle intergranular fracture in a 70-30 brass. This fracture is the result of a slow crack propagation under cyclic load in a centrally notched panel of brass. 3000X

Intergranular fracture is a separation of the crystals from each other along the grain boundaries. Figure 13 is a typical intergranular fracture in a 4340 steel. The grain boundary facets are slightly curved which show that the conditions for metastable equilibrium of the grain boundary network were satisfied at the austenitizing temperature. The small "hairlines" on each facet are unaccounted for and may be related to the second phase particles or to the mechanism of separation of the grains. Another example of a perfect intergranular fracture is shown on Figure 14 which represents the fatigue fracture surface of a 70-30 brass.

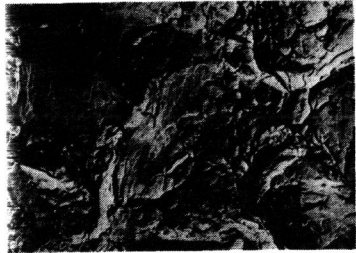
Figure 16 - MIXED PLASTIC - INTERGRANULAR FRACTURE Example of juxtaposition of two modes of fracture: plastic and intergranular in a 4340 steel. 2500X

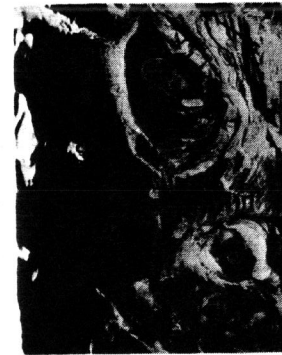
Figure 18 - FATIGUE FRACTURE - Examples of ductile fatigue striations and brittle fracture of second phase particles in a 7178 aluminum alloy. 3500X

Data reporting crack growth rates  $\frac{da}{dN}$  as a function of stress intensity are readily available in the literature. (21) A basic discrepancy between growth rates determined by surface optical techniques and electron fractographic means has been reported by Pelloux. (22) If the crack front does not move in a uniform manner over its whole length, common for  $K_{II}$  values, the average spacing of the striations will be larger than the macroscopic growth rate. However, at higher  $K_{II}$  values brittle fracture of inclusions and ductile tearing around these inclusions results in a rapid local advance of the crack front. Consequently, the striation spacing is, in general, smaller than the macroscopic crack growth rate observed on the surface of a test panel. Figure 18 illustrates clearly the extensive brittle fracture of large inclusions.

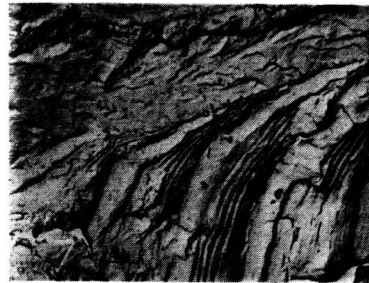
2200X

Figure 22 - FATIGUE FRACTURE - Ductile and brittle striations in a 7178 aluminum alloy occur in adjacent areas, but only the ductile striations are clearly defined.

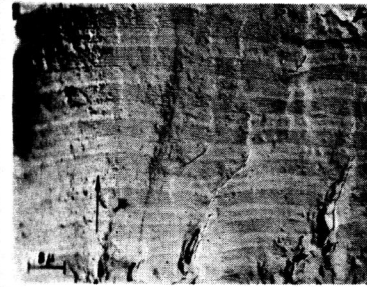
2200X.

Figure 25 - FATIGUE FRACTURE - Three distinct growth bands are apparent in the fracture topography of this spectrum loaded 7178 aluminum alloy. Loading in this spectrum was divided into three general load levels. Even though striations are not clearly defined in each area, some growth did occur.
