# CORROSION FATIGUE FRACTURE BEHAVIOR OF HIGH-STRENGTH Cu TROLLEY WIRE FOR HIGH-SPEED RAILROAD SERVICES

K. Minoshima, K. Miyazawa and K. Komai

Department of Mechanical Engineering, Kyoto University, Kyoto 606-8501, Japan

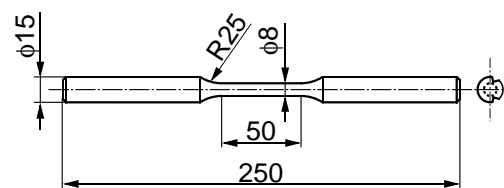
**Figure 1:** Shape and dimensions of smooth test specimens. All dimensions are in mm.

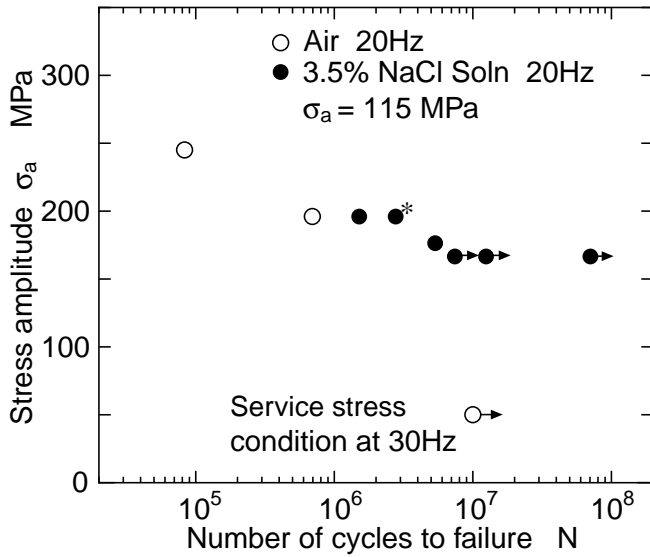
**Figure 2:** S-N curves of Cu trolley wire in laboratory air and in a 3.5% NaCl solution at 25°C. The tests were conducted under a mean stress of 115 MPa, corresponding to tension stress of the trolley wire in a service condition.

Figure 2 illustrates the relationship between the stress amplitude and the number of cycles to failure (S-N

curves) of fatigue conducted in laboratory air and in NaCl solution. The superscript “\*” denotes the number of cycles to failure of an interrupted fatigue test mentioned before. Although the number of samples conducted in laboratory air is small, fatigue strength in NaCl solution was almost equal to that conducted in laboratory air. The run-out result conducted at a stress amplitude of 50 MPa was that of a simulated test of a service stress condition. These indicate that the trolley wire is strong enough for fatigue loading of a service operation. In a corrosive environment, the crack which led the final failure was initiated not at the exposed surface, but at the coated surface. This indicates that the fatigue fracture mechanism operating in a corrosive environment was the same as that of the fatigue conducted in laboratory air. Note that the failed specimen at a stress amplitude of 167 MPa was fractured at a gripping position due to fretting, and this is considered an exception.

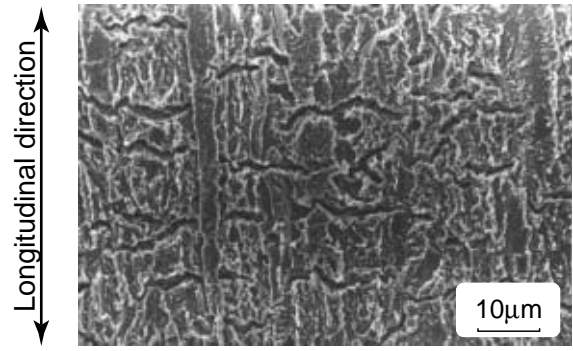
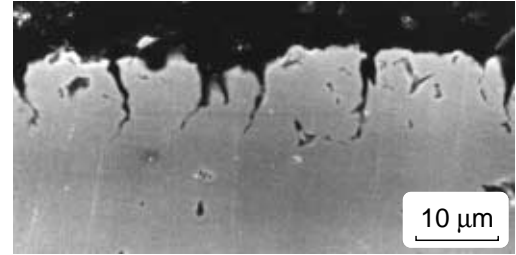
(a) Sample surface.

(b) Cross section along the longitudinal direction  
**Figure 3:** Corrosion fatigue damage at  $\sigma_a = 196$  MPa ( $\sigma_m = 115$  MPa,  $N_f = 1.5 \times 10^6$ )

Figures 3 to 5 illustrate the SEM images of corrosion-fatigued specimen surface and the cross sections along

the loading direction. It is clear that the specimen surfaces were subjected to general corrosion, and no corrosion pit that would induce the crack initiation was observed. The morphology of the general corrosion was influenced by the texture of the material owing to drawing. The amount of general corrosion increased with an increase in the number of cycles (compare Fig. 5 with Fig. 3).

When the applied stress was high, multiple short transverse cracks were formed on the exposed surface (see Fig. 3(a)). Cross sectional views showed that the depth of these cracks remained short and was about 10  $\mu\text{m}$  (Fig. 3(b)). The other noticeable point is that the crack wall was corroded, and this is in particular large near the surface. When the multiple cracks are formed on the surface, the stress concentration factors are increased or decreased depending on the distribution of surface defects. Ishida and Igawa [14] investigated the influence of multiple crack distribution on the stress intensity factor of a crack in a infinite body. They showed that the stress intensity factor is decreased when the cracks lined up, but increased when the cracks are distributed in a zigzag manner. From Fig. 3, the surface cracks tended to line up rather than to form in a zigzag manner. This indicates that the multiple crack formed on the surface may release the stress concentration, leading to lower crack growth rate.

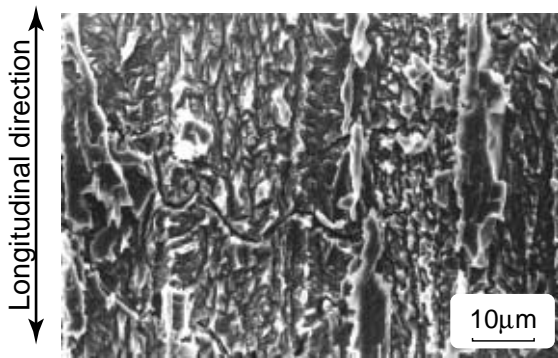
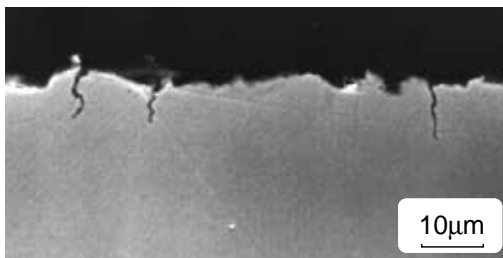
(a) Sample surface.

(b) Cross section along the longitudinal direction.

**Figure 4:** Corrosion fatigue damage at  $\sigma_a = 167$  MPa ( $\sigma_m = 115$  MPa,  $N_f = 7.4 \times 10^6$ )

As is discussed, multiple transverse cracks were nucleated, and then they grew due to coalescence (Figs. 4(a) and 5(a)). When multiple long cracks become long as shown in Fig. 5(a), the stress concentration factors are decreased. In addition, the crack walls were severely corroded, and the crack tip became blunt (Fig. 5(b)). From Fig. 4(b) and Fig. 5(b), it is clear that the extension of the crack toward the inside of the specimen was relatively short. The apparent crack growth rate computed was small, and was obtained at about  $1.1 \times 10^{-11} \text{ m/s} \approx 5.5 \times 10^{-13} \text{ m/cycle}$ . This was caused by the relief of the stress concentration due to crack blunting, and the crack growth rate became so much as that of general corrosion rate.

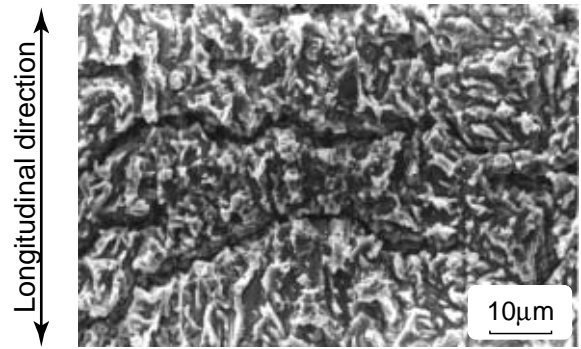
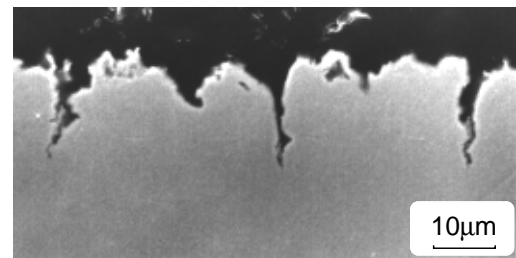
(a) Sample surface.

(b) Cross section along the longitudinal direction.

**Figure 5:** Corrosion fatigue damage at  $\sigma_a = 167$  MPa ( $\sigma_m = 115$  MPa,  $N_f = 1.2 \times 10^7$ )

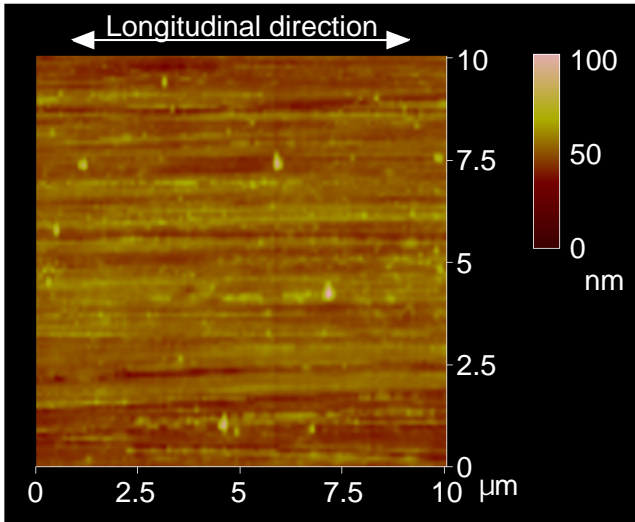
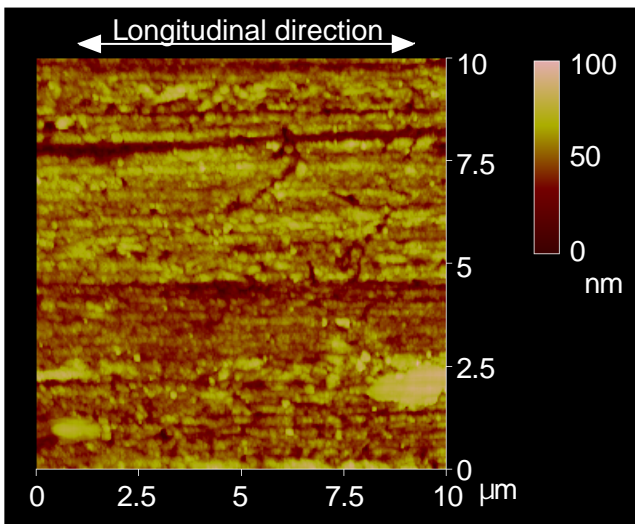
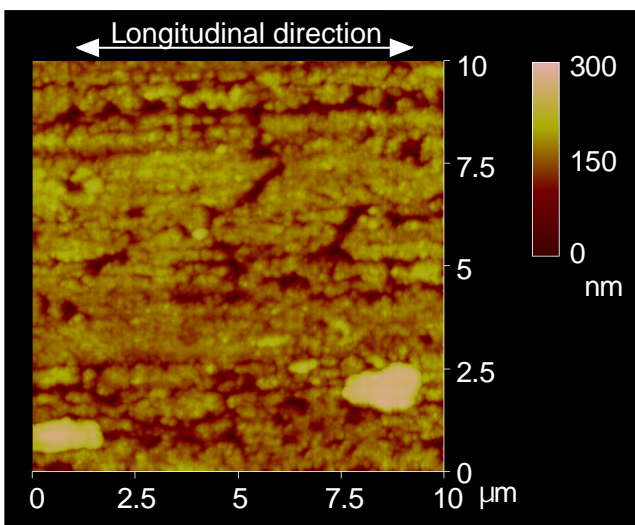
(a) Virgin sample surface

(b)  $n = 1.4 \times 10^5$ , corresponding to two hour testing.

(c)  $n = 7.2 \times 10^5$ , corresponding to ten hour testing  
**Figure 6:** AFM imaging of the sample surface fatigued at  $\sigma_a = 196$  MPa with  $\sigma_m = 115$  MPa in a 3.5% NaCl solution. The test was periodically interrupted to observe the sample surface.

In order to investigate the influence of the varying load on general corrosion, interrupted tests were conducted in samples with and without cyclic loading, and the changes in surface were examined by atomic force microscopy. The results are shown in Fig. 6 (under varying loads) and Fig. 7 (without loading). The longitudinal grooves that were observed in the virgin samples were due to final finish by diamond paste. From these AFM images and SEM images that are not shown here, the corrosion preferentially progressed along the longitudinal direction. This may be resulted from the influence of the longitudinal scratches induced by polishing and the longitudinal textures due to drawing. The second important thing which could be deduced from the figures is that the corrosion morphology was not influenced by varying load when the crack was not nucleated on the surface. Figure 8 illustrates the changes in roughness, root mean square roughness (RMS) and center plane roughness,  $R_a$ , measured with the AFM. Note that the unit used is nm. It is clear that the both roughness increased with an increase in testing duration, and no influence of varying load was observed. This indicates that although the corrosion behavior of this material was dependent on the microstructure, no influence of varying load was observed, as far as severe plastic deformation did not occur. When the testing duration was larger than 25 h, the roughness became smaller. This is due to measurement error owing to large roughness. The principle of the operation of the AFM is that the small, sharp tip positioned at the end of a micromachined small, weak cantilever is raster-scanned on the surface: the observed surface was so rough that the tip could not reach the bottom of the surface.

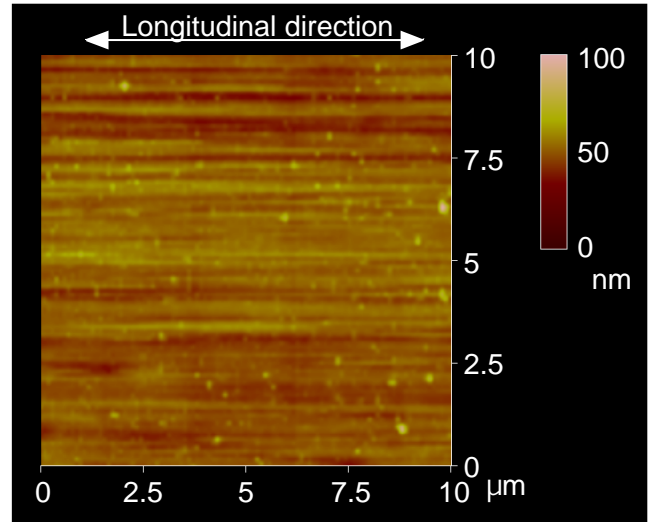
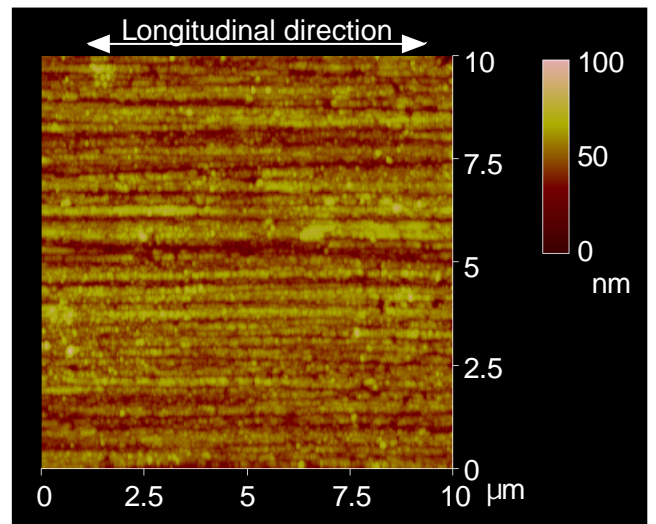
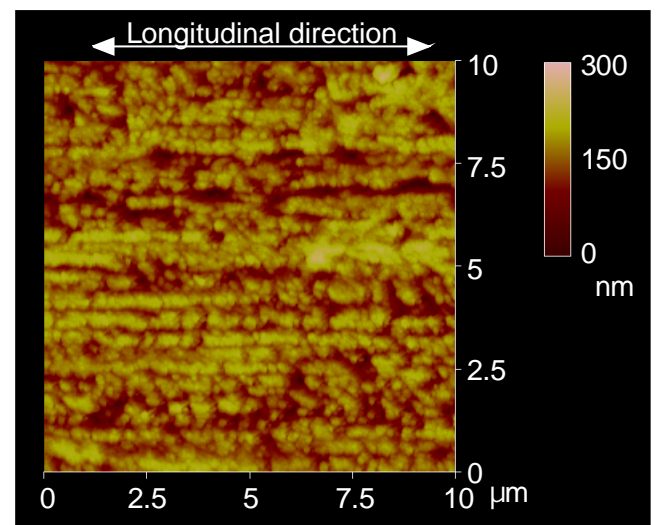
(a) Virgin sample surface

(b) Testing duration: two hours.

(c) Testing duration: ten hours.  
**Figure 7:** AFM imaging of the sample surface without any loading in a 3.5% NaCl solution (Static corrosion). The test was periodically interrupted to observe the sample surface.

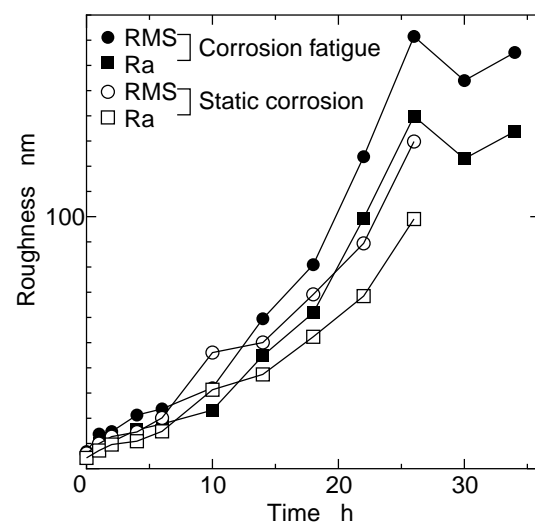
**Figure 8:** Changes in roughness of sample surface of corrosion fatigue and static immersion without loading.
