On the propagation of stress-corrosion cracks in a magnesium-aluminum alloy

E. N. PUGH, J. A. S. GREEN and P. W. SLATTERY

Research Institute for Advanced Studies, Martin Marietta Corporation,
Baltimore, Maryland, U.S.A.

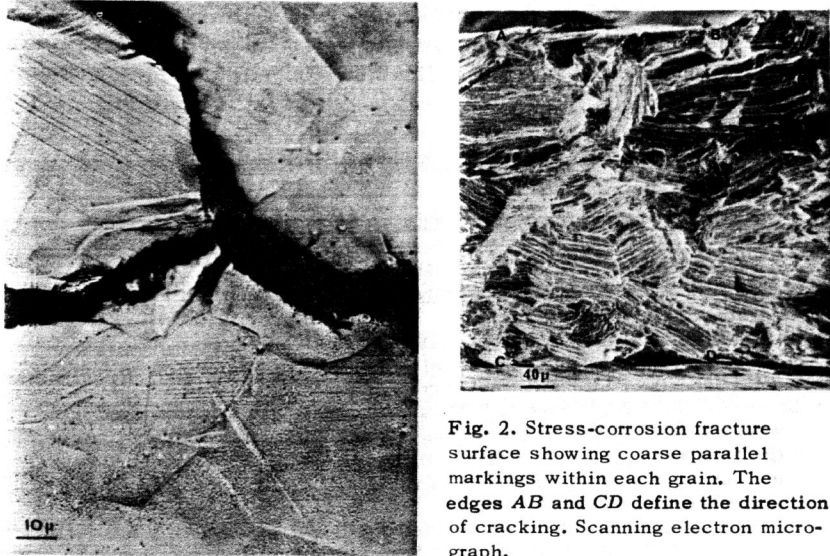
Fig. 2. Stress-corrosion fracture surface showing coarse parallel markings within each grain. The edges AB and CD define the direction of cracking. Scanning electron micrograph.

Fig. 1. Surface of gauge length in vicinity of a transgranular stress-corrosion crack, showing slip bands and deformation twins. Optical micrograph.

Examination of the surface of the gauge length in the vicinity of the stress-corrosion crack confirmed that failure was transgranular. Slip traces and deformation twins were evident in the grains in this region, Fig. 1; a *single* set of slip markings existed within each grain. The orientation of selected grains was determined by means of the Laue back reflection method, and one-surface trace analysis indicated that glide occurred on the basal plane. This conclusion is in agreement with recent findings by Clark [10] on the deformation of solution-treated specimens of a binary alloy containing 9 wt.% aluminum, and is consistent with earlier work [11]. The orientation of the twins was not determined but, from the literature [10, 11], it is probable that they occur on $\{10\bar{1}2\}$ planes.

Examination of the stress-corrosion fracture surfaces using the optical and scanning electron microscopes indicated that a single set of coarse parallel markings existed within each grain, Fig. 2. The direction of these markings varied from grain to grain, but in all cases they were approximately parallel to the direction of crack propagation*. Measurements taken from a large number of grains established that the maximum deviation from parallelism was $\pm 20^\circ$. It is evident from a consideration of the annealing texture and from the metallographic observations that these coarse markings represent the traces of basal glide planes. These

* The propagation of a single edge crack in thin sheet permits the direction of cracking to be accurately defined; it is parallel to the intersection of the fracture surface and the surface of the sheet, e.g. edges *AB* and *CD* in Fig. 2.

The absence of secondary slip (i.e. slip on systems other than the basal plane) on the surface of the gauge length within grains adjacent to the fracture surface, e.g. Fig. 1, would appear to rule out the possibility that the fine markings correspond to slip steps. This conclusion is supported by observations on specimens which were cold rolled (25% reduction in thickness) before testing. It was considered that slip during crack propagation would be suppressed by the 'cold work', and it was found that the basal-slip traces were in fact virtually eliminated from the fracture surfaces in such specimens. Significantly, the fine markings persisted, Fig. 3 (b). The density of twins in grains adjacent to the fracture surface (~ 2 per grain) is not sufficient to account for the fine markings. By a process of elimination, then, it is concluded that the markings represent striations, that is, they correspond to the successive positions of the crack front during discontinuous crack propagation. The presence of the 'triple points' indicates that the crack front does not advance uniformly in all instances, segments advancing ahead of, or remaining behind, the main crack front. Similar configurations have been observed in the striations on the fracture surfaces of embrittled silver chloride [2].

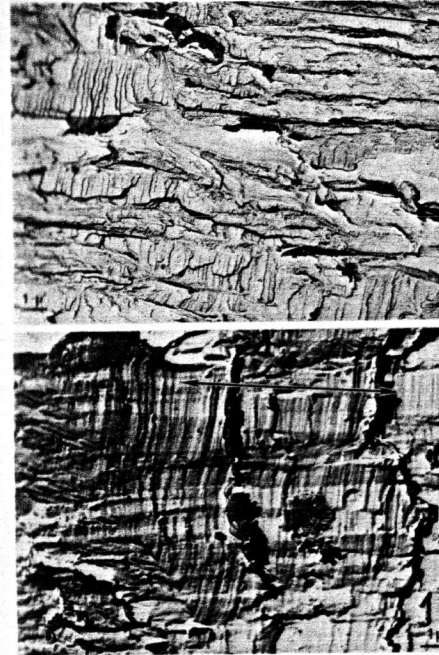
Fig. 3. Replicas of stress-corrosion fracture surfaces of (a) solutions treated and (b) cold rolled specimens, illustrating striations. The arrows indicate the direction of cracking. Electron micrographs.

Electron-microscope studies revealed that each grain exhibited a second series of parallel markings, considerably finer than the basal-slip traces, and which were approximately perpendicular to the macroscopic direction of cracking, Fig. 3 (a). The average spacing between the fine markings was $0.1-0.8\mu$, and did not vary significantly with position on the fracture surface, i.e. the spacing was not dependent on the crack length. It can be seen that neighbouring markings in some instances merge together, forming 'triple points', Fig. 3 (a), and in this respect they resemble cleavage markings. However, it should be emphasized that the markings in the present case are *perpendicular* to the cracking direction, whereas cleavage markings would be *parallel*.

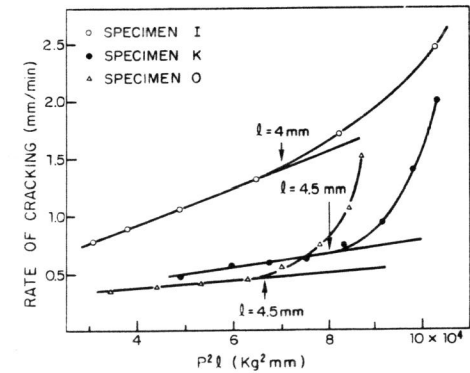
Fig. 5. The relationship between the rates of stress-corrosion cracking and the square of the intensity parameter, $P^2 l^2$.

For thin sheet, the stress-intensity parameter for relatively short cracks is $P l^{1/2}$ [16]. In Fig. 5, the rates of cracking, obtained by taking the slopes of the curves in Fig. 4 (a), are plotted against the square of the stress-intensity parameter. It can be seen that for $l < 0.2-0.25$ sheet width, the relationship is linear, so that
