## Fatigue Behaviors near Endurance Limit of Copper

J. Awatani, K. Katagiri  
A. Omura and T. Shiraishi  
Inst. Scientific & Industrial Research,  
Osaka University, Japan

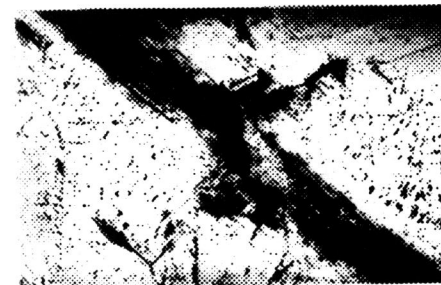
Fig.7 The micro-crack after annealing and stressing for  $1.6 \times 10^9$  cycles, showing propagation of the crack

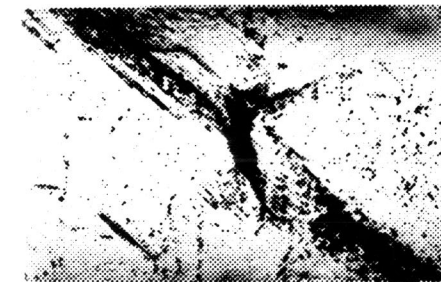
Fig.8 The aspect of the crack after a slight polishing

Then, the specimen was annealed at  $500^\circ\text{C}$  (1 hr), and stressed for the same number of cycles ( $3.2 \times 10^9$  cycles), but all the cracks showed no changes. Hence, the annealing temperature was elevated up to  $600^\circ\text{C}$  (1 hr) and the same stressing as above was again repeated. Although other cracks did not extend in this treatment, the above crack showed a considerable extension, with the slip-markings as seen in Fig.7. Polishing of a slight amount of the specimen surface could reveal the progress of the crack during this treatment (Fig.8).
