FRAC TOGRAPHIC OBSERVATIONS ON STRESS CORROSION CRACKING OF
SOME FACE-CENTRED-CUBIC ALLOYS

H. E. Hänninen, J. A. Honkasalo and H. A. A. Pitkänen*

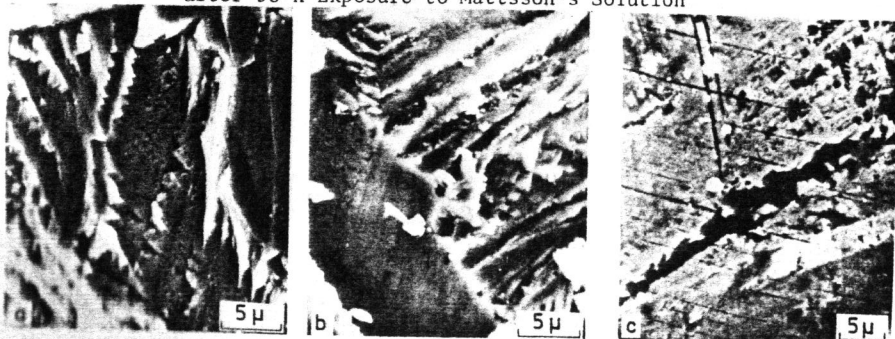
Figure 6 (a), (b) and (c) Fractographs of Cu-6Al after 335 h Exposure to 25% NH₃ Atmosphere

This corrosion product film which formed in NH₃ atmosphere on the fracture surfaces of α -Cu-Al alloys made the study of fracture surface morphology of these alloys rather difficult. Figure 6(a) shows a part of the fracture surface of Cu-6Al alloy after 325 h exposure to 25 % NH₃ atmosphere having very similar saw-tooth morphology as could be seen in Cu-37Zn. Figure 6(b) shows the change from intergranular to transgranular mode of fracture and in Figure 6(c) is shown a part of the intergranularly
