ANISOTROPIC FRACTURE OF A HOT-STRETCHED ACRYLIC THERMOPLASTIC

Keith Williams*

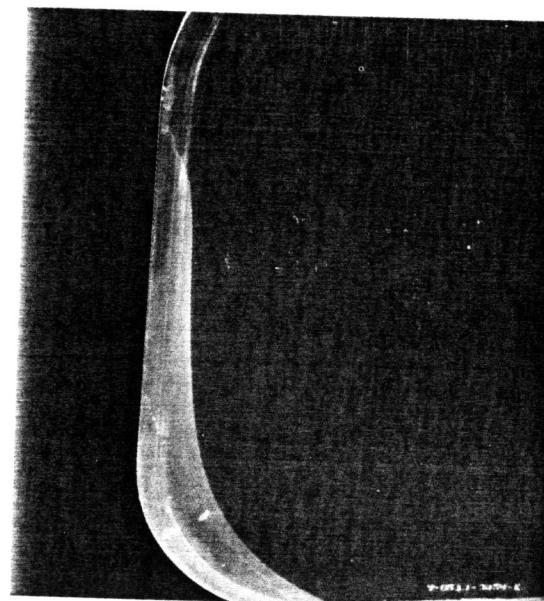
Figure 1 In Plane Cracking in an Airliner Cabin Window. Window Size Approximately 385 mm x 285 mm
