MECHANICAL FAILURE ON THE MICROSTRUCTURAL  
LEVEL IN HAVERSIAN BONE\*

P. Frasca\*\*, R. A. Harper\*\*\* and J. L. Katz\*\*\*

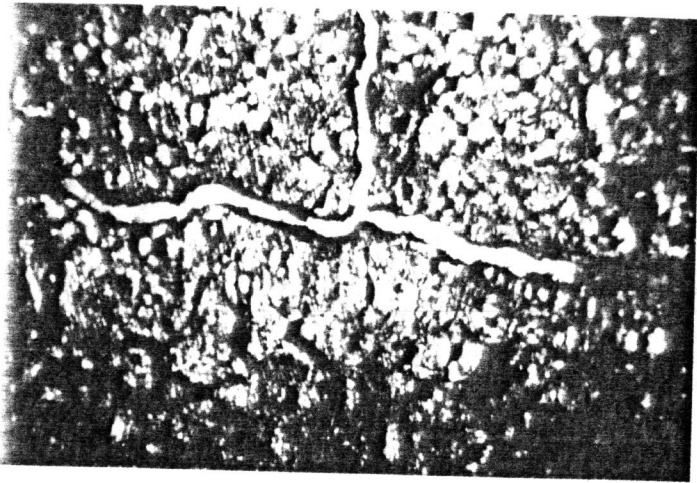
Figure 1 Thin cross-section of human cortical bone broken by bending by hand. Note the tendency of fractures to circumvent osteons. Mag. 30X.

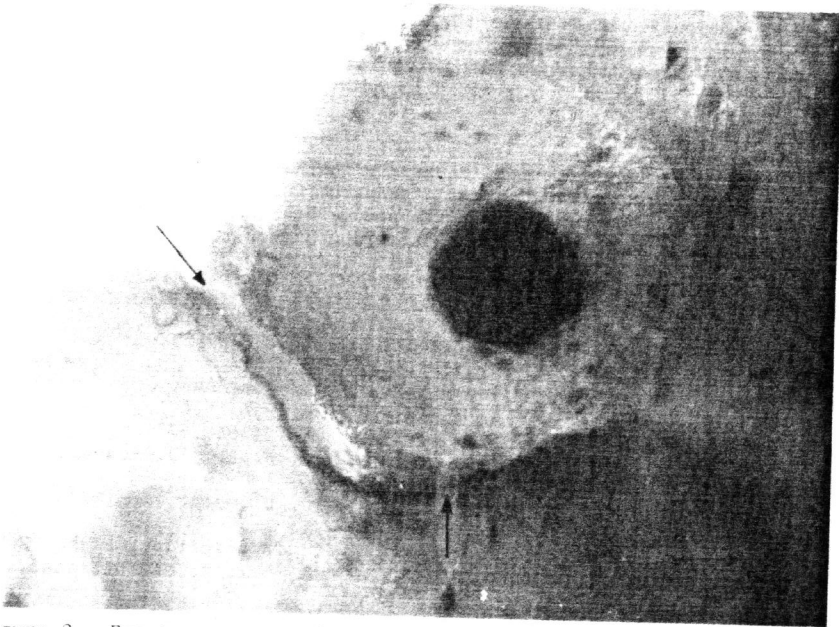
Figure 2 Fracture propagation through a portion of the cement line bordering between an osteon and interstitial bone belonging to a thin transverse cross section of human cortical bone. Mag. 250X.

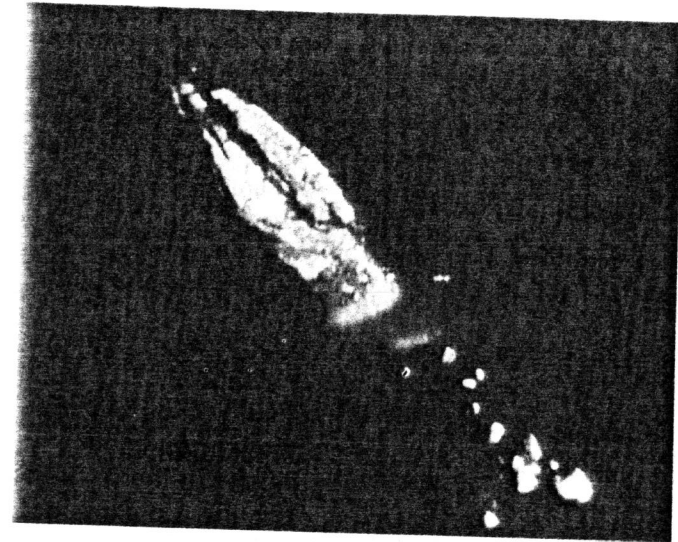
Figure 3 Portion of a single human osteon broken by cyclic torsional stress overload at a frequency of 10 hertz. Note the exposed Haversian canal as well as the spiral nature of the fracture surface inclined at about 30° with the osteon axis. Mag. 75X

Another example of bone fracture not influenced by the microstructure can be found in an osteon fractured by cyclic (10 hertz) torsional stress overload, Figure 3. The fracture site presents a spiral, well defined surface indicative of a brittle, structurally homogeneous material; no microstructural effects were noticed. A closer look with scanning electron microscopy reveals an additional fracture plane; this is a consequence of the cycling mode which alternates the plane of maximum tensile stress from the  $45^\circ$  plane (for a homogeneous isotropic material) to the  $135^\circ$  plane upon reversal of twist direction. Although failure must have initiated at one plane, the other plane apparently was also made to reveal the history of destructive tensile stresses, see Figure 4.

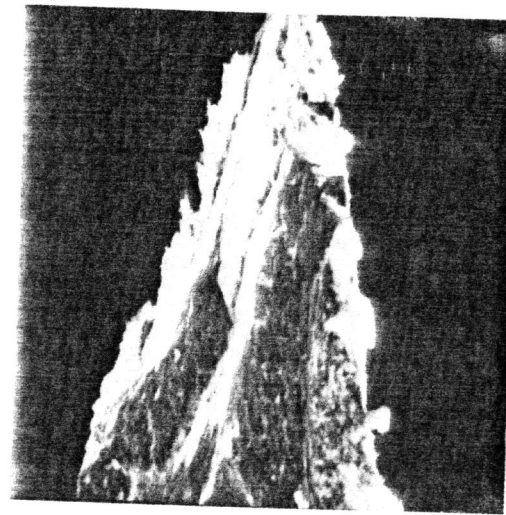
Figure 4 Osteon sample of Figure 3 observed with scanning electron microscopy. Note the two fracture planes - inclined at about 30° with the osteon axis - representative of cyclic rather than unidirectional stress overload. Mag. 200X

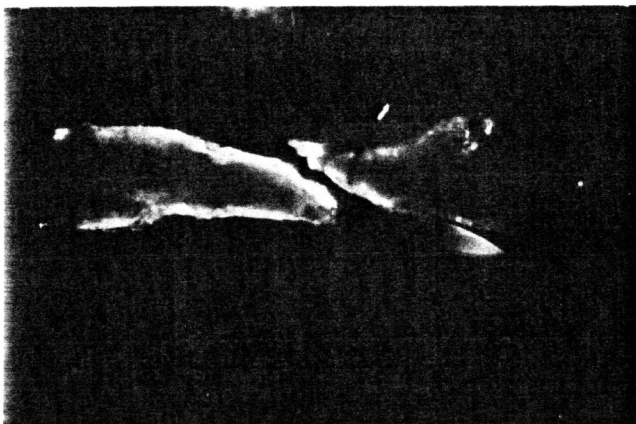
Figure 5 Microsample of human cortical bone containing several osteons, broken by unidirectional stress overload. The fracture planes are inclined at less than  $45^\circ$  with the osteon axis. Mag. 25X.

When subjected to unidirectional torsional overload microsamples containing several osteons such as shown in Figure 5, displayed only one fracture plane inclined at less than  $45^\circ$  with the general osteon axis. The spiral fracture plane was not equally visible in all samples. The inclination of these fracture planes with respect to general osteon axis are comparable to those obtained with respect to the bone axis for whole dog tibias and femurs subjected to unidirectional torsional loading [5]. Samples containing several osteons subjected to fatigue by torsional cycling exhibited general fracture planes of less than  $45^\circ$  (with respect to the general osteon axis), which were not well-defined, but rather highly irregular. Microstructural consequences of fatigue-induced failures are still under study.

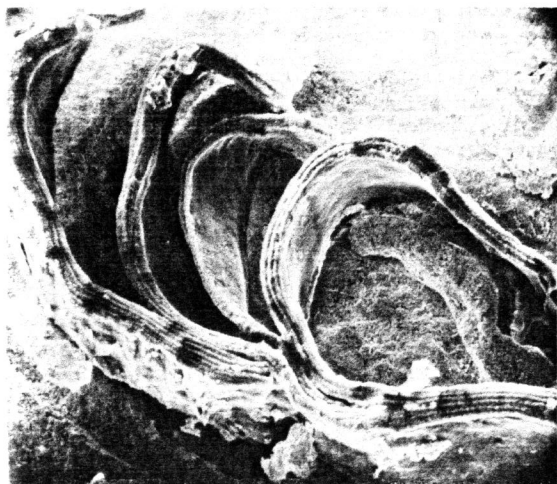
Figure 6 EDTA decalcified human osteon sample subjected to repeated fingertip compression between two glass slides until some collagen-rich lamellae were forced to separate from each other at their interface. Mag. 200X.

Subjecting decalcified single osteons with aspect ratios of one or less to compressional loading in the direction of the osteon axis results in a completely different failure mechanism from that obtained for undecalcified osteons; the collagen-rich lamellae detach themselves from each other at their interfaces as seen in Figure 6. This is accomplished not with a single loading, but with repeated loadings applied with finger pressure to the wet osteon sample sandwiched between two glass slides. No microfissures are produced in the elastic wet collagen sample as occurs with the undecalcified osteons; rather, the damaging stresses are transmitted to the weak interlamellar region which once decalcified are believed to consist of a relatively low density of collagen structures as well as of presently unidentified ground substance components [7].

With each compressive loading the osteon contracts along its axis and expands in the direction perpendicular to it. The collagen lamellae themselves remain undisturbed, but the interlamellar constituents eventually fail and a clean separation between collagen lamellae results. That radial tensile forces are at least partially responsible for this failure mode can be appreciated from evidence of radially disposed broken collagen fibers which, prior to the sustained damage, bridged across consecutive collagen-rich lamellae [8].
