Fractographic Analyses of Fatigue Fracture Surfaces of 7050 Aluminium Alloy

R. GÜRBÜZ and M. DORUK* and W. SCHÜTZ**
**Metallurgical Engineering Department Middle East Technical University, 06531 Ankara, Turkey*

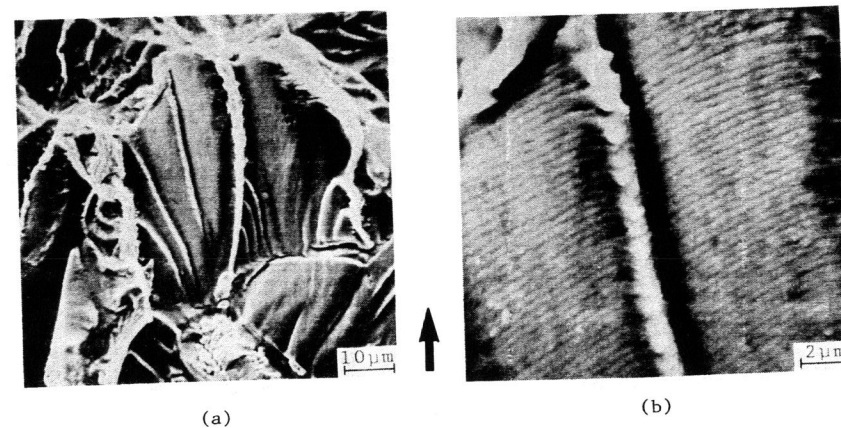
Fig. 2. SEM fractographs

a) S-L in air, c.g.r. $\approx 2 \times 10^{-4}$ mm/cycle

b) S-L in air, c.g.r. $\approx 5 \times 10^{-4}$ mm/cycle

Arrow shows the crack growth direction.

The tear ridges and furrows parallel to the crack growth direction observed on almost all specimens show that cracks propagate with several local fronts on different growth planes. Those local cracks with individual fronts then coalesce with each other as the macro crack extends. This coalescence takes place with ductile tearing between the planes of local cracks and thus forms tear ridges or furrows parallel to the local crack propagation direction. This phenomenon creates an appearance that resembles river patterns but is not really so (Figs. 2a and 5a).

Fatigue striations are observed extensively in all specimens at relatively lower and medium crack growth rates, on the transgranular planes separated by tear ridges or furrows (Figs. 2b, 5b and 6a). The density of the striations, however, decreases with increasing crack growth rate. Dimples, voids and void coalescence begin to appear together with striations at high ΔK values approaching the critical condition for crack instability (Figs. 3b and 7a). The curvature of the striations that shows the position of an advancing local crack front is always observed to be convex.

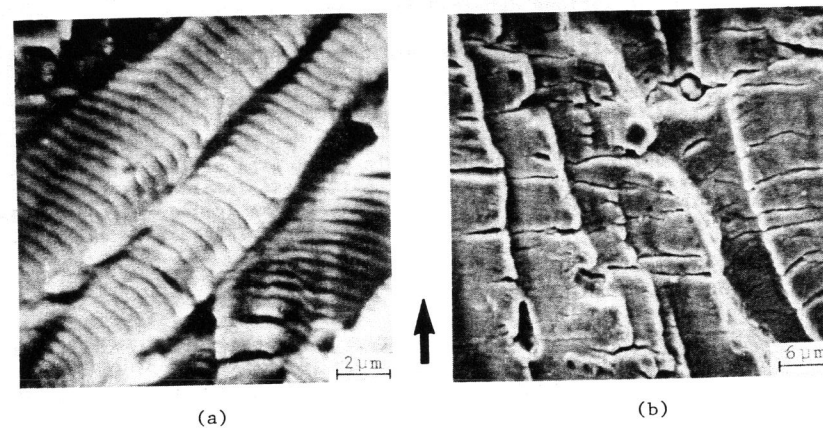
Fig. 6. SEM fractographs

- a) S-T in salt water fog, c.g.r. $\approx 7 \times 10^{-4}$ mm/cycle
 - b) T-S in air, c.g.r. $\approx 4 \times 10^{-4}$ mm/cycle
- Arrow shows the crack growth direction.

Secondary cracks parallel to crack fronts and growing in a plane perpendicular to main crack growth plane are observed frequently in all specimens (Figs. 5b, 6b). They sometimes coalesce with each other and form longer secondary cracks. The coalescence of secondary cracks that seems to be texture dependent is extensively observed in T-S orientation where the secondary cracks are parallel to rolling direction. It is clearly apparent from the Figs. 5b and 6a that too many secondary cracks form between the
