CHARACTERISATION OF HYDROGEN INDUCED FRACTURE IN THE TITANIUM ALLOY IMI685

M.R. BACHE, H.M. DAVIES and W.J. EVANS

*I.R.C. in Materials for High Performance Applications,
University of Wales, Swansea, West Glamorgan, SA2 8PP, U.K.*

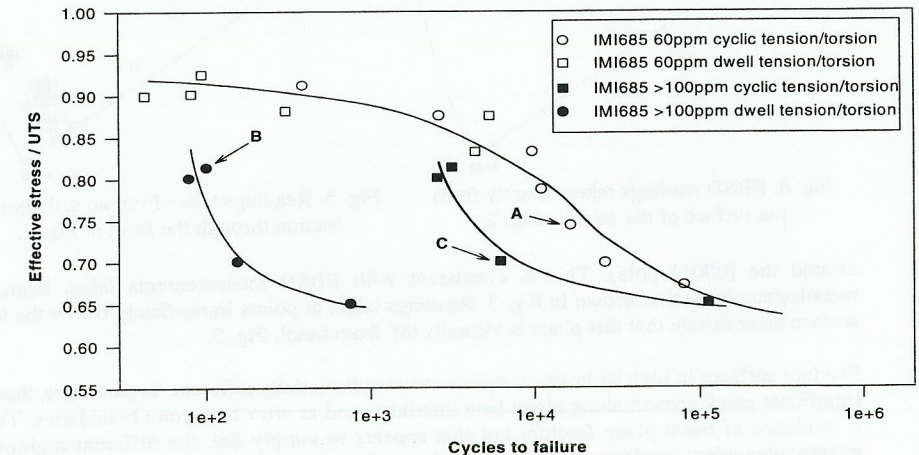
Typical cyclic and dwell fatigue data for IMI685 with 60ppm and 250ppm hydrogen contents are shown in Fig. 1. The tension and torsion results have been correlated through a von Mises equivalent stress criterion. The applied fatigue stress levels are normalised by the monotonic tensile strengths of the alloy with the two hydrogen contents (976 and 998MPa at 60 and 250ppm respectively). On this basis, increased hydrogen levels reduce fatigue life, especially under dwell loading where reductions up to two orders of magnitude are observed compared to the 60ppm material. Specimens selected for subsequent EBSD analysis are indicated by the letters A, B and C.

Fig. 1. Low cycle fatigue data for IMI685.

The mechanical property data also display important variations depending on the amount of hydrogen present. Figure 1 displays one aspect of this, in which it is evident that at 60ppm the fatigue lives of dwell and non-dwell loading conditions are similar i.e. for the aligned microstructure there is not a significant dwell sensitivity. Previous work (Evans and Bache, 1994) has confirmed a similar pattern of behaviour for low hydrogen levels. In contrast, the 250ppm hydrogen concentration induces a large dwell sensitivity in which the 120 second hold at maximum load causes a two orders of magnitude reduction in life compared with the cyclic waveform. Conversely, if the data are plotted on a time basis the response at the two hydrogen levels is reversed. The time to failure for cyclic loading of 60ppm material is now considerably shorter than the equivalent dwell cycle. At the same time the rate and level of strain accumulation is significantly larger under dwell. At >100 ppm, however, both dwell and cyclic experiments fail in approximately the same time, Fig. 13. Furthermore, the strains at failure are approximately the same for both loading modes - about 0.0055 at 750 MPa. Subsequently, when the strain - time records under dwell loading for 60 and 250ppm levels are compared, it

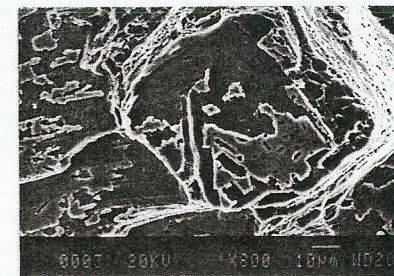
Fracture surface features are consistent with the metallographic sections and with the deductions from the EBSD analysis. Thus there is clear evidence of α/β interface cracking, grain boundary separation and propagation across basal planes, Fig. 9. At higher magnifications, the interfaces show evidence of terraces, containing residual material or rafts, Fig. 10. EBSD measurements taken from these rafts demonstrated a body centred cubic

Fig. 10. Beta raft upon underlying alpha plate, exposed via α/β interface cracking.
